Research & Development Highlights

Technical Series
90-232

Air Tightness, Air Movement and Indoor Air Quality in British Columbia High-Rise Apartment Buildings

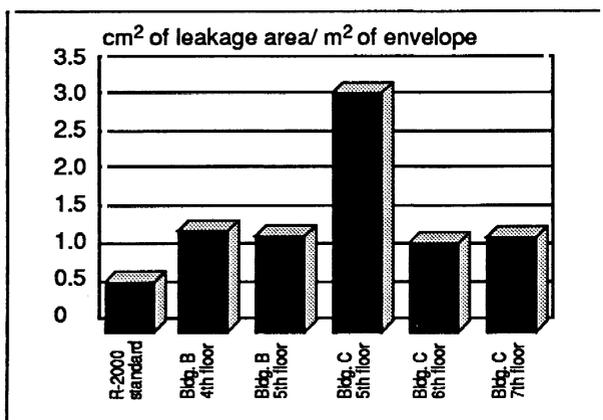
Normalized leakage areas

- Of the five floors whose depressurization test data has sufficiently high correlation coefficients, four have similar rates of leakage. The average Normalized Leakage Area (NLA) for these floors is 1.25 cm² per m² of envelope area. This is 1.8 times greater than the maximum allowable NLA for R-2000 houses. The remaining floor had an NLA of 3.17 cm² per m² of envelope area.

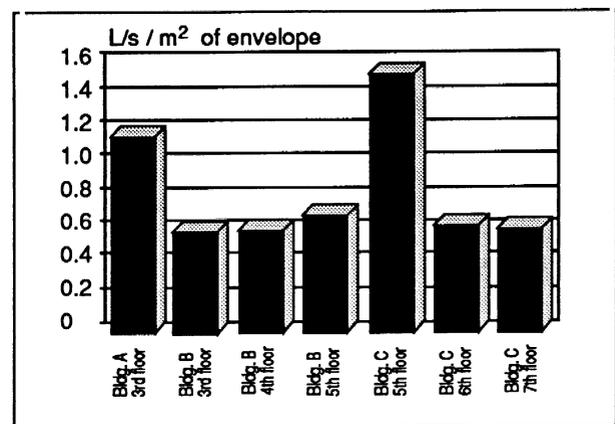
Comparative leakage at -40 Pa

- The greatest sources of air leakage, from most to least, are:
- elevator shafts;
- floors and ceilings;
- stairwell doors;
- sliding glass patio doors;
- suite fans with ineffective backdraft dampers; and
- various other service shafts.
