Technical Series 90-240

Wet-Sprayed Cellulose Insulation in Wood-Frame Construction

Research Report: Field Monitoring of Cellulose in Walls—Edmonton

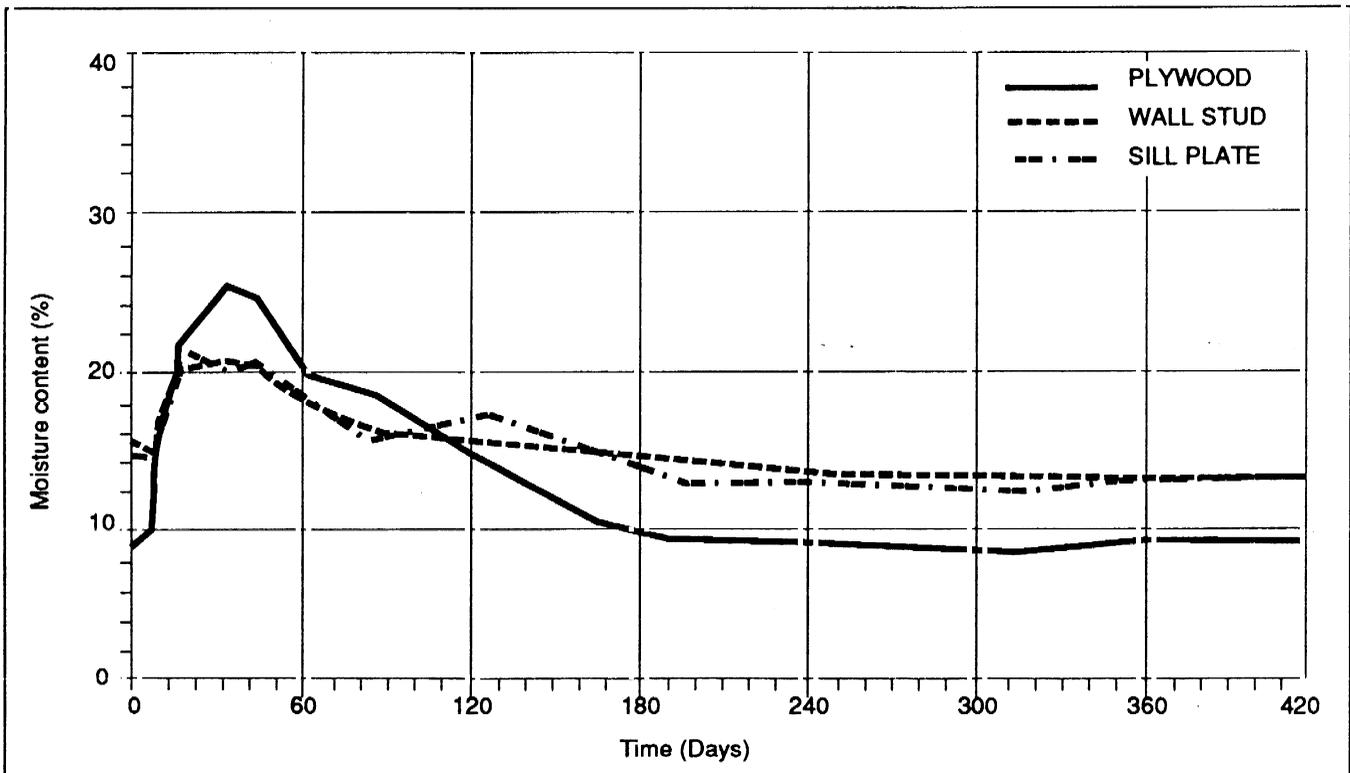
Average wall moisture contents

Sections of the frame adjacent to the dry insulation showed normal absorption and drying rates. After the wet-sprayed cellulose was installed, the plywood's sheathing moisture level increased to 26% after 30 days, decreased to near original levels (15%) after 160 days, and dried 1% more by the end of the test (420 days).

The framing timbers' moisture level increased to 22% in the first 10 days, dried to slightly over original levels (9%) after 80 days, and then dried 3% more by the end of the test (420 days). From these observations, the study concluded:
