## Fixing Houses with High Radon— A Canadian Demonstration

## Research Highlight

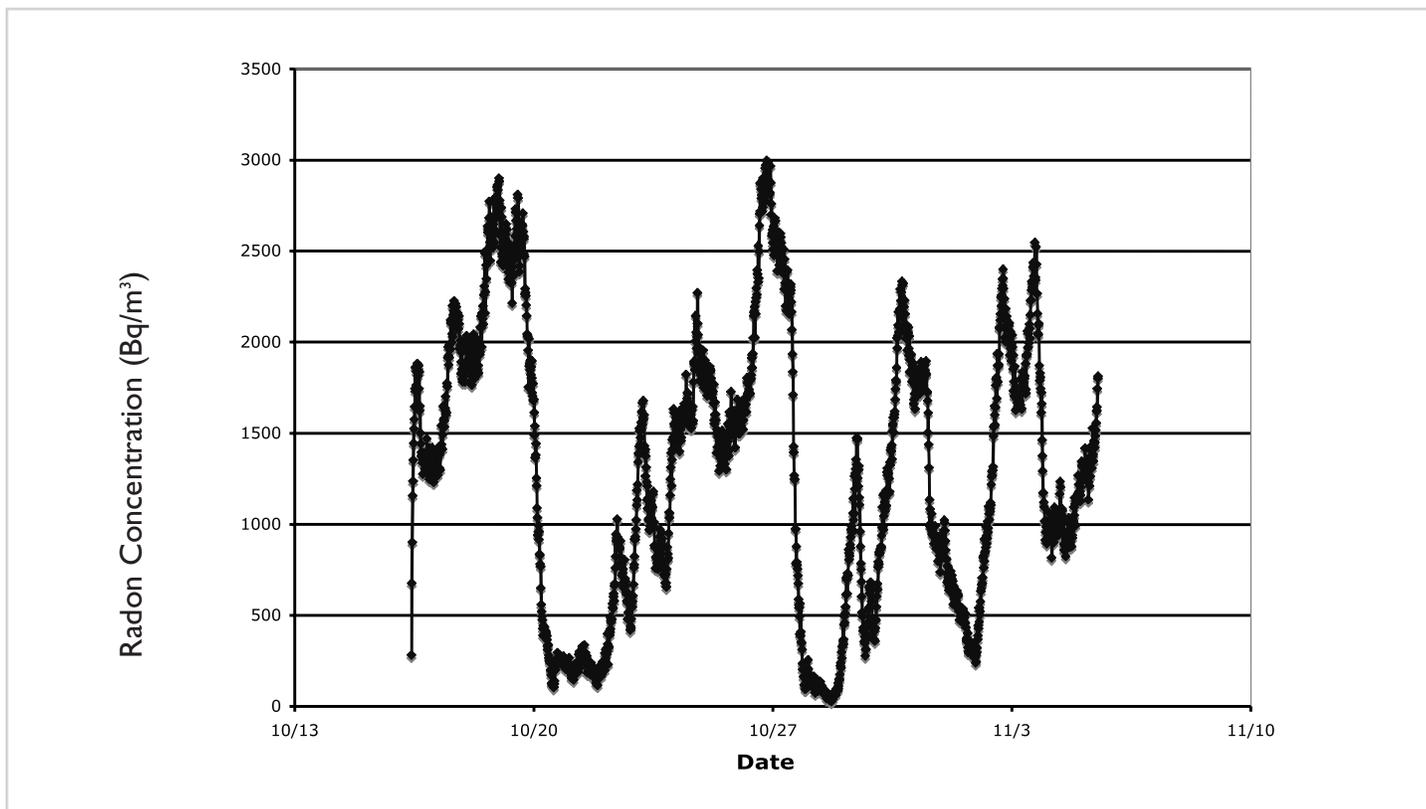
A homeowner in the community of Kanata in western Ottawa contacted CMHC and Health Canada for advice on high radon concentrations he had measured in his new house. Figure 1 shows almost a month of radon readings from his basement. Note that the concentration fluctuates due to house operation, climate factors, and so on. A short reading of two days duration could give a reading as low as 150 Bq/m<sup>3</sup> (for example, Oct. 28) or as high as 2,700 Bq/m<sup>3</sup> (Oct. 19). For that reason, *Radon: A Guide for Canadian Homeowners* recommends that houses be tested for at least one month.

Averaged over the test period, the homeowner's results were in the order of 1,400 Bq/m<sup>3</sup>, considerably in excess of either the new or old guideline. The basement had a poured concrete floor and walls, and was not remarkably different from neighbouring houses. It had a slab poured on polyethylene sheeting, which should reduce the radon entry rate.

Figure 1 Continuous radon monitor trace, October–November, 2007

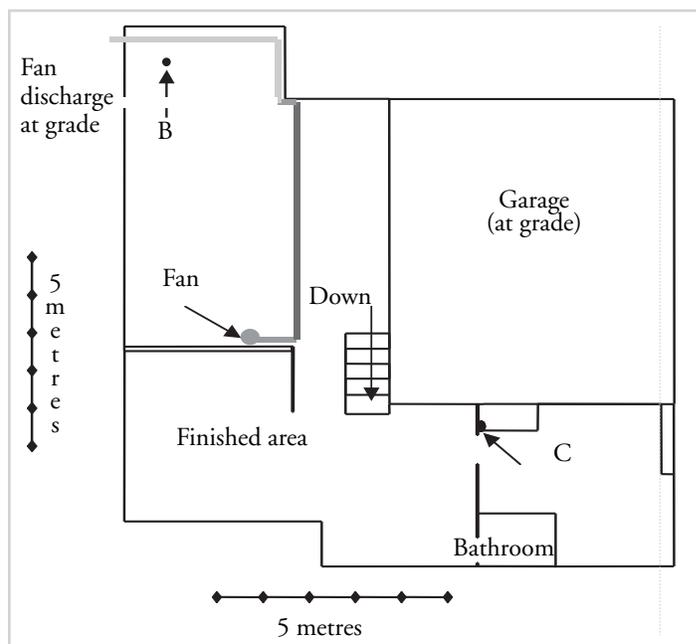
During the commissioning of the system, the fan flow was not quite high enough to make a consistent depressurization at the test holes B and C shown in Figure 2. This was cause for some concern, but it was decided to run the fan for a month and monitor its effectiveness before looking for a way to increase fan flow.

Figure 2 Installed fan and piping layout

The consultant drilled several small holes in the floor to measure whether all the air contained in the gravel layer under the slab could be depressurized by an exhaust fan connected through the slab at a single entry point. A ventilation contractor installed the fan and ducting to the consultant’s recommendations, and the system was activated.

The exhaust fan discharged the sub-slab air at grade and not at roof level, as recommended by the United States Environmental Protection Agency (EPA). This was due to concerns regarding the possible condensation and ice build-up problems within vertical vents on the outside of houses in cold Canadian climates. The project team felt that, if re-ingestion of the exhausted radon through windows, doors or other envelop leakage points in the vicinity of the exhaust fan discharge point was a large factor, the post-mitigation test would show high levels of radon inside the house. The radon concentrations were measured for a month in the winter following installation of the system. Figure 2 shows the basement, the location of the measurement holes (B, C), and the fan and ducting system.

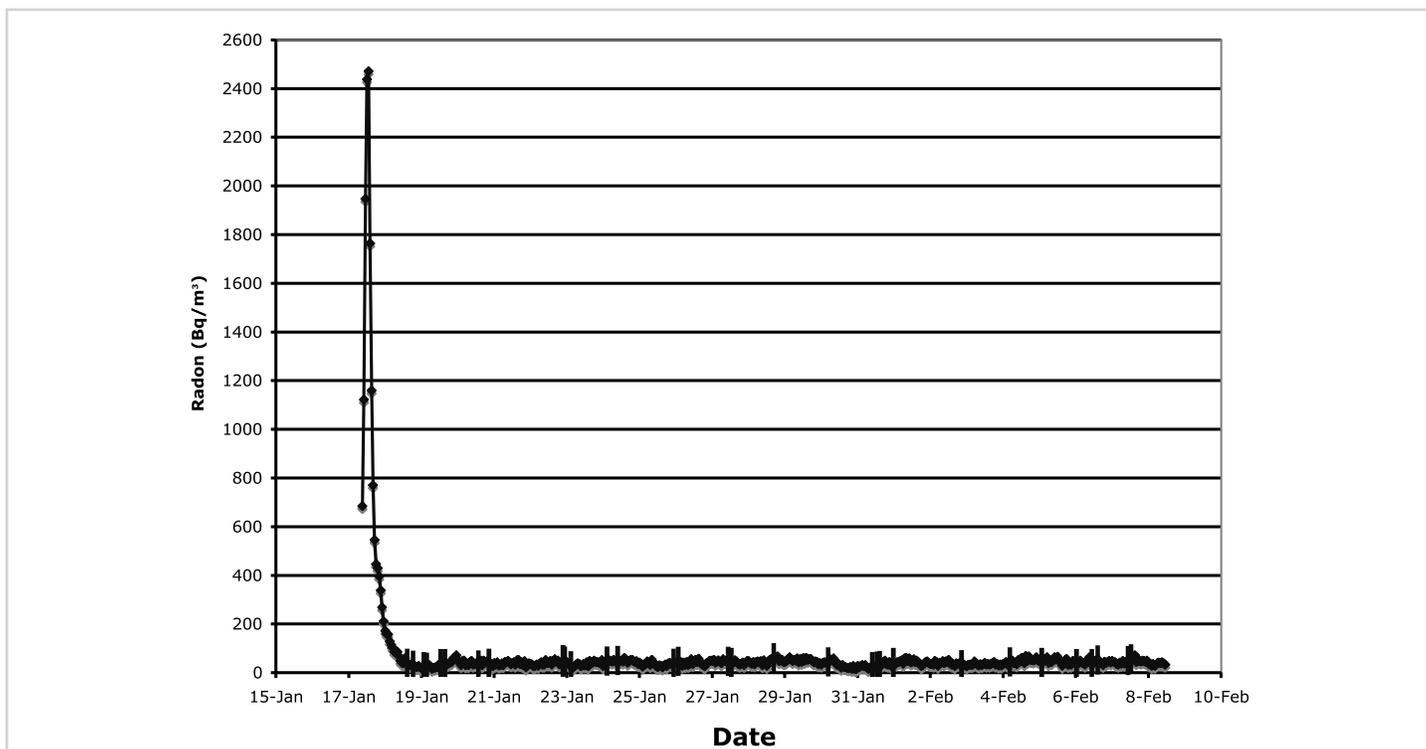
The system was remarkably effective (see Figure 3). Radon concentrations dropped from an average of 1,400 Bq/m<sup>3</sup> to about 40 Bq/m<sup>3</sup> for the month following, significantly below the HC 200 Bq/m<sup>3</sup> guideline. The homeowner was happy with the installation of the system and with the results. Re-ingestion of the exhausted radon was not a significant factor in this location during this period.

Figure 3 Continuous monitor trace during and after mitigation
