AVIATION INVESTIGATION REPORT

A99W0061

IN-FLIGHT FIRE

AEROSPATIALE AS 355 F1 TWINSTAR (HELICOPTER)

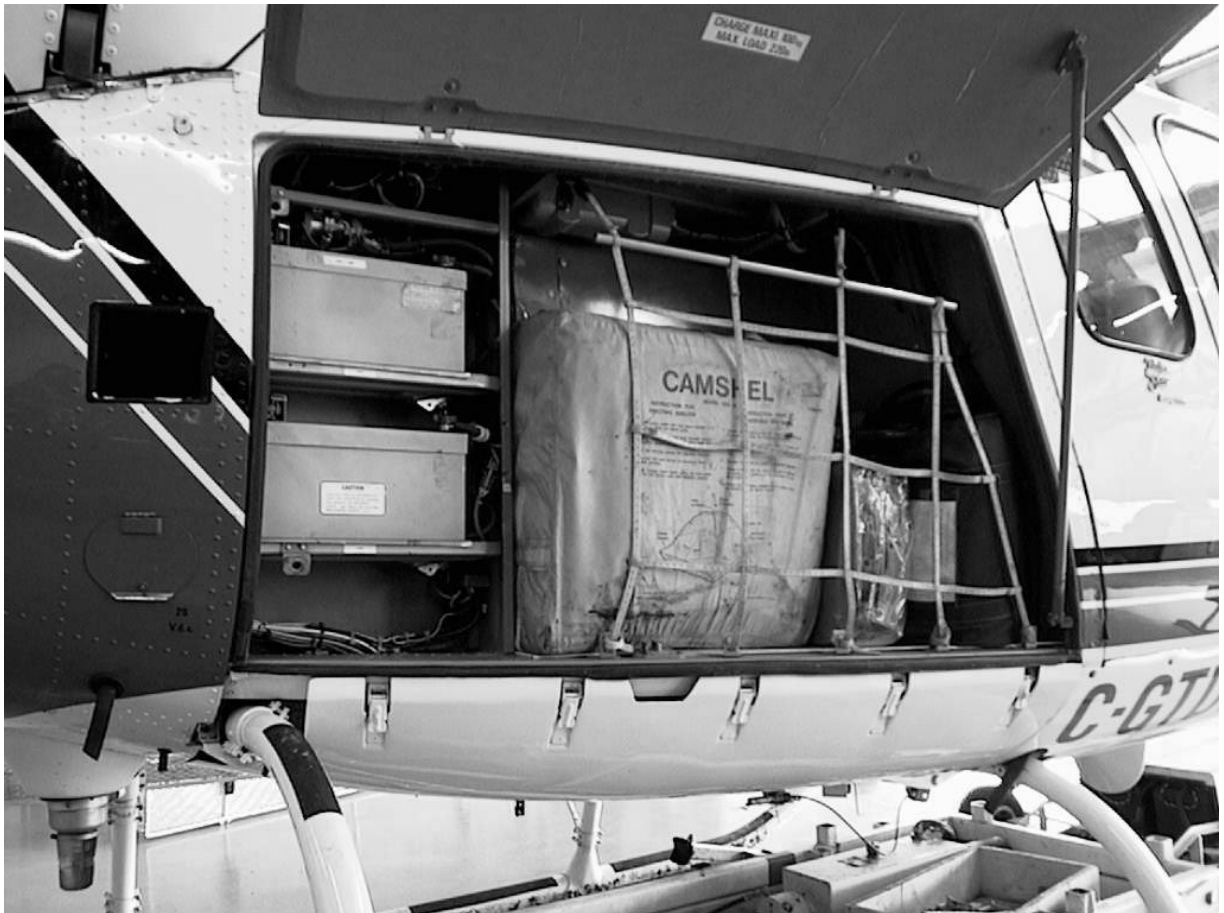
Appendix A - Battery and Baggage Compartment Configuration

The right baggage compartment is located immediately forward of the battery compartment on AS 355 helicopters (see Appendix A). The compartments are separated by a 0.050-inch-thick aluminum bulkhead. The company used the right baggage compartment in each of the four company helicopters for storage of the required survival and emergency equipment. The survival and emergency equipment included a five-person survival shelter and a survival kit that contained emergency flares. The bags that housed the survival shelter and the emergency kit were made of flammable nylon, and the survival shelter was also packaged in a waxed

The AS 355 F1 helicopter sustained an in-flight fire that occurred as a result of the auxiliary-battery-to-main-battery parallelling cable not being attached to the positive post of the main battery. The maintenance error was not detected before the flight. Based on witness information, the battery compartment mock-up testing, and the TSB Engineering Laboratory examination of the recovered section of the arc-damaged battery cable, it was concluded that the unattached cable contacted an unpainted area of the battery compartment forward bulkhead, arced through the bulkhead, and ignited the survival gear in the adjacent baggage compartment.
