RAILWAY INVESTIGATION REPORT
R09T0092

MAIN-TRACK TRAIN DERAILMENT

CANADIAN NATIONAL
TRAIN NUMBER M36231-20
MILE 247.20, KINGSTON SUBDIVISION
BRIGHTON, ONTARIO
21 MARCH 2009

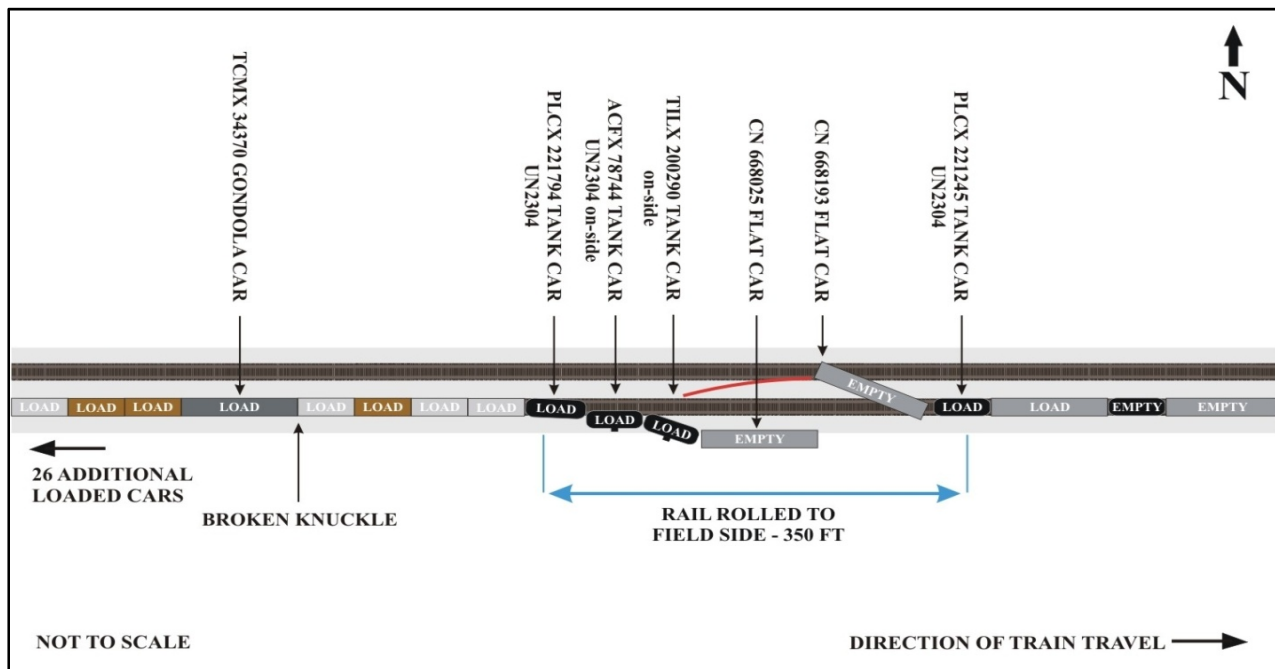
Figure 2. Accident site diagram

The derailed cars came to rest at the bottom of a sag³ in undulating territory.⁴ The first derailed car was PLCX 221245 (the 98th car), which had the two south wheels on the leading truck and all wheels on the trailing truck derailed. The 99th and 100th cars were long, empty flat cars. They remained upright and jackknifed to the north and south side of the track respectively. The 101st car came to rest on its side with its lead truck pushed south of the track. The 102nd and 103rd cars remained parallel to the track with the 102nd car on its side and the lead truck of the 103rd car derailed to the south (see Figure 2). The draft gears on cars that did not derail were compressed. On some cars, the coupler horn was contacting the centre sill striker face. There were no pre-existing defects observed on the derailed cars.

Broken knuckles and knuckle pins from previous train events were found about the right-of-way. Inspection of the track revealed that spikes were either pulled out or sheared off. Extending eastward from the 103rd car to the 98th car, both rails had rolled to the field side (approximately 350 feet). Where the rail had first rolled, wheel impact marks were observed on the ties about six inches inboard of the gauge side of the north rail.

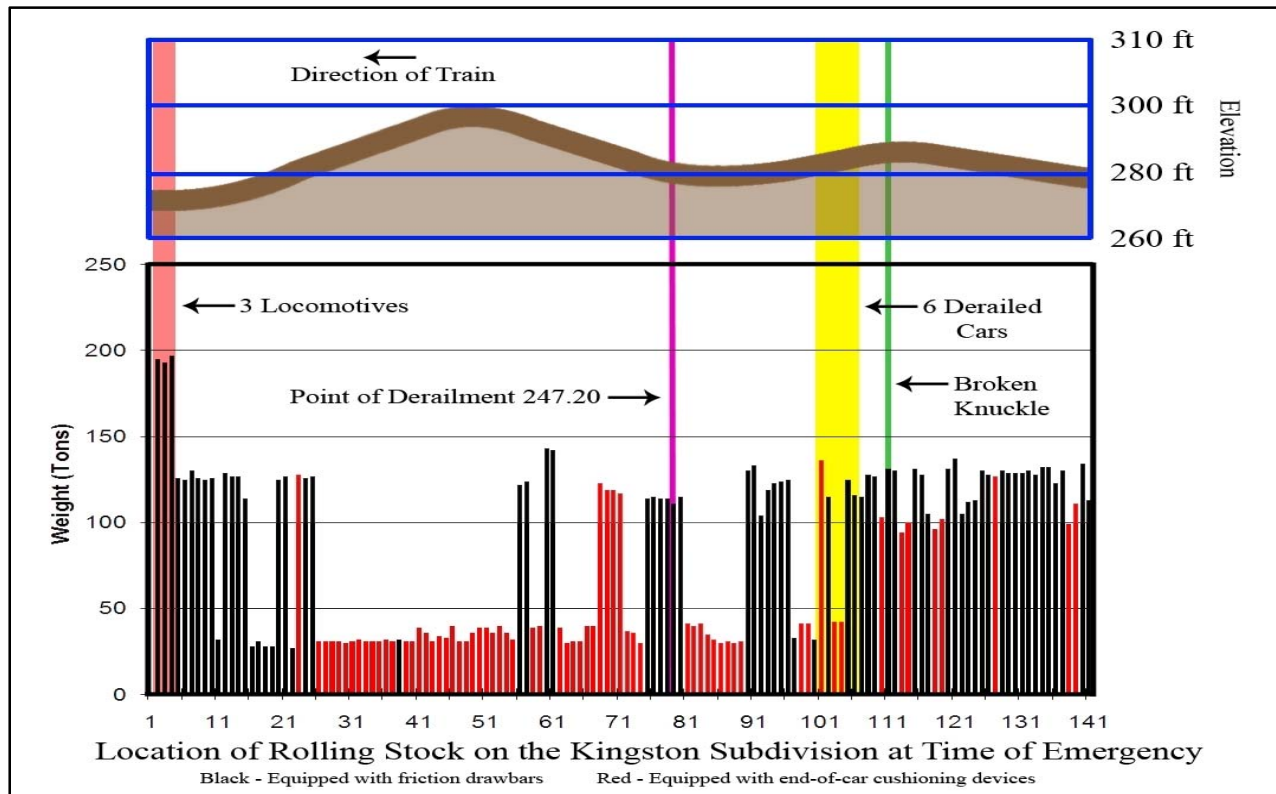
Figure 3. Train tonnage profile in relation to track elevation and point of derailment

A tonnage profile of the occurrence train in relation to the track elevation and point of derailment is contained in Figure 3.

Train marshalling and train length affects the magnitude of in-train forces. When trains are marshalled with light cars at the head end and heavy cars at the tail end, the head end slows down quicker than the tail end, particularly when the locomotive independent brake remains applied. With greater momentum, heavier tail-end cars will run into the slowing cars at the head end, generating high run-in buff forces. The amount of train slack and the run-in buff forces are further increased on long trains, and on trains containing cars equipped with long travel hydraulic EOCCDs. The risk of derailment can be further increased when long, empty cars are coupled to short, loaded cars (long car/short car combination). All of these
