Transport  
Canada

TP 185E  
Issue 4/2010

# AVIATION SAFETY LETTER

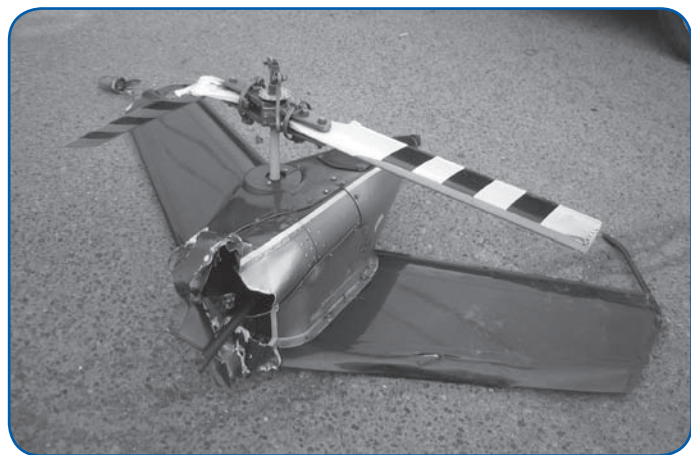
The engine, fuel control unit (FCU) and power turbine governor (PTG) were disassembled and examined in detail. They had been exposed to extreme temperatures during the post-crash fire and had suffered significant damage. The TSB tests showed no mechanical anomaly that could have affected their function; however, a latent malfunction of either the FCU or the PTG could not be ruled out. (*For more details, including references to a 2005 investigation on a similar PTG, readers should refer to the complete TSB Final Report on the TSB's Web site. —Ed.*)

*Tail rotor unit shown at the accident scene. The main and tail rotor blades were relatively undamaged.*

The cause of the loss of engine power was not determined. No evidence was found to suggest that any of the engine modules had suffered any pre-impact mechanical event that would have contributed to a loss of engine power. The accident FCU and PTG were damaged, and while it is possible that either one malfunctioned, the TSB could not make a definitive conclusion on them.

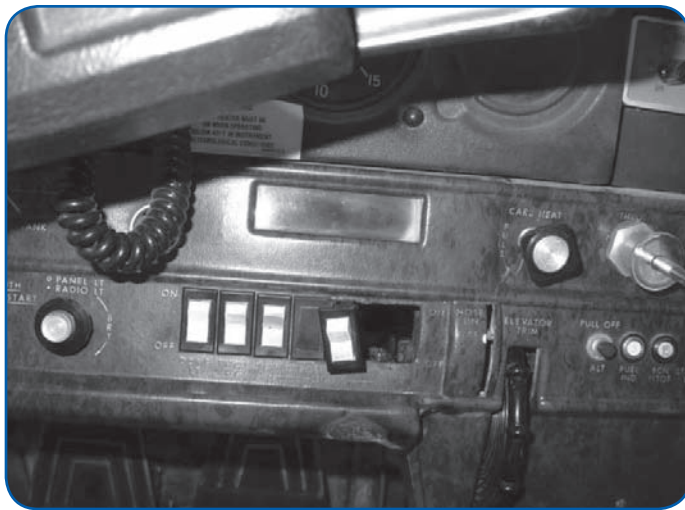
*Front of instrument panel*

The TSB determined that the landing light switch installed in the occurrence aircraft was beyond its design capability and therefore was unsuitable for the circuit it was controlling. Excessive heat from arcing and oxidization within the switch weakened the switch structure and contact support, allowing the contacts to fall out or be exposed. Arcing from the contacts caused oil residue to flash, which ignited a nearby dust accumulation and started the fire. Combustion was sustained by the plastic instrument panel. The TSB stated that similar landing light switch systems are incorporated on most

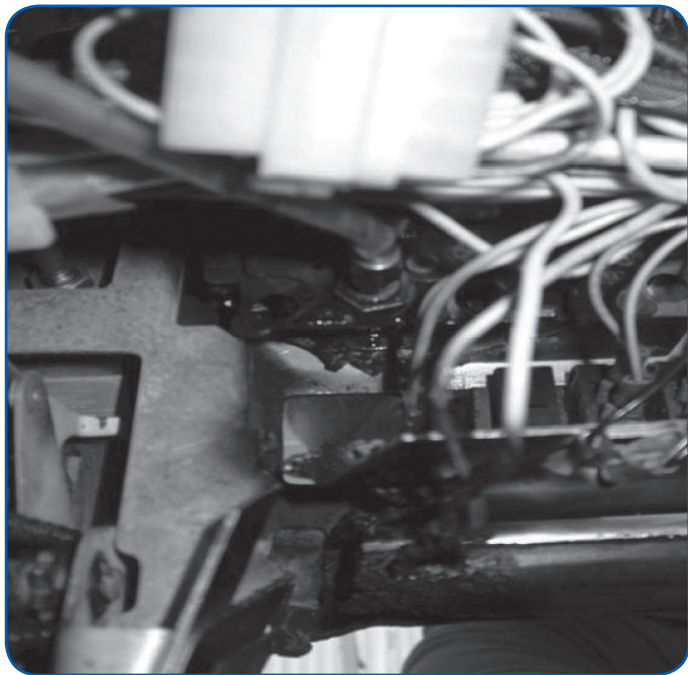
*Rear of instrument panel*

The switch was identified as a rocker-style switch rated at 10A 250VAC, 15A 125VAC, 3/4HP125-250 VAC. No DC ratings were found for this switch. The switch showed evidence of melt damage beginning at the base and progressing upward on both sides. The same damage was evident on the interior of the switch. The switch exterior had a thick coating of dust and an oily residue, which was also found inside the switch. A scanning electron microscope (SEM) and energy dispersive spectroscopy (EDS) analysis of the residue indicated that it might have been engine oil.

The landing light circuit wires remained attached to the contact but showed evidence of fire damage near where the contact enters the switch. The contact was coated with the plastic casing material and when the surface was examined there was evidence of repeated arcing, which had severely eroded the contact's surface. Arcing within the landing light switch could have provided the ignition source necessary for a fire to start. The dust covering evident on the switch and the oil residue provided by possible seepage from the oil pressure gauge line located above the switch may have provided the kindling necessary to start a fire. The oil would consistently reach its flash point when exposed to arcing, and when it was in proximity to the dust it would cause the dust to ignite. A small section of the plastic instrument panel was tested for flammability by introducing a direct flame to the

plastic. The piece of panel readily ignited and sustained flame. It also produced gases that were quite harsh when inhaled, and without sufficient ventilation may cause some incapacitation to the pilot.

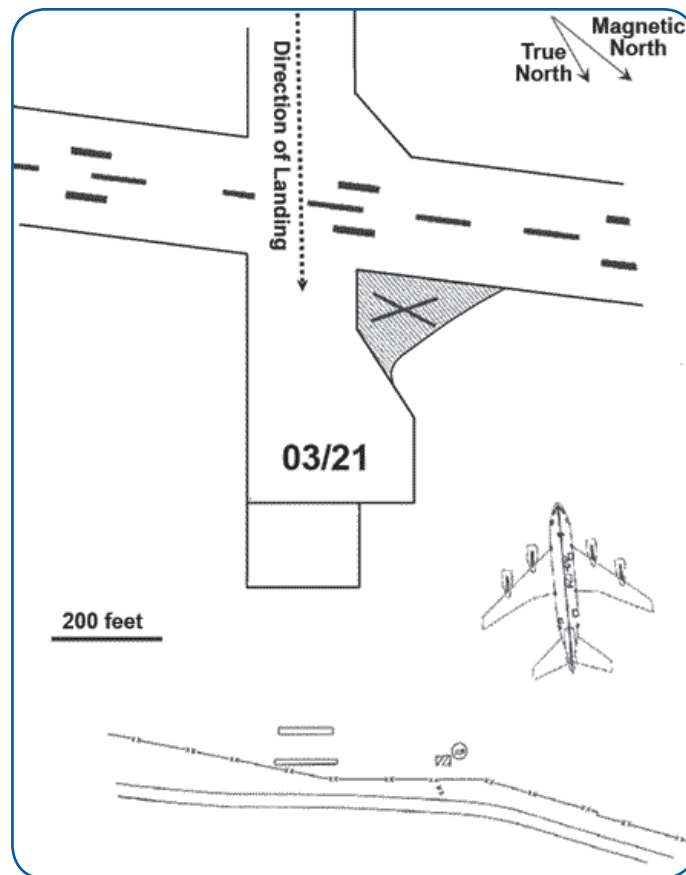
*Final position of aircraft*

1. A “B” nut loosened, resulting in a leak and depletion of the hydraulic fluid and preventing normal operation of the flaps, spoilers, thrust reversers, and wheel brakes.
2. The crew did not notice that there was a loss of hydraulic pressure and therefore did not plan for a landing without normal stopping systems or for the use of the emergency brake system.
3. When the aircraft landed, the flaps were extended to only 20°, the spoilers did not deploy because there was no hydraulic or backup air pressure, the thrust reversers did not deploy, normal braking did not work, and the emergency brake system was not used. Consequently, the aircraft overran the runway.

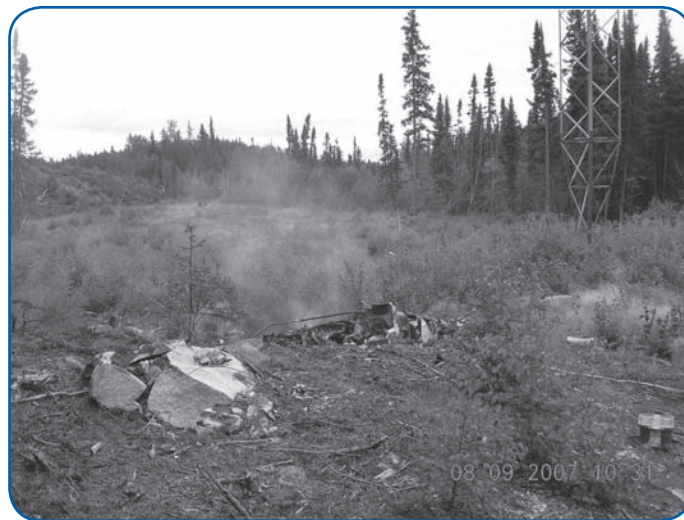
*Wreckage next to Tower 63*

During examination of the switch, black powder residue was found and the switch was seized within its casing; thus, electrical contact was never established and the ELT failed to activate. The ELT was properly attached and located in the cockpit of the helicopter as per current regulations, but the accident impact forces were in a direction that may not have activated the G-switch even if it had been serviceable. The failure of the ELT did not affect the rescue of the three injured persons because of the availability of phone service at the communications tower.
