AVIATION INVESTIGATION REPORT

A05A0059

STALL AND LOSS OF CONTROL DURING CLIMB

DE HAVILLAND DHC-8-100 C-GZKH

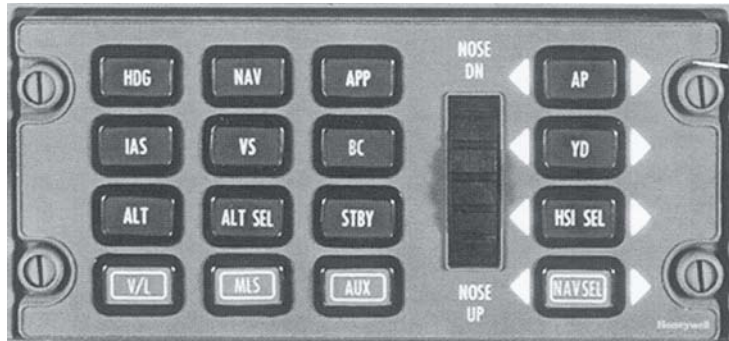
Figure 1. Flight guidance controller

guidance controller toward nose down (see Figure 1) to increase the airspeed. While attempting the adjustment, the captain saw the aircraft's stick shaker activate, causing the autopilot to disengage. This occurred at 14 800 feet above sea level, at 104 KIAS. The captain then began to manually fly the aircraft.

The aircraft is configured with a Sperry SPZ-8000 digital automatic flight control system (AFCS). A single flight guidance controller (see Figure 1) is used to select modes of operation and engage/disengage the autopilot. Most of the controls on the AFCS controller are alternate-action push-button (push ON, push OFF). There are two vertical modes available. The IAS button captures and holds the aircraft's indicated airspeed at the time of selection. The vertical speed (VS) button captures and holds the aircraft's VS at the time of selection. When VS mode is engaged, the airspeed is not controlled by the AFCS.

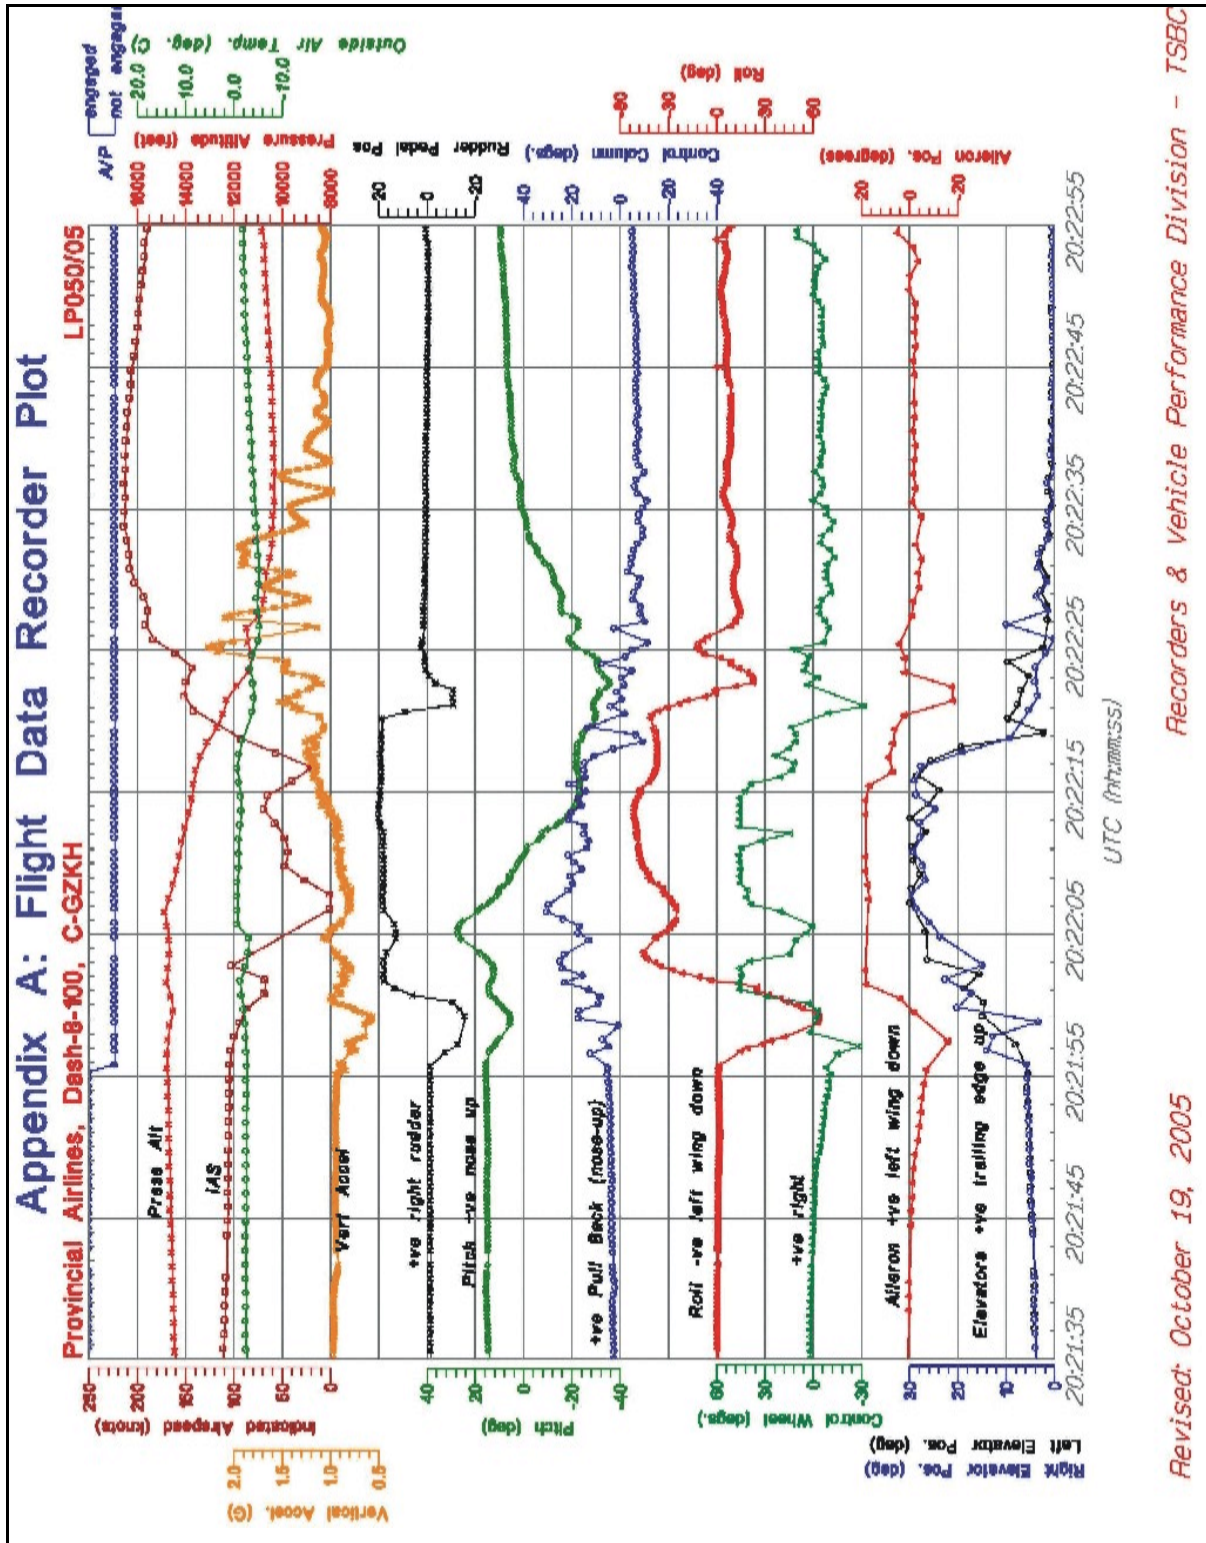
Within a second of autopilot disengagement, the aircraft began to roll right and pitch down (see Appendix A – Flight Data Recorder Plot and Appendix B – Flight Data Recorder Plot – Engines). Immediately after the aircraft began to roll, it was noticed that there was ice on the left engine inlet. The roll angle increased to 64°, the pitch angle went from 15° nose up to 5° nose up, and the aircraft vertical acceleration dropped to approximately 0.5 g. The aircraft pitch then increased to 30° nose up briefly before decreasing to 40° nose down. These conditions are indications that the aircraft wing had fully stalled. However, the captain interpreted the indications as severe turbulence.

The FDR data show that the aircraft underwent three distinct stalls during the loss-of-control event, with the third stall being the most severe. The data show that the control column position cycled rapidly back and forth as the stall developed, but was moved generally aft, remaining aft during all three stalls. There was significant aileron and rudder pedal movement during the event, but these controls were ineffective in regaining control and were in response to the aircraft's movement, rather than the cause of it. The data indicated that aircraft control was regained when the control column was moved forward.
