## AVIATION INVESTIGATION REPORT

A05P0143

**AIR PROXIMITY – SAFETY NOT ASSURED**

**ABBOTSFORD TOWER/VANCOUVER AREA CONTROL CENTRE**

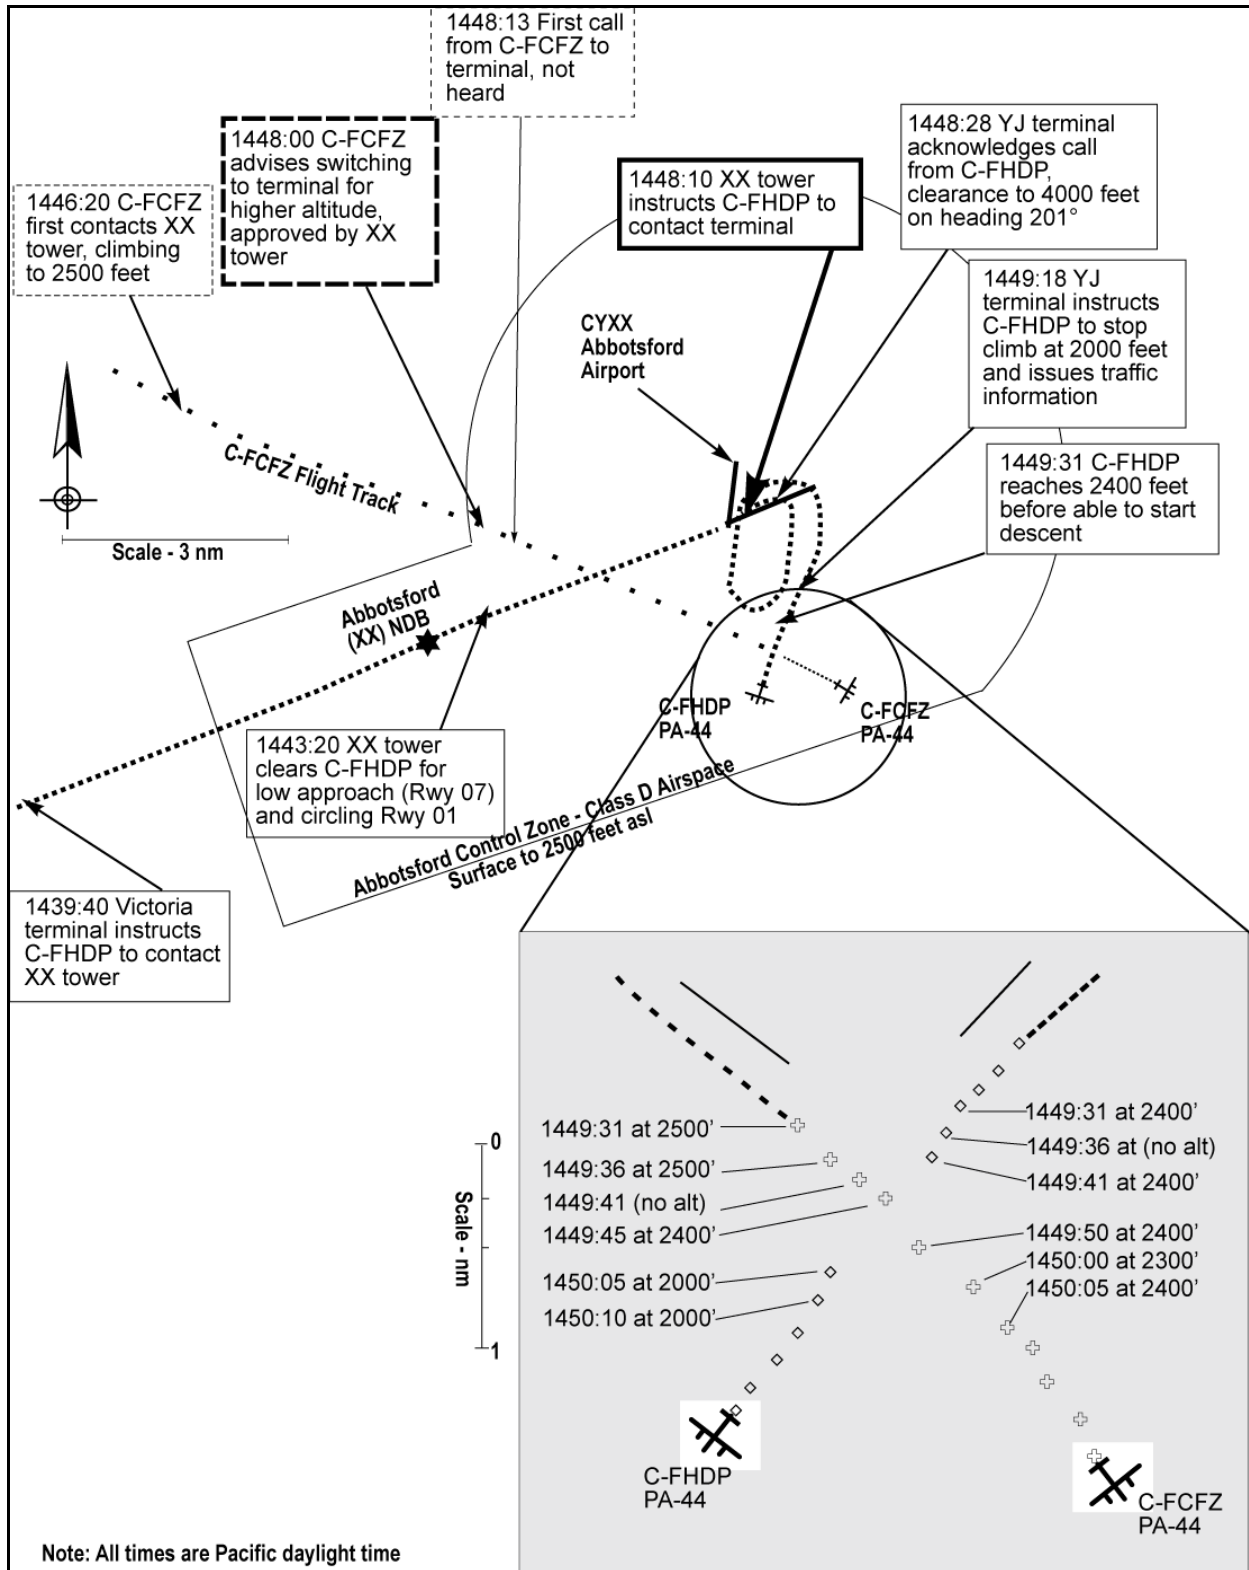
# Appendix A – Sequence of Events

On completion of the circling procedure, C-FHDP commenced the published missed approach procedure, which called for a climb to 1200 feet asl on a track of 068 degrees magnetic, followed by a right climbing turn to a heading of 202 degrees magnetic to 3000 feet asl, and then a right turn to the XX NDB. As C-FHDP was climbing through 2100 feet asl and was 1.3 nautical miles from C-FCFZ, the terminal controller in Victoria, British Columbia, noticed C-FCFZ on radar and saw the impending conflict. He instructed the pilot of C-FHDP to stop the climb at 2000 feet asl and issued traffic information. The pilot of C-FHDP reacted quickly by beginning a descent to 2000 feet. The two aircraft passed with about 0.75 nautical miles lateral and 500 feet vertical spacing, and safety was not assured.

At 1449:15, C-FCFZ called Victoria terminal a second time, but again got no response. At 1449:18, the Victoria terminal controller noticed C-FCFZ's radar target, recognized there was a conflict, instructed C-FHDP to stop the climb at 2000 feet asl, and advised of traffic at one thirty position at one mile, indicating 2500 feet. At the time this instruction was received, C-FHDP was 1.3 nm from C-FCFZ, climbing through 2100 feet asl. C-FHDP reached 2400 feet asl before starting to descend. C-FHDP was at 2000 feet asl when it passed under C-FCFZ.
