**AVIATION INVESTIGATION REPORT
A10F0012**

RUNWAY EXCURSION

AIRBUS A320-232, C-FRAA

31 JANUARY 2010

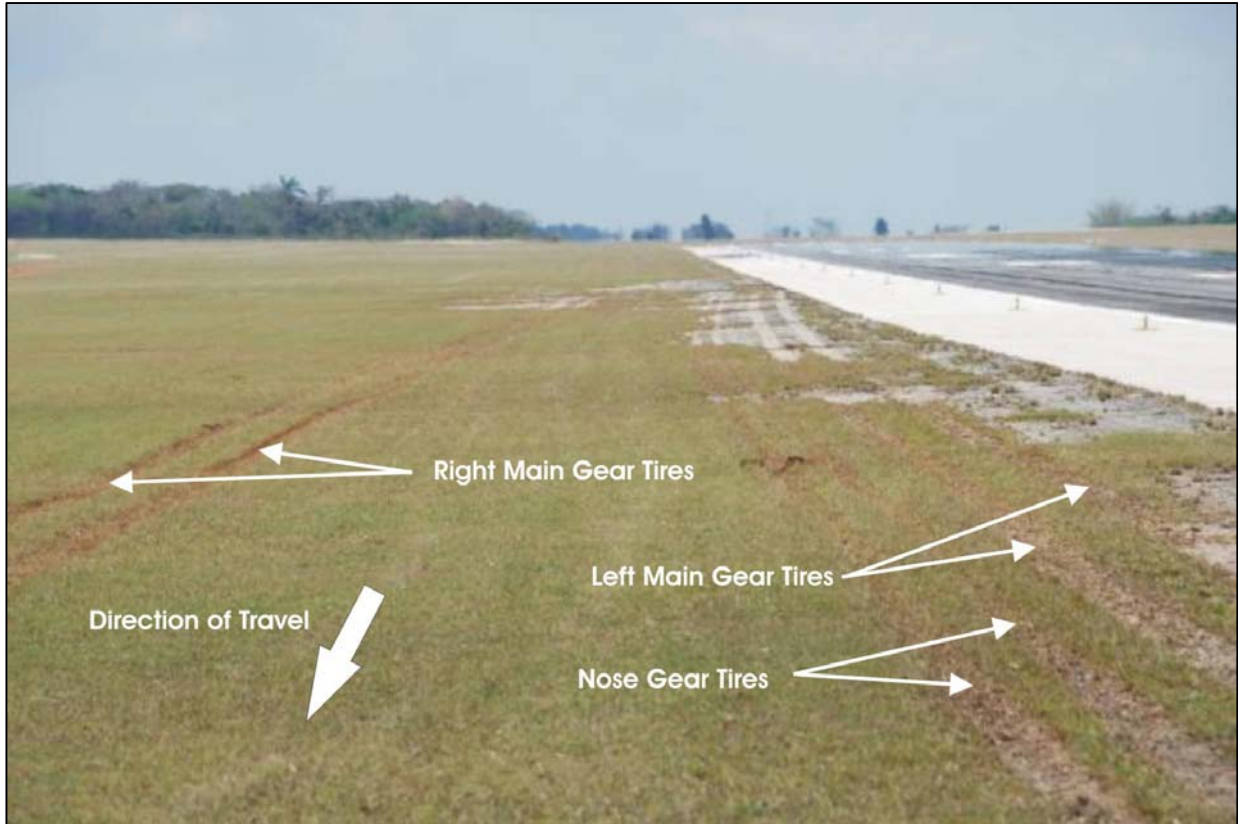
The aircraft then began tracking parallel to the runway with a 10° left crab for approximately 1745 feet. During that time, the engines began developing reverse thrust. At approximately 4300 feet from the threshold and at a speed of 40 knots, the aircraft re-entered the runway (see Photo 1).

Photo 1. Tire tracks off the runway

The aircraft paralleled the runway for a considerable distance with the heading crabbed to the left. It is likely that a combination of wet ground, reverse thrust, slope and wind (045° at 10 knots) resulted in the captain being unable to manoeuvre the aircraft back on the runway until the speed was reduced enough to allow for better tire traction. However, the extent to which any of the above factors contributed to the length of the excursion could not be established.

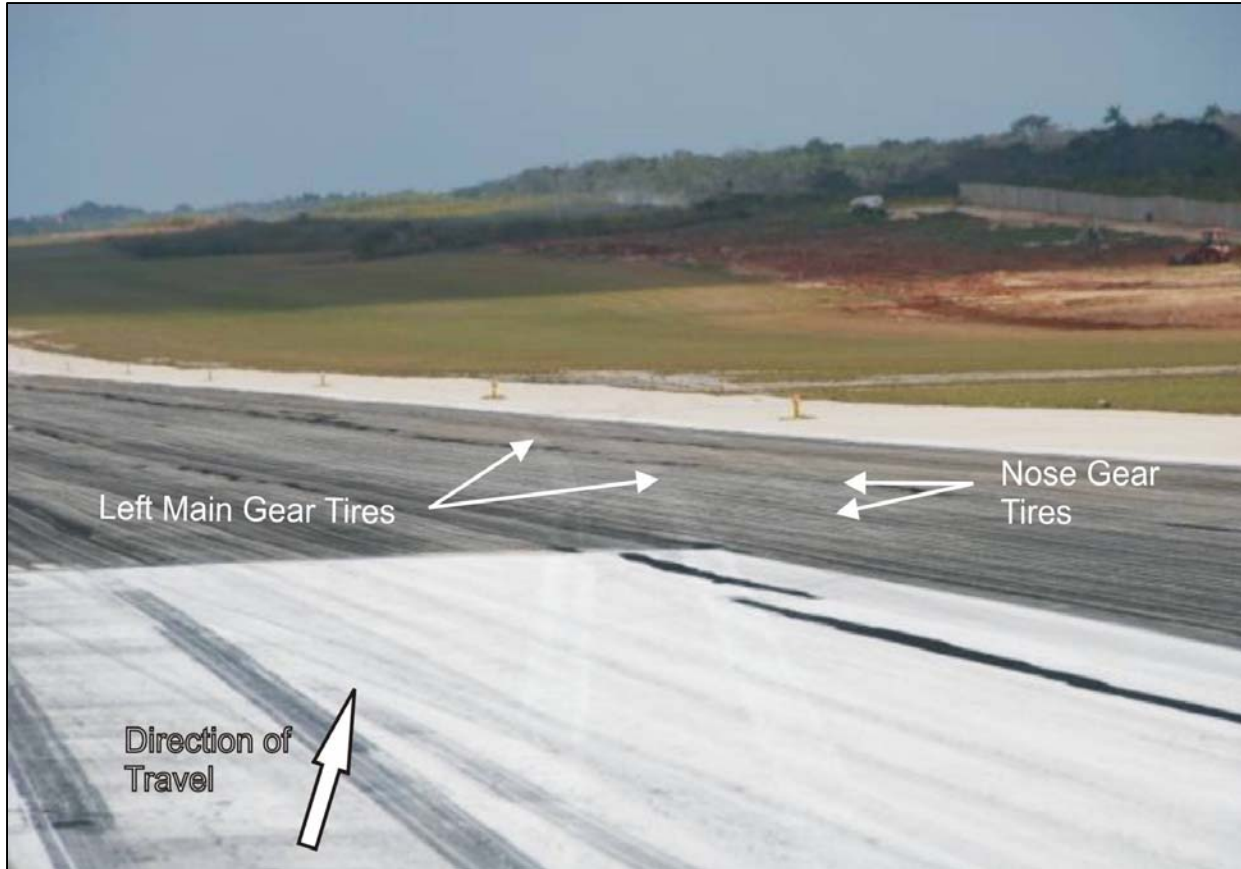
Photographs taken of the runway surface following the occurrence showed white 'steamed cleaned' tire tracks near the aircraft touchdown point (see Photo 3).

Photo 3. Tire tracks on the runway

Although no reverted rubber hydroplaning damage was present on the aircraft tires, the white streaks left by the tires are indicative of scouring action caused by some form of hydroplaning. As the aircraft touched down in an established right turn, the combination of momentum, low tire cornering forces due to the contaminated runway and some form of hydroplaning, caused the aircraft to drift until it left the runway.
