AVIATION INVESTIGATION REPORT

A10Q0070

COLLISION WITH TERRAIN

CESSNA 172 C-FEAR

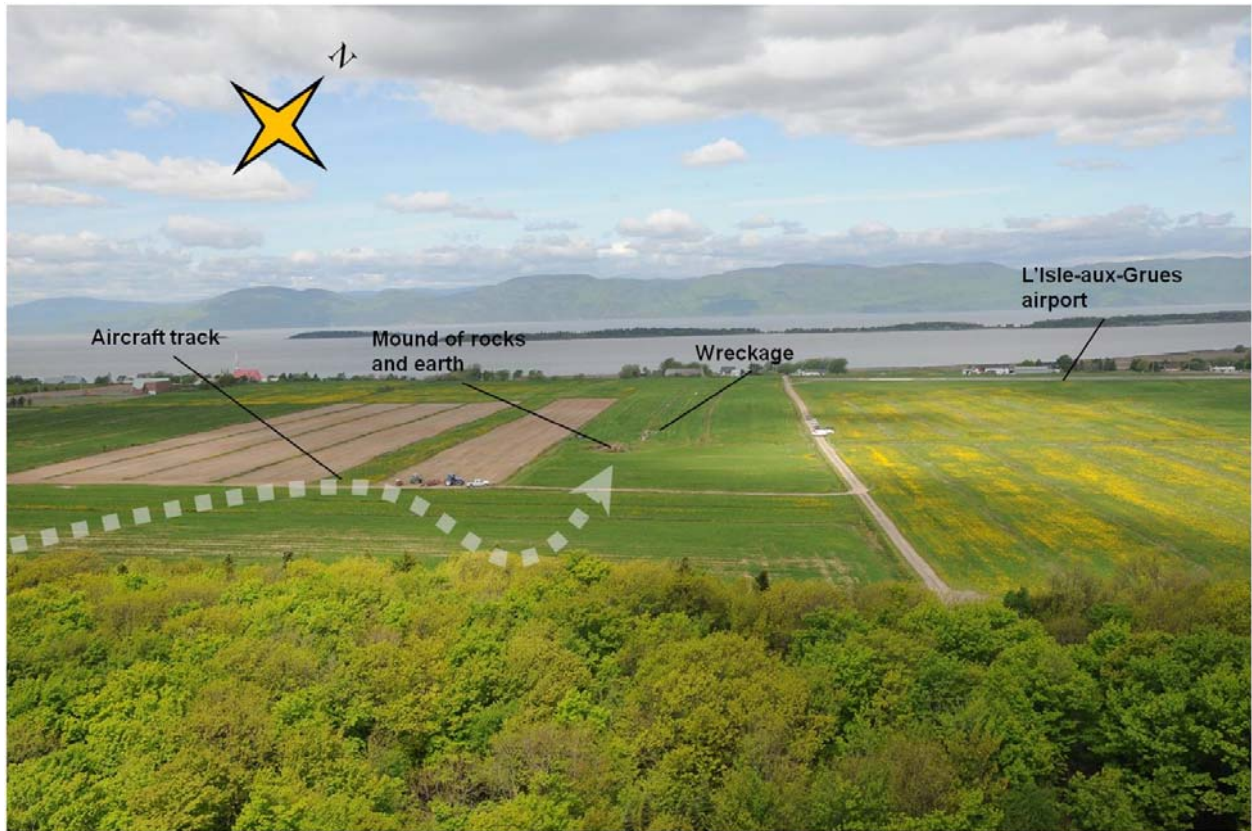
Figure 1. Aerial view of accident site

The accident occurred in an alfalfa field. Oriented northwest, the field was not suitable for a precautionary landing. Plant cover was such that obstructions could be hidden, its surface was bumpy, and it contained some ploughed furrows (see Figure 1).

The aircraft struck a mound composed of rocks and earth that was 8 feet high and 30 feet wide and located about 2000 feet south of the runway. It was the only elevated point of terrain in the area. The mound was partly covered with grass and small shrubs. The Cessna 172 was on a heading of 325 degrees magnetic at the time of the collision. The first impact marks indicate that the landing gear of C-FEAR struck the mound about 5 feet from its base. The wings were horizontal or almost horizontal. Two propeller blade marks approximately 14 inches apart were found on the mound. Due to impact forces, C-FEAR partly broke up. The aircraft continued in the air until it crashed on its back in a ditch 255 feet from the initial point of impact. The impact resulted in a fire. There was no evidence found of any pre-impact fire damage.

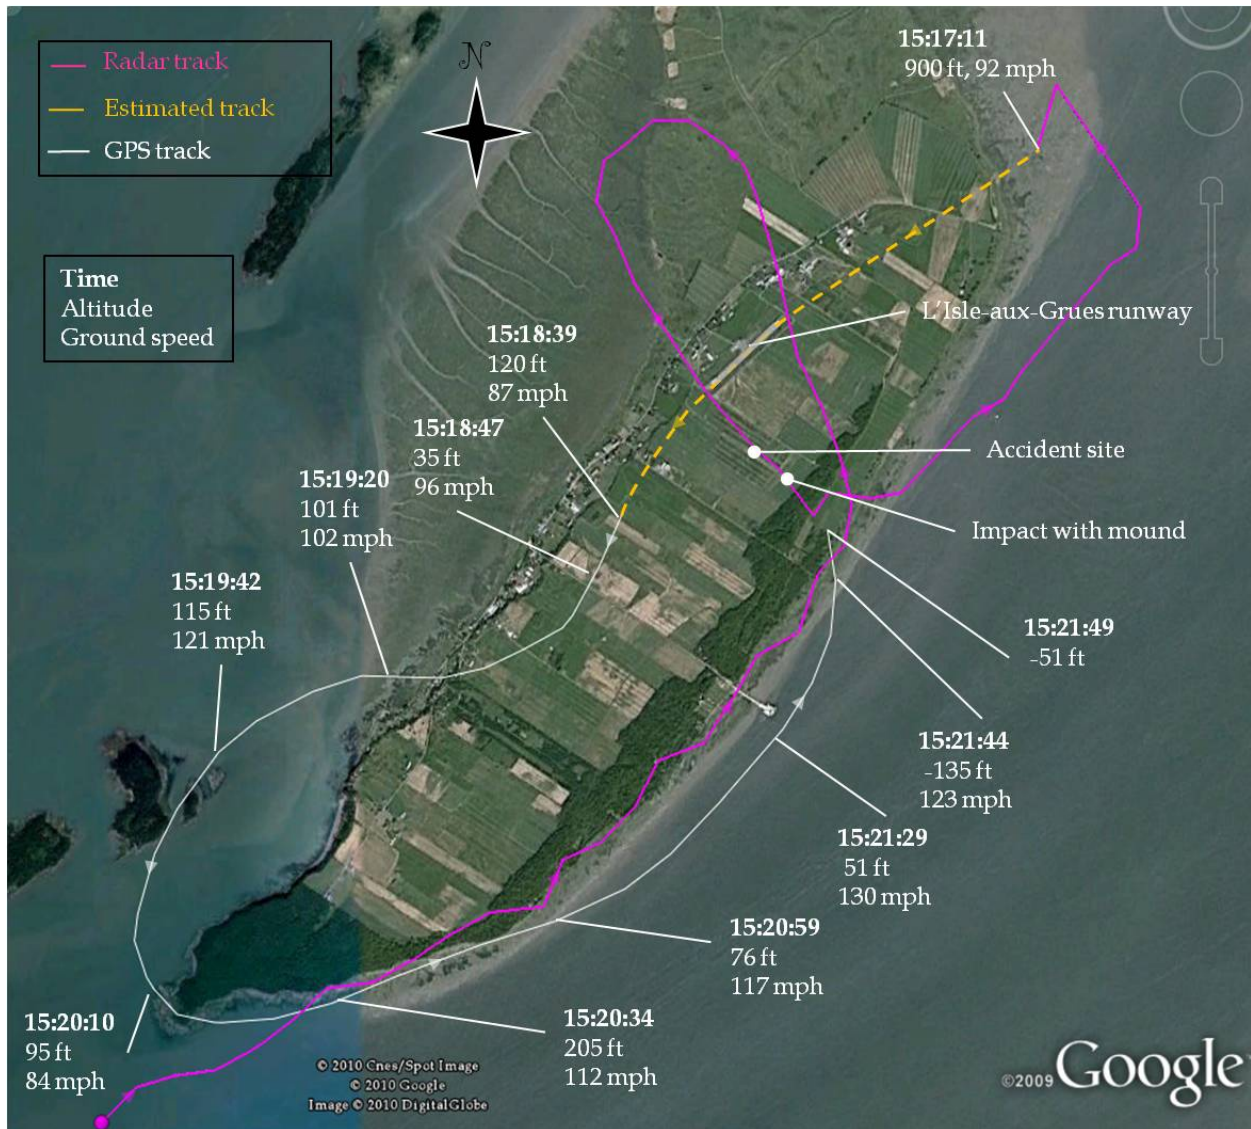
Annex A – Track based on GPS and radar

The aircraft entered the circuit for runway 25 by initially following the south shore of L'Isle-aux-Grues island (see Annex A – Track based on GPS and radar)² to a position abeam south of the airport. The aircraft then proceeded overhead the runway for the left-hand downwind leg. About 1 nm northeast of the runway threshold, the aircraft entered the base leg. At 1517 the aircraft vanished from the radar screen as it commenced its final approach 1 nm from the runway at 900 feet asl.

The Cessna halted its climb shortly after its touch-and-go and continued flying at low altitude. It disappeared behind the trees on the western tip of the island, then proceeded east along the south shore of the island about 200 feet above the ground. Abeam the airport, the aircraft turned left and headed northwest on a track perpendicular to the runway centre line. The aircraft overflew a small wood then descended to a few feet above a field. The aircraft flew just above the ground for a distance of 350 feet before striking a mound of rocks and earth. The aircraft partly broke up and continued in the air until it struck the terrain and caught fire. The final impact was in a field about 255 feet from the mound. The pilot and two passengers were fatally injured. The other passenger died in hospital a few hours later.
