## AVIATION INVESTIGATION REPORT

A10A0085

### COLLISION WITH WATER

CESSNA 414A, C-GENG

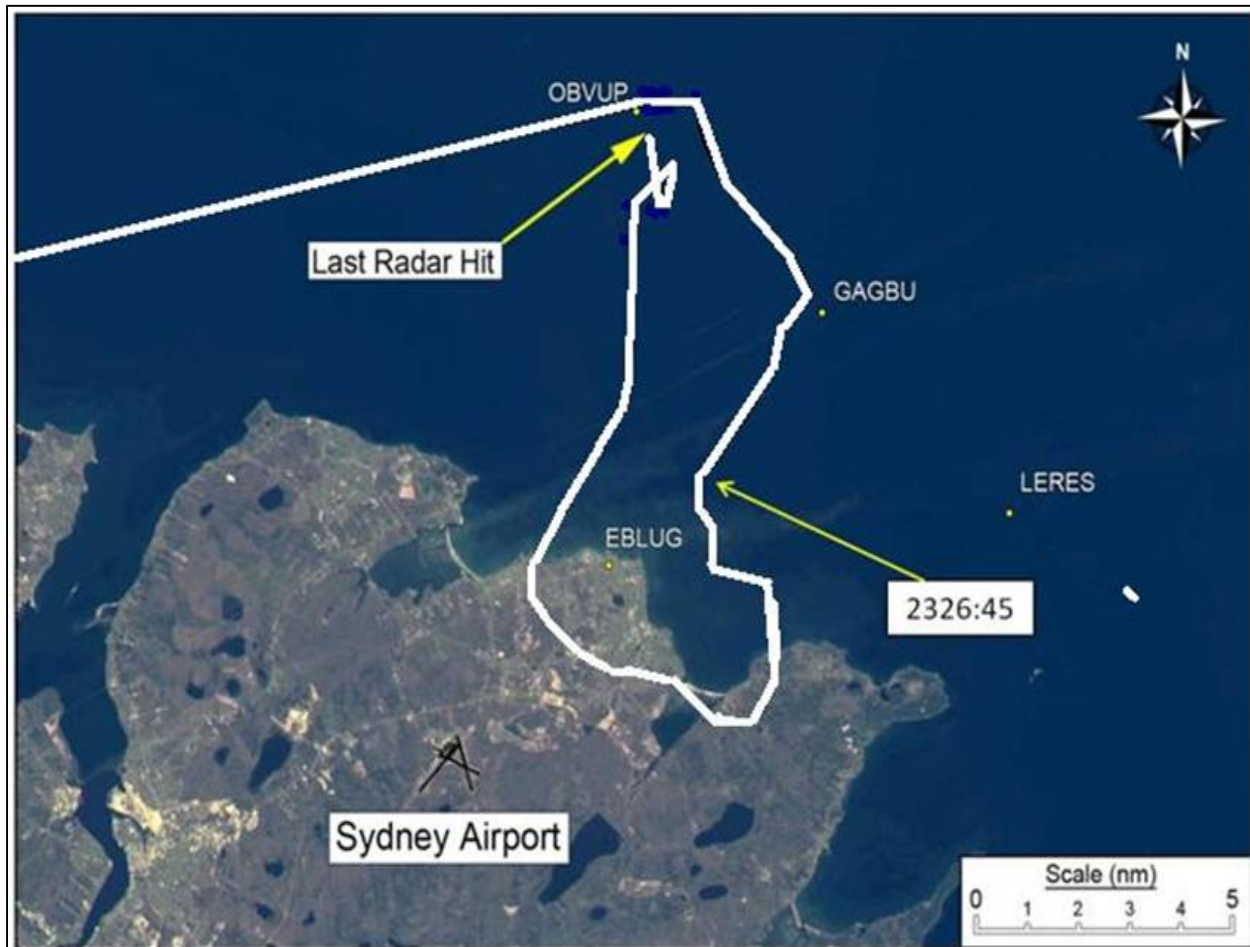
**Figure 1.** Aircraft flight path

After the aircraft turned left the flight path became erratic (see Figure 1). The aircraft changed heading numerous times with altitude deviations of up to 500 feet, which was consistent with the aircraft being flown manually (possibly while the GPS was being reprogrammed). During this period the airspeed did not substantially change. This erratic flight path continued for more than 4 minutes during which radio communications were maintained with both Moncton ACC and Charlottetown Radio.<sup>5</sup>
