AVIATION INVESTIGATION REPORT
A10O0101

POWER LOSS AND COLLISION WITH BUILDING
CIRRUS SR20 C-GYPJ
TORONTO BUTTONVILLE MUNICIPAL AIRPORT, ONTARIO
25 MAY 2010

Report Number A10O0101

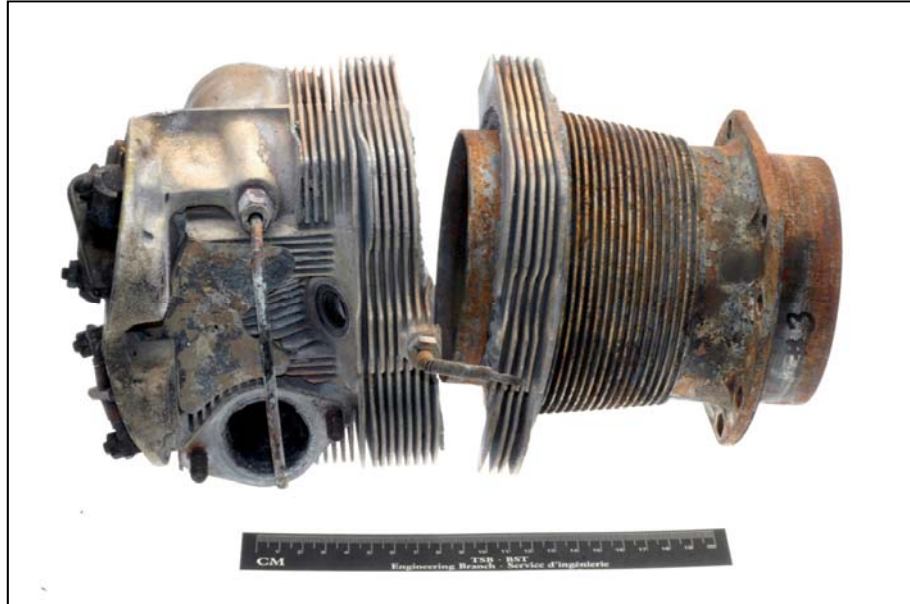
Figure 1. Number 3 cylinder after removal from the engine

Examination of the engine showed that the number 3 cylinder head had separated from the barrel (see Figure 1). The cylinder head remained held in place by the induction and exhaust systems. No other abnormalities were found with the engine that would have prevented it from producing power.

cylinder head showed it had failed near the second and third threads and there were visible signs of fatigue on the fracture surface; externally this would be at the roots of cooling fins 4, 5 and 6.³

A high cycle fatigue crack originated from the notch⁴ created by the sharp edge of the steel barrel thread crest on the aluminum thread flank of cylinder 3. Once the crack dimension had grown to a critical size, the remaining load-bearing section could no longer withstand the load and the head separated in a single-cycle overstress. Although no specific defects were observed in the region of the cylinder where fatigue initiated, this region had post-fracture rubbing damage masking the original features.

The fatigue crack in the number 3 cylinder head developed at the notch created by the steel threads of the barrel. Given its location, there are no practical means of non-destructive testing that would identify a crack. A crack in a cylinder head could go undetected and the engine would continue to operate normally until the crack reached a critical dimension, at which point the cylinder head would fail in overload without warning. This would result in a reduction of power, a rough running engine or a complete engine failure.

1. The number 3 cylinder head failed in fatigue and separated from the cylinder during takeoff, resulting in reduced power from the engine.
2. While manoeuvring, the aircraft stalled and entered a spin at an altitude from which recovery was impossible.
