# AVIATION INVESTIGATION REPORT A10C0104

## INSUFFICIENT FUEL

PERIMETER AVIATION  
DEHAVILLAND DHC-8-102 C-GWPS  
WINNIPEG, MANITOBA  
29 JUNE 2010

Report Number A10C0104

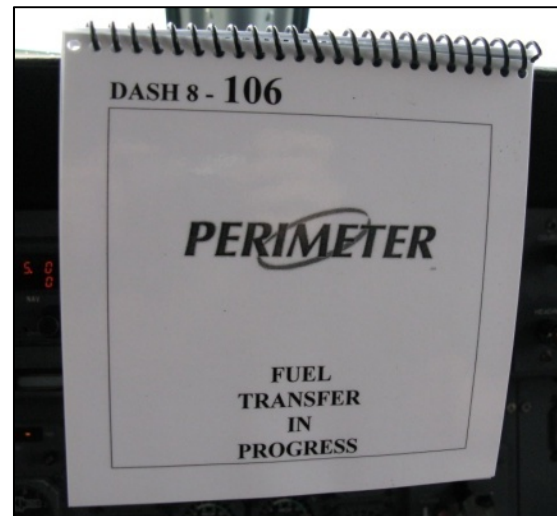
**Photo 1.** Fuel Transfer Card

The crew placed the fuel transfer card<sup>3</sup> (see Photo 1) on the glare shield to remind them of the 2 deferred checklist items to be completed before initiating the engine start. Subsequently, they opened the cockpit escape hatch to the vent position, and the fuel transfer card also served as a reminder to close the hatch.

3. Using the adaptation that had become accepted practice, the PAG107 pilots completed the BEFORE START - ENROUTE checklist to the line, and placed the fuel transfer card on the glare shield as a reminder that the fuel quantity check had been deferred.

4. The PAG107 pilots subsequently opened the cockpit hatch for ventilation, and also used the fuel transfer card as a reminder to close the hatch before engine start. Consequently, the card served as a reminder for two unrelated purposes, the incomplete fuel quantity check and the open hatch.

6. The crew subsequently closed the cockpit escape hatch and removed the fuel transfer card from the glare shield. Both pilots forgot their intent to use the fuel transfer card as a reminder that the fuel quantity check had been deferred. The fuel quantity was not verified and the flight departed with insufficient fuel.

Short-term corrective action was implemented immediately after the occurrence. On 29 June 2010, the chief pilot issued Perimeter Dash 8 Operation Memo #05-10 to all company DHC-8 pilots. The memo indicated that “doing the ‘Before Start Checklist’ while passengers were deplaning from the inbound flight and then the crew leaving the aircraft” had led to a serious flight irregularity. The memo directed all pilots to cease the practice, and stated that, “effective immediately, the ‘Before Start Checklist’ will only be done when the captain and first officer are in their respective seats and ready for the start.”
