AVIATION INVESTIGATION REPORT
A10P0147

LOSS OF CONTROL - COLLISION WITH WATER

**ATLEO RIVER AIR SERVICE LTD.
CESSNA 185F, C-GIYQ
AHOUSAT, BRITISH COLUMBIA**

29 MAY 2010

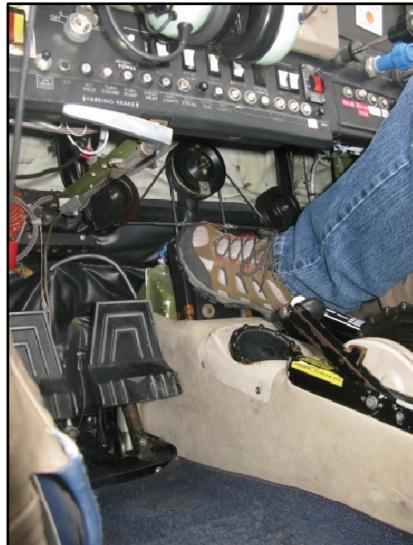
Photo 1. Foot on pitch control system

These tests revealed that a person in the passenger front seat can place a foot onto the control system under the instrument panel (see Photo 1), and push the control column forward, thereby causing a nose down control input. In this scenario, however, the pilot can easily overcome the interference.

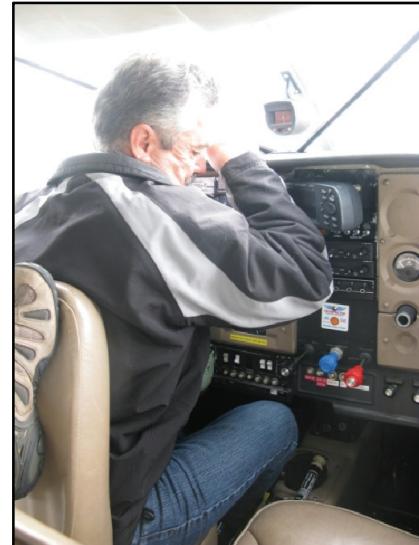
Photo 2. Pilot pushed into controls

It was also found that if the pilot's upper body is not secured by the shoulder harness, a rear passenger could push the pilot's seatback forward (see Photo 2) causing the pilot to push the control yoke forward, thereby causing a nose down control input. It was noted that the pilot had no space to leverage his arms and push back sufficiently to overcome the passenger's leg force from behind. In this scenario, a pilot could not resist a push from the back unless it was expected and the pilot braced accordingly.

The pilot's broken right wrist and the bent V brace suggest that the pilot was bracing or trying to resist a force imposed from behind. The broken ankles of the passenger behind the pilot are consistent with that person bracing with both feet, or pushing forward with both feet, at the time of impact. It is possible the passenger seated behind the pilot kicked the pilot's seatback forward and held it there, pushing the pilot into the instrument panel and the controls forward thereby inducing a dive.

Because there was no locking mechanism on the pilot's seatback, and because the pilot was not wearing his shoulder strap, he would have been unable to prevent his upper body from being forced onto the instrument panel.
