AVIATION INVESTIGATION REPORT
A10Q0162

BIRD STRIKE ON TAKE-OFF AND COLLISION WITH TERRAIN

MAX AVIATION INC.
BEEHCRAFT B100, C-FISK
MONTMAGNY AIRPORT, QUEBEC
22 SEPTEMBER 2010

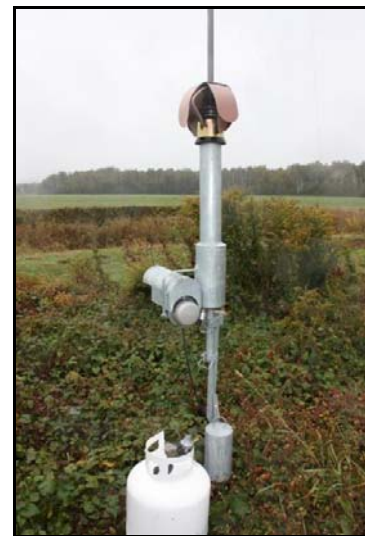
Photo 1. Propane-powered cannon

Several measures were put in place to mitigate the risk, including selective killing and the use of a propane-powered cannon near the runway edge (see Photo 1). The cannon was installed at Montmagny Airport in June 2010. Malfunctions were reported from 27 to 31 August 2010. Although the supplier was contacted for repair action and the cannon was put back in operation, it was not working on the day of the accident.

This propane cannon produces both visual and auditory stimulus to scare birds. The cannon produces thrust to propel a mechanism that causes a fringed rubber disk to slide up a pole mounted on a tripod. The mechanism drops back rapidly, but the disk descends more slowly, somewhat like a parachute. This decoy is designed to imitate a falcon hunting a bird. The cannon is reported effective within a 150-metre radius.

According to the publication entitled *Evaluation of the Efficacy of Products and Techniques for Airport Bird Control (TP 13029)*, the explosions produced by a cannon may initially scare birds away. But without any concurrent measures to signal to birds that the noise of the cannon represents danger, birds soon become accustomed to the noise.

Moreover, birds quickly get used to propane cannons that produce explosions at regular intervals and are never moved. The cannons become totally ineffective within a relatively short

period. Best results can be achieved if the explosions are timed at different intervals, the number of explosions per sequence is varied, and if the cannon is moved and pointed in different directions. One good technique is as follows: 2 or 3 explosions in quick succession, with different intervals between firing sequences, and rotating the cannon after every explosion. The cannon used at Montmagny is at a fixed location, and the intervals between explosions can be varied from 2 to 4 minutes.

TP 13029 indicates that cannons should not be relied upon as the sole or even the major component of a bird control program. Cannons are recommended for occasional use as part of an integrated airfield bird control program, in conjunction with other products and techniques. At Montmagny, killing and a flare gun are techniques used to supplement the propane cannon. However, on the day of the occurrence, none of these techniques was used because no congregations were seen or reported.

To reduce the risks associated with bird activity, a wildlife management program was in place. Although only one bird strike was reported at Montmagny Airport in the last 5 years, the bird hazard risk assessment by the Quebec Department of Transport found that gulls and geese pose a high risk at this airport. For that reason, bird control measures were in place, including selective killing and the use of a flare gun and a propane cannon. Since no bird congregations were seen prior to the take-off, selective killing and the flare gun were not used. The only bird control measure remaining was the propane cannon. However, the cannon was out of order on the day of the occurrence.

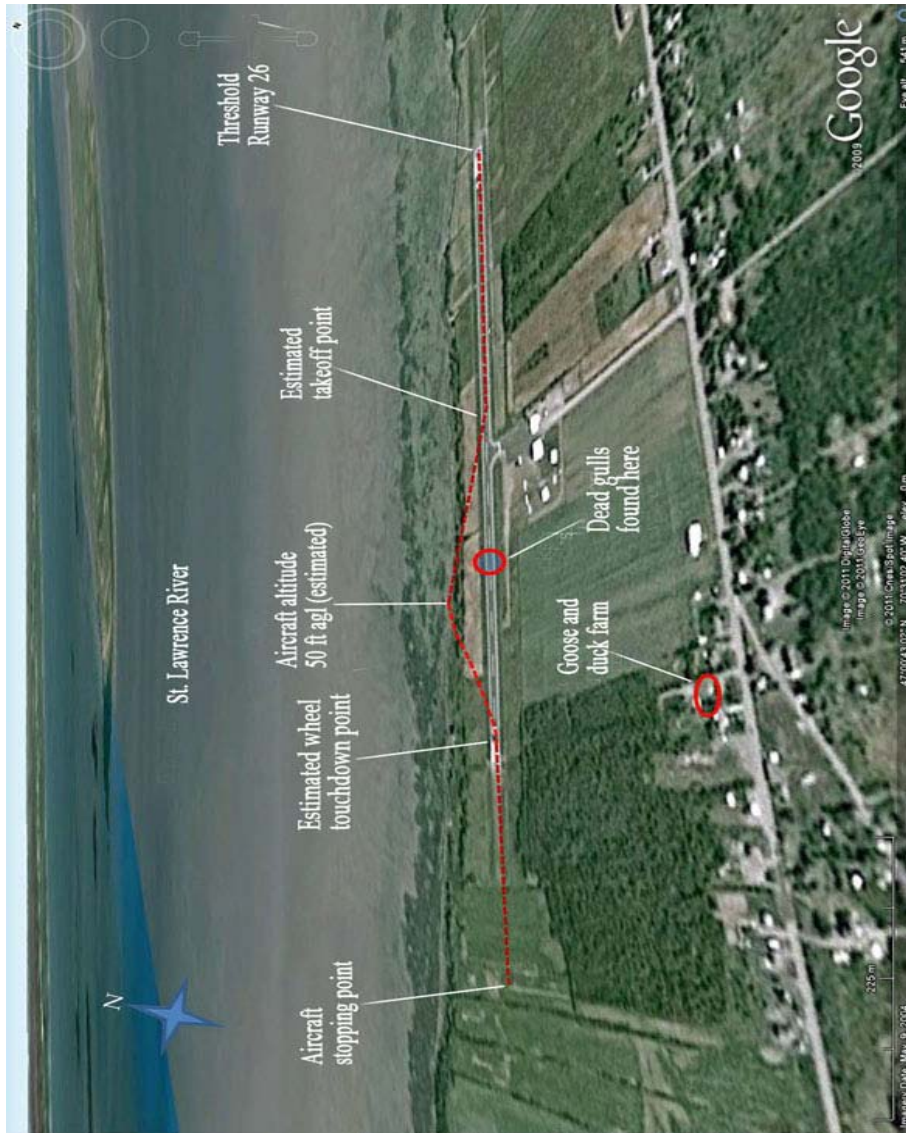
Appendix A – Estimated take-off profile

Given the outside temperature at the time of the occurrence, ¹¹ aircraft weight, ¹² surface winds ¹³ and pressure-altitude, ¹⁴ the take-off distances calculated from the performance diagrams were used to estimate the take-off profile on the day of the occurrence (see Appendix A).

Given the no-flaps climb gradient and the location where the birds were found, the bird strike would have occurred at a height of 40 feet. A take-off with 30% flaps would have placed the aircraft 10 feet higher at the same point.

As for the accelerate-stop distance for a no-flaps take-off, the performance diagrams show that 3300 feet of runway is required to bring the aircraft to a halt if one engine fails at the rotation speed (V_r). For a take-off with 30% flaps, the accelerate-stop distance is reduced to 3200 feet. Although these diagrams are provided in the AFM as a reference, 703 operators are not required to ensure that the usable accelerate-stop distance is equal to or greater than the accelerate-stop distance indicated in the performance diagrams. For 704¹⁵ and 705¹⁶ operators, take-off is not permitted if the required accelerate-stop distance exceeds the usable accelerate-stop distance.

Even if the take-off had been aborted at that point, the aircraft would have travelled about 300 feet past the runway end. The aircraft would have sustained less damage, since it would have come to rest before the first ditch.
