AVIATION INVESTIGATION REPORT

A98P0164

LOSS OF SEPARATION

VICTORIA, BRITISH COLUMBIA

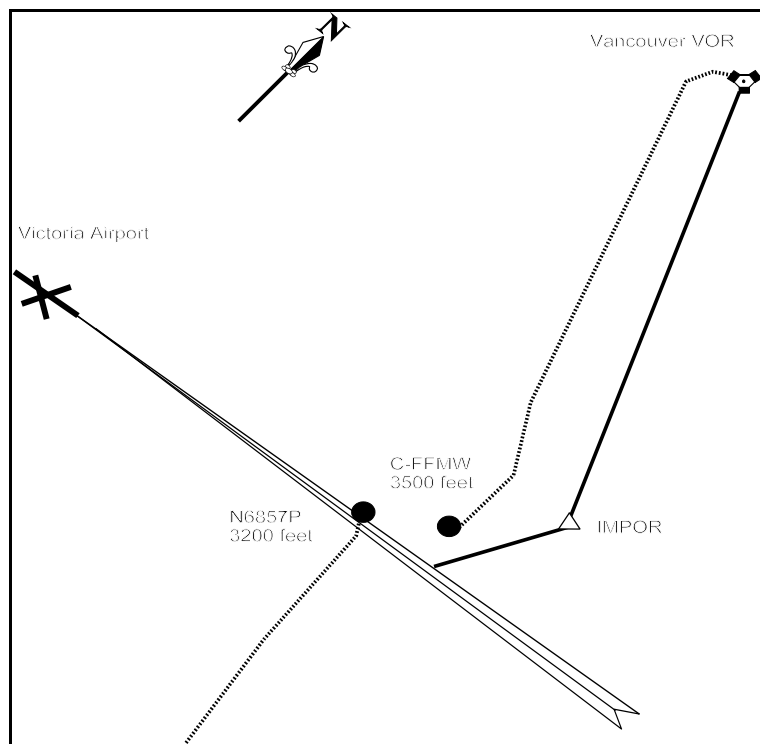
Figure 1. Loss of Separation at 1045 PDT

A review of the recorded radar information showed that the aircraft was not tracking the Vancouver VOR (very high frequency omnidirectional radio range) 157 degree radial toward the IMPOR intersection accurately, but was consistently west of track by as much as 2 nautical miles (nm). The trainee controller did not take any action to advise the aircraft of the observed deviation. This resulted in the aircraft turning inbound earlier than normal to intercept the localizer, which resulted in an unexpected decrease in spacing with the aircraft ahead. During a previous conversation, the on-the-job instructor (OJI) had cautioned the trainee about the possibility of C-FFMW turning in on a tighter track if no correction was initiated. The OJI did not intervene at this point.

the ILS approach and ahead of C-FFMW. However, at 1045:11, the trainee notified N6857P that the sequencing plan would not work, and he instructed the pilot of N6857P to climb to 4000 feet and to turn left to a heading of 340 degrees. Six seconds later, while still at his position at the adjacent console and without coordinating with the trainee, the OJI took over control of the arrival traffic. He instructed N6857P to turn further left to a heading of 300 degrees and to descend to 3000 feet. Shortly thereafter, he instructed N6857P to turn left to a heading of 280 degrees to intercept the final approach course. At the same time, he instructed C-FFMW to turn left onto a heading of 170 degrees and to descend to an altitude of 2500 feet. He advised the pilot that he was going to vector the aircraft through the localizer for spacing.

1. The trainee did not correct the flight path of C-FFMW, which was consistently west of the Vancouver VOR 157 degree radial flying toward the IMPOR intersection, and the OJI did not intervene.

5. With N6857P and C-FFMW on converging tracks, the trainee cleared both aircraft to the same altitude (3000 feet).
6. The trainee changed the approach sequence of N6857P ahead of C-FFMW on the approach to runway 27 at Victoria without communicating this plan to the OJI.

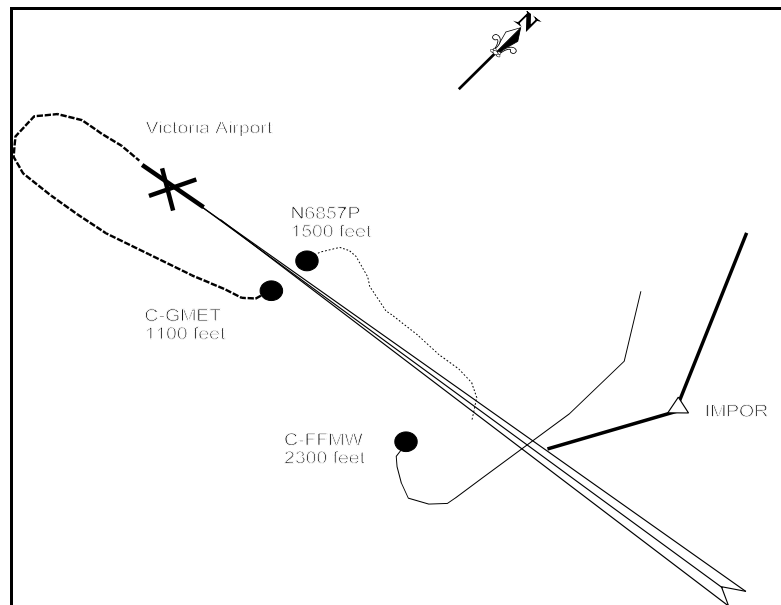
Figure 2 Operating Irregularity at 1048 PDT

seeing N6857P turning toward the approach course for runway 27, the airport controller again called Victoria terminal on the hotline and asked what they were going to do with N6857P. The trainee controller replied that N6857P was visual and was following the traffic ahead that was just crossing the threshold of runway 27. However, this traffic was another IFR aircraft on

approach to runway 27 and not C-GMET in the circuit. Moments later, at 1048:04, N6857P checked in on the tower frequency. The airport controller immediately realized that there would be a conflict between the two aircraft and instructed C-GMET to turn directly toward the button of runway 27. When queried as to whether there was sufficient spacing behind C-GMET, the pilot of N6857P replied that an orbit was preferred to increase the spacing with the traffic ahead and that he had the traffic in sight. Both aircraft landed without further incident.

7. The OJI did not inform the Victoria airport controller regarding his plan of action for N6857P.
8. The Victoria terminal data/supervisor did not ensure that information passed to Victoria tower regarding the arrival controller's intention for N6857P was correctly understood.

9. The Victoria ground controller did not correctly understand the information regarding N6857P, nor did he seek clarification.
10. The Victoria ground controller did not correctly relay to the Victoria airport controller the information that N6857P would be continuing with a visual approach to runway 27.
