AVIATION INVESTIGATION REPORT

A98P0303

CONTROLLED FLIGHT INTO TERRAIN

CESSNA 208B CARAVAN N9352B

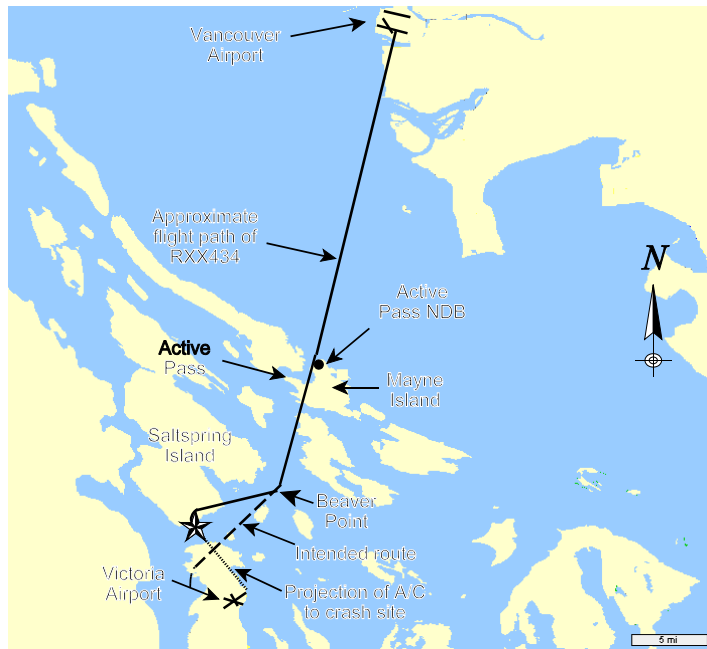
Figure 1 - Aircraft routing and crash site

As the aircraft approached Active Pass, the crew made a radio call to inform any traffic in the Victoria area of their intention to join left-base for a landing on runway 09 at the Victoria airport. Several minutes later, the crew made a second report indicating that they were 10 nm back, for a landing on runway 09. The last position report was made as they approached Beaver Point, at the south-east end of Saltspring Island. Recorded radar data then showed the aircraft made a noticeable turn to the right, in the vicinity of Beaver Point, and began to track towards high ground north of the Victoria airport (solid line depicted on Figure 1).

At 0026, the aircraft began a gradual, descending turn to the left onto a south-easterly heading, before striking trees near the peak of Mount Tuam on the southern end of Saltspring Island. Information gathered at the crash site indicates that the aircraft was in level flight when it first contacted the trees and that its flight path was lined up with the east side of the Victoria airport (dotted line depicted on Figure 1).

longitude 123°29.05' west, and is about 100 feet below the peak of the mountain, at an estimated elevation of about 1850 feet asl. The debris trail was 400 to 500 feet in length, orientated on a magnetic bearing of 123 degrees, and was in line with the east side of the Victoria airport. (See dotted line on Figure 1.)
