AVIATION INVESTIGATION REPORT

A98H0004

RISK OF COLLISION

TERRACE AIRPORT, BRITISH COLUMBIA

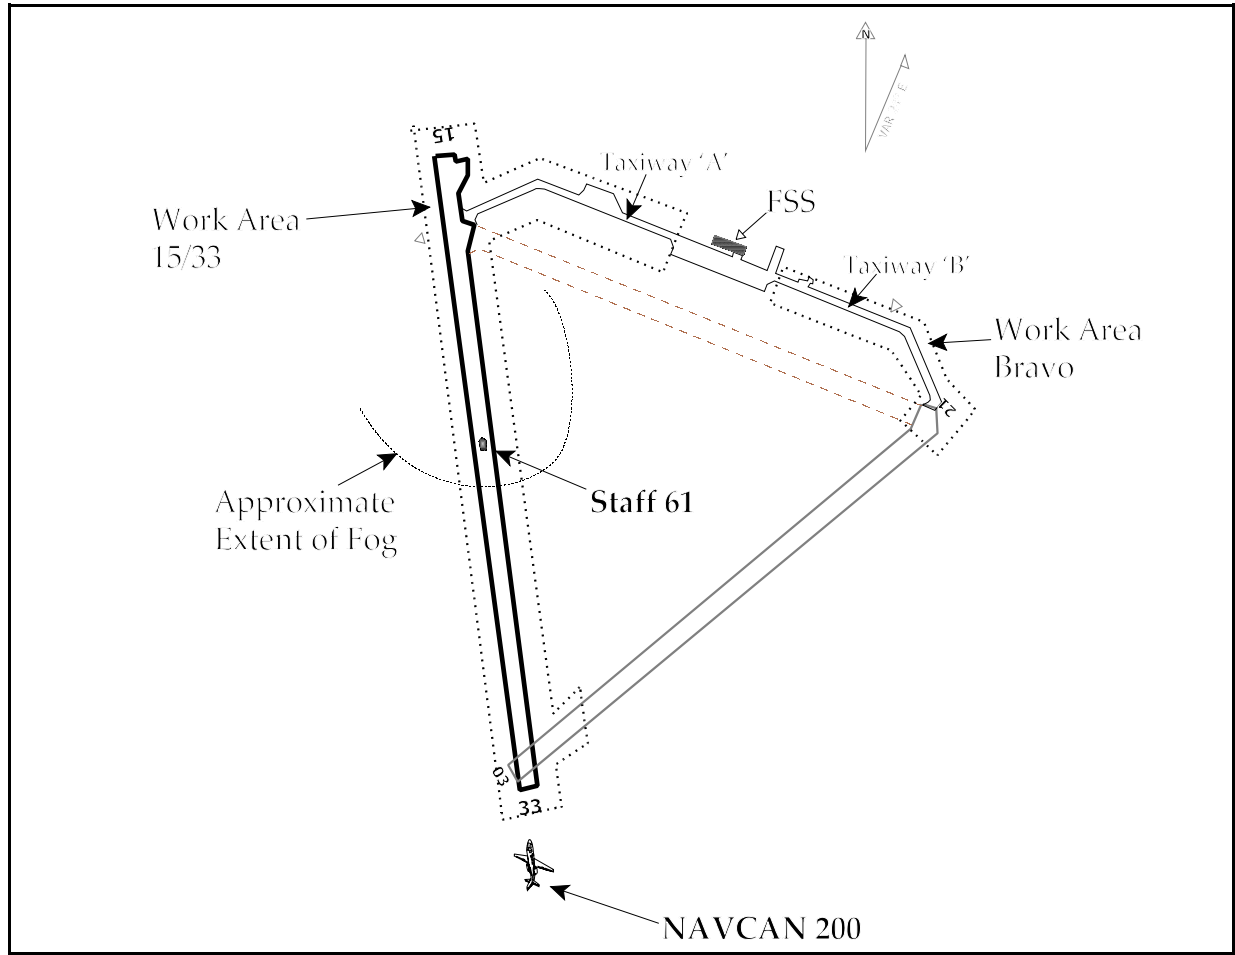
Appendix A—Terrace Airport Diagram

Positions of NAVCAN 200 and Staff 61 (at approximately 1119 PST)
