AVIATION INVESTIGATION REPORT

A98A0191

COLLISION WITH TREES

**KNIGHTHAWK AIR EXPRESS LIMITED
DASSAULT-BREGUET FALCON 20D C-GTAK
ST. JOHN'S, NEWFOUNDLAND
30 DECEMBER 1998**

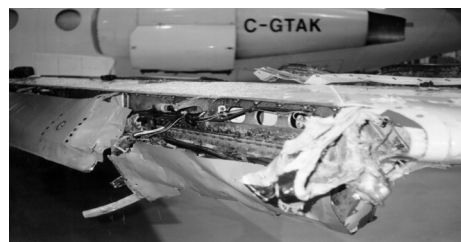
Outer left wing

The left wing sustained the following damage: approximately three feet of the outboard droop leading edge was torn loose and curled under the wing; the outboard wing extension lower skin was twisted; and the aileron and outboard flap panel exhibited minor damage. The left wing inboard droop and fixed leading edges exhibited several substantial impact marks.
