**RAILWAY INVESTIGATION REPORT  
R10C0016**

**NON-MAIN-TRACK DERAILMENT**

**CANADIAN PACIFIC RAILWAY  
FREIGHT TRAIN 292-02  
MILE 0.0, BROOKS SUBDIVISION  
MEDICINE HAT, ALBERTA  
03 FEBRUARY 2010**

Report Number R10C0016

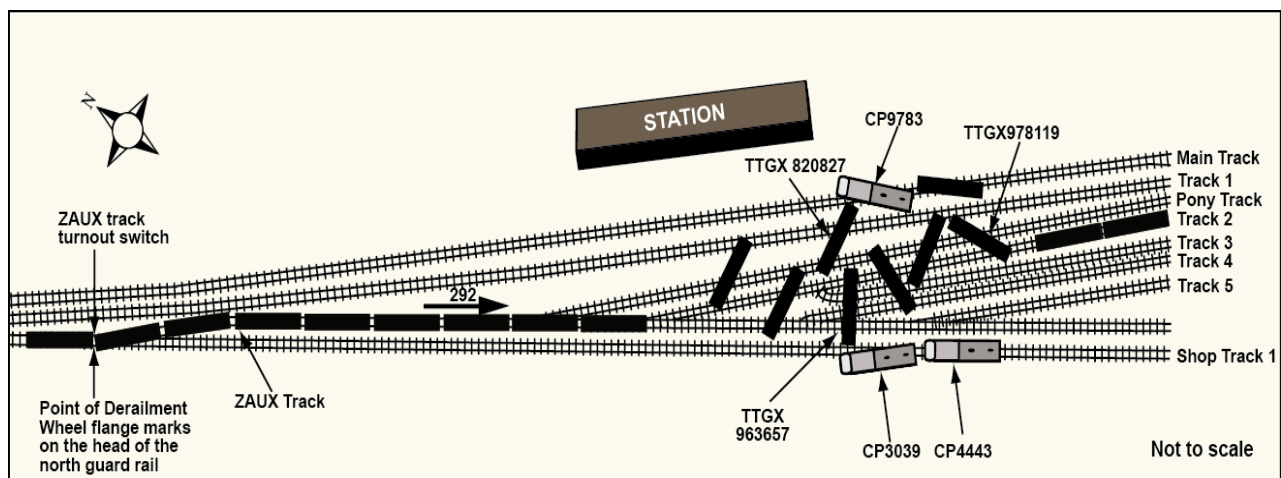
**Figure 2.** Medicine Hat Yard accident site diagram

The first car, TTGX 978119, had its rear truck derailed; the following 6 cars had all of their trucks derailed. The 16<sup>th</sup> car, TTGX 963657, derailed southward from track 2, striking and derailing yard service locomotive CP 3039 which was stationary on shop track 1. As a result, the fuel tank of CP 3039 punctured and diesel fuel spilled onto the ground. The yard assignment locomotive engineer, who was in the cab, was not injured.

The 17<sup>th</sup> car on train 292, TTGX 820827, derailed northward from track 2 and struck the head-end of train 103 on the main track. The impact caused lead locomotive CP 9783 and the first car, an empty auto carrier, to derail. The fuel tank on CP 9783 punctured and diesel fuel spilled onto the ground. The conductor, who was in the cab of the locomotive, was not injured.

During site examination, the first wheel flange marks in the vicinity of the derailment were found on the head of the north guard rail of the frog in the Number 11 - 100 lb left-hand turnout between the west shop track 1 and the ZAUX track.

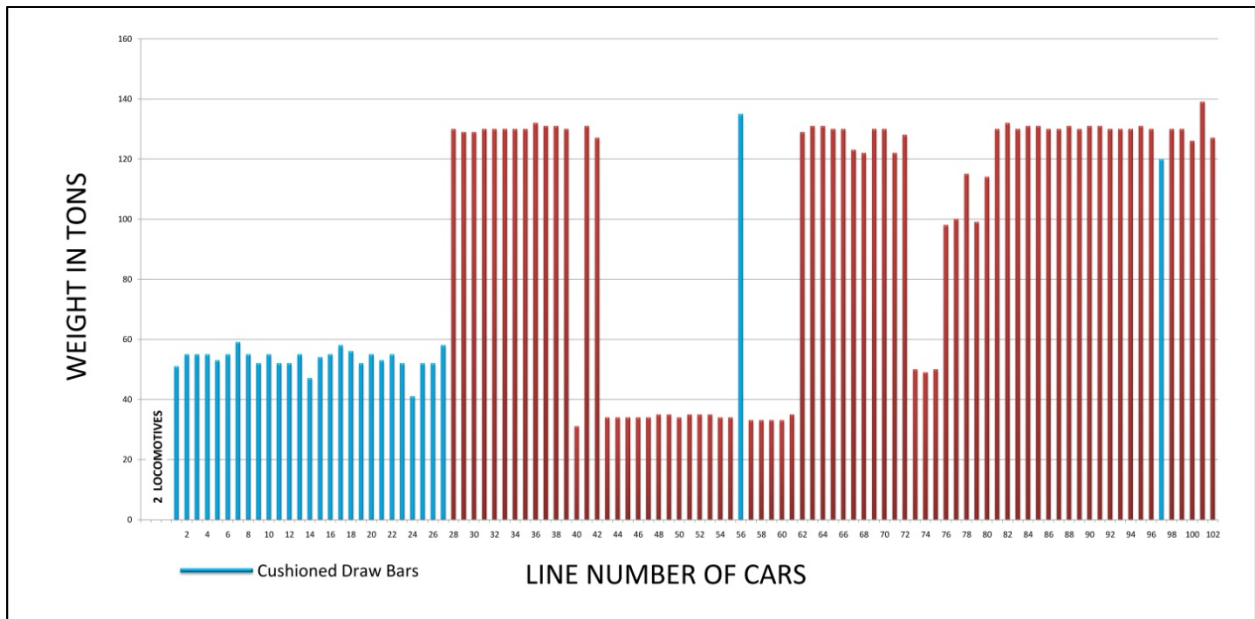
Figure 3. Tonnage Profile for Train 292 (Note: The locomotives weigh 210 tons each)

The rear 4500 feet of train was heavier and on a steeper grade than the lighter 2800 foot long head-end portion. Although not a TrAM violation, marshalling of the long and lighter empty multi-level auto carrier cars ahead of the heavier rear portion of the train made it vulnerable to the large in-train buff forces generated when attempting to control train speed using DB only. The buff forces compressed the EOCCD draft gear, producing high transformed lateral forces due to the wide angle couplers. These cars when empty are more than 50% heavier than empty conventional cars and TrAM considers them to be loads. Had they been placed on the tail end of the train behind heavier loaded cars, the risk of derailment would have been reduced. While it may seem appropriate to apply the TrAM load threshold of 45 tons to empty long cars with wide angle couplers and pre-loaded EOCCD draft gear, marshalling them ahead of heavier loaded cars increases the risk of derailment during heavy braking events.
