RAILWAY INVESTIGATION REPORT
R10T0035

MAIN-TRACK TRAIN DERAILMENT

CANADIAN NATIONAL
FREIGHT TRAIN NUMBER M36921-02
MILE 92.10, KINGSTON SUBDIVISION
MORRISBURG, ONTARIO
02 MARCH 2010

Report Number R10T0035

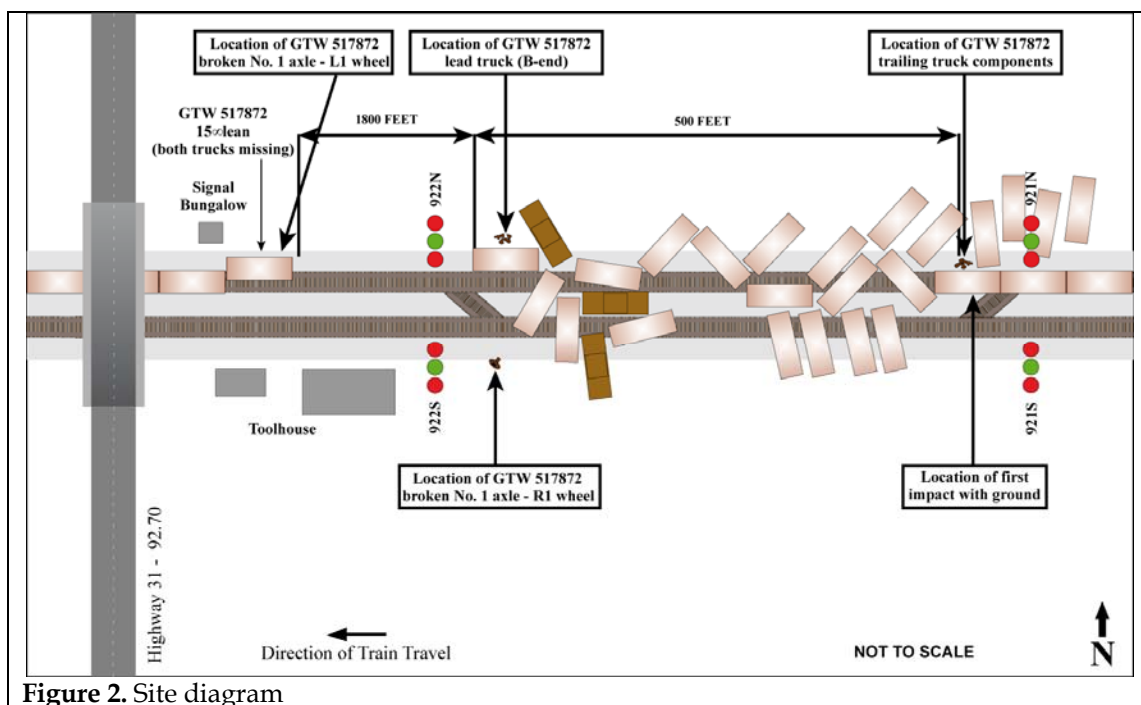
Figure 2. Site diagram

The main derailment area was located primarily between the east crossover at mile 92.10 and the west crossover at mile 92.20, a distance of approximately 500 feet. A total of 25 cars, the 40th to the 64th from the head end, came to rest in various positions throughout this area. The 39th car, box car GTW 517872, had uncoupled and separated from the 40th car near the west crossover. GTW 517872 remained with the head end of the train and was dragged westward, leaving a gap of about 1800 feet between the car and the main derailment area, damaging the track in the process.

At the east end of the derailment site, impact marks were observed on the ties of the north track extending westward from the east crossover. The trailing A-end truck from GTW 517872 was located to the north side of the track near the east crossover. Approximately 500 feet of the north track was destroyed. Four switches, 2 crossovers, about 1800 feet of the north track and 300 feet of the south track were damaged (see Figure 2).

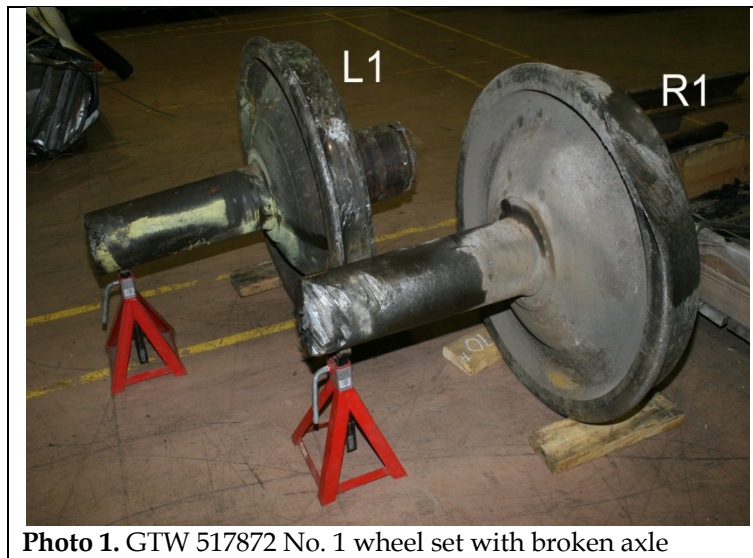
- The axle fractured transversely near the midpoint of the axle body (see Photo 1). The fracture was relatively flat and perpendicular to the principal stresses acting on the axle. There was no evidence of overheating.

- The axle body and fracture surfaces were battered after the separation. Several heavily oxidized surface impact marks (dents) were observed near the middle of the axle body that pre-dated the accident. One of these marks measured 0.08 inches deep and was located near the fatigue origin while a second mark measured 0.10 inches deep.

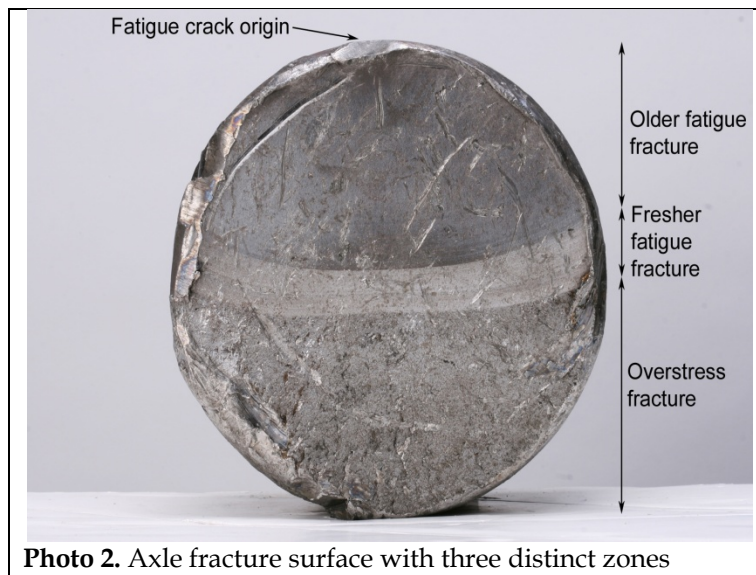
- The fracture surface displayed three distinct fracture zones (see Photo 2):

- The primary zone was worn, oxidized and extended through approximately 45% of the axle cross-section. It had microscopic features (striations) that were flattened due to prolonged mutual rubbing of the two mating sides of the crack before the separation.
- The secondary zone, which was directly beneath the primary zone, was fresher, lighter in color and extended through about 10% of the axle cross-section. Beach marks were observed throughout this zone.
- The third zone had a rough fibrous texture typical of brittle failure associated with instantaneous overstress fracture.

- The characteristics observed in the primary and secondary zones indicate that they were produced by fatigue cracking. The appearance of the primary zone in contrast to the secondary zone suggests that the wheel set was dormant for an extended period of time during which the axle primary fatigue crack became more oxidized.

- The fatigue crack originated from a single anomaly or impact mark on the axle surface that created a notch effect, acted as a stress raiser and initiated the crack. There were no other cracks observed elsewhere on the axle.
