**RAILWAY INVESTIGATION REPORT
R10V0038**

MAIN-TRACK TRAIN COLLISION

**CANADIAN PACIFIC RAILWAY
TRAINS 300-02 AND 671-037
MILE 37, MOUNTAIN SUBDIVISION
KC JUNCTION, BRITISH COLUMBIA
03 MARCH 2010**

Report Number R10V0038

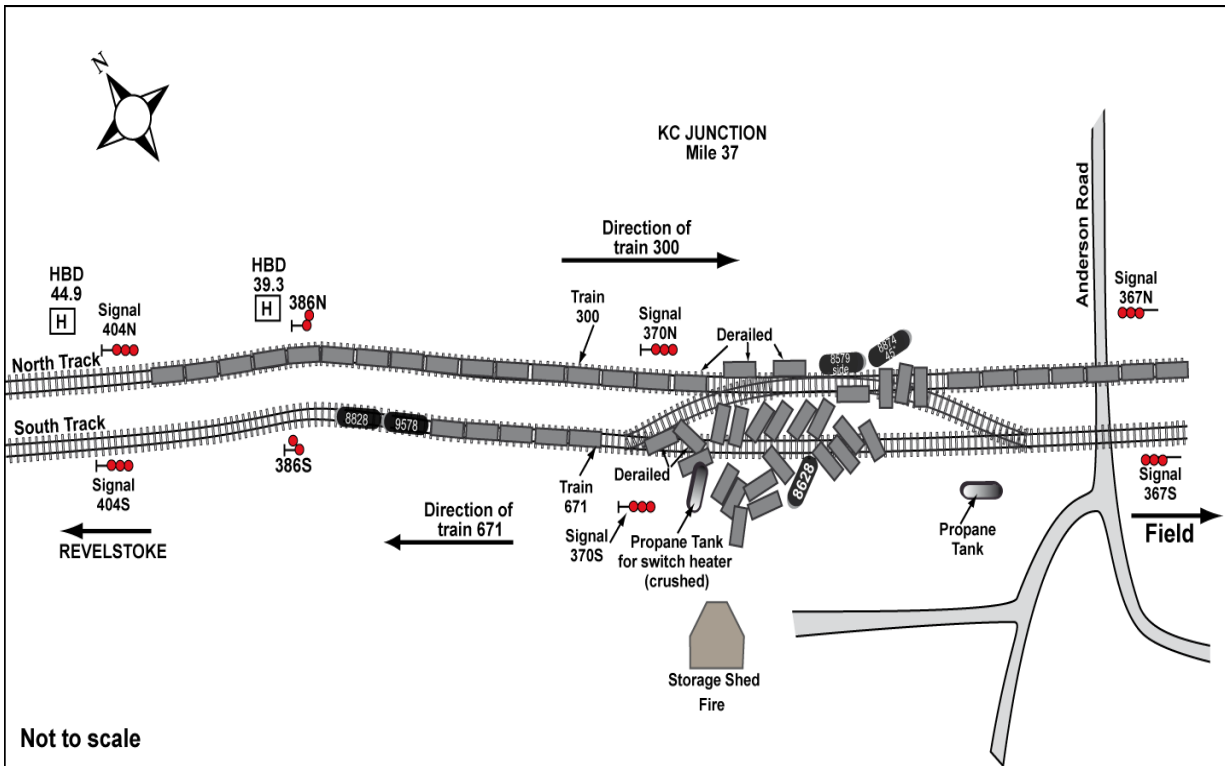
Figure 2. Track and Signal Layout at KC Junction

At about 1410, ¹ train 300 was lined to controlled block signal ² 370N at KC Junction (Mile 37) on the north main track of the Mountain Subdivision (see Figure 2). The Centralized Traffic Control (CTC) system had set signal 370N to display a “Stop” indication. Westward train 671 had just finished fuelling on the north main track at Golden (Mile 36) and was departing through the crossover to the south main track. Train 300 was scheduled to stop for fuel at Golden after train 671 cleared the north main track. At this location, it was common practice to fuel locomotives from the north main track. The crew on train 300 did not have a train line-up³ and were not aware that train 671 had fuelled in Golden and was crossing over at KC Junction to continue westward on the south main track.

300 on the north track up to signal 370N at KC Junction. Train 671 was lined westward at signal 367N to depart KC Junction through the crossovers from the north to the south main track.

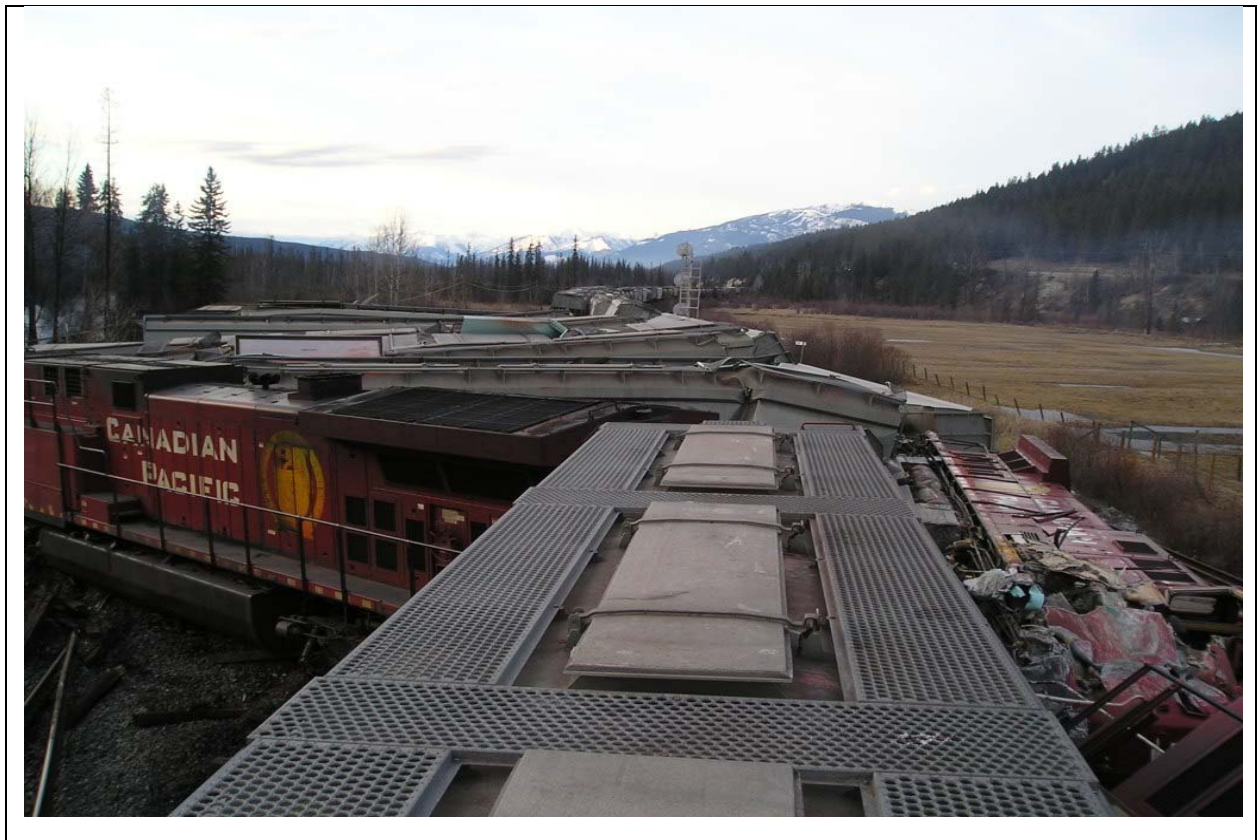
Photo 1. Derailment damage of cars from train 300 and train 671

Train 300's lead locomotive and second locomotive (8874 and 8579) along with 3 empty hopper cars derailed. Train 671's mid-train locomotive (8628) and 23 loaded potash cars derailed (see Photo 1). Six additional loaded potash cars from train 671 were damaged but did not derail. A punctured 4500 litre propane tank used to fuel a switch heater at the crossover caused a fire resulting in a nearby tool/storage shed being destroyed. The propane tank was situated within 15 feet of the track. The railway right-of-way at that location was about 100 feet wide. Several nearby residences and businesses were evacuated.

There was no diesel fuel released from locomotive 8874. However, approximately 3260 gallons of diesel fuel were released from locomotive 8579, of which about 260 gallons were recovered. About 22 gallons of diesel fuel were released from locomotive 8628, none of which was recovered.

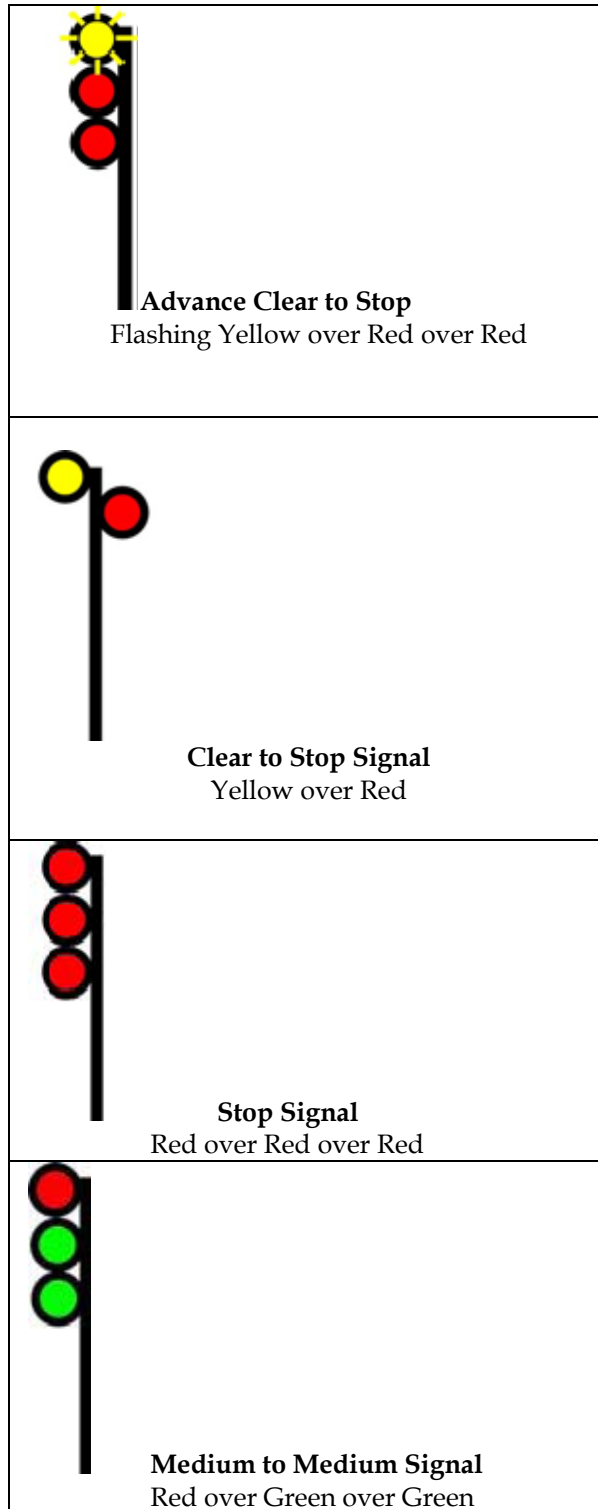
Figure 3. Signal Aspects

- An Advance Clear to Stop indication at signal 404N (i.e., the intermediate signal preceding the advance signal to KC Junction).
- A Clear to Stop indication at signal 386N (i.e., the advance ⁵ signal to KC Junction).
- A Stop indication was displayed on signal 370N, (i.e., the controlled signal governing eastbound movements on the north track, at KC Junction).

- Medium to Medium Signal indication at signal 367N (i.e., the controlled signal governing westward movements through the controlled location ⁶ at KC Junction).

The indication of the signal 404N and the advance signal to KC Junction (signal 386N) were communicated by train 300's crew within the locomotive cab and over the radio. The crew identified them appropriately as Advance Clear to Stop and Clear to Stop. The indication of the

controlled block signal at KC Junction signal 370N, was a Stop signal. This signal was not called in the cab or over the radio.
