RAILWAY INVESTIGATION REPORT
R10T0056

MAIN-TRACK DERAILMENT

CANADIAN NATIONAL
TRAIN M37631-30
MILE 1.40, YORK SUBDIVISION
PICKERING, ONTARIO
30 MARCH 2010

Report Number R10T0056

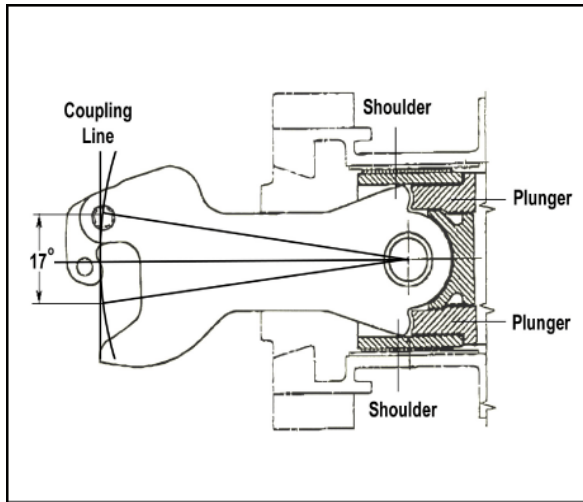
Figure 3 - Alignment control coupler

Most freight locomotives are equipped with alignment control couplers (see Figures 3 and 4) and bolster stops that limit coupler swing. Alignment control couplers limit the coupler angle under buff conditions, to within 8° from centreline. This limits the lateral force imparted on the track due to high in-train longitudinal compressive buff force and reduces the risk of derailment. In contrast, some older locomotives, yard switchers and locomotives in passenger service, such as the 4 isolated locomotives on CN 376, are not always equipped with alignment

- The alignment control couplers on the 3 operating locomotives limited the coupler angle within 8°.
 - The maximum axle lateral force transformed from the in-train buff force at the third operating CN locomotive was about 16 kips, less than the track panel shift resistance of 41 kips.

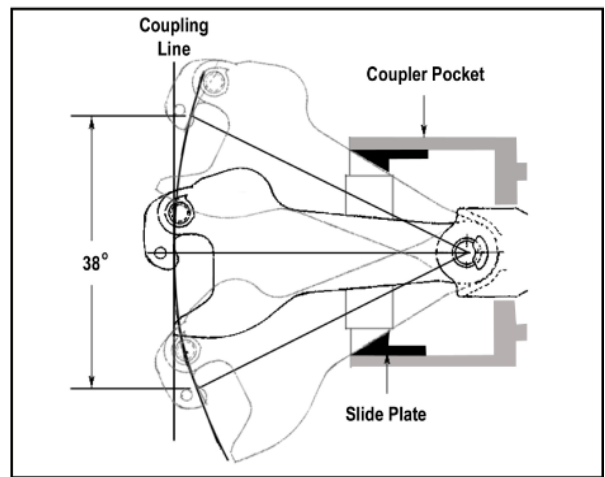
Figure 4 - Coupler without alignment control

Initial visual inspection of the derailed equipment revealed that all 4 of the isolated locomotives were equipped with pin type couplers with no alignment control features (see Figure 4). The sill housings and the coupler shanks of the couplers which connected the second and third isolated locomotives displayed significant damage as a result of contact. There were no other pre-existing conditions or defects observed on any other of the derailed rolling stock that could be considered as causal.

- The couplers on the isolated passenger locomotives with no alignment control had coupler angles up to 21° in jackknifed positions as measured on the derailed equipment.

The alignment control couplers on the operating locomotives limited the coupler angle to 8°, but the non-alignment control couplers on the isolated passenger locomotives had coupler angles of up to 21°. In the presence of high in-train buff forces exceeding 200 kips, the large coupler angle of the isolated locomotives with no coupler alignment control magnified the lateral drawbar force and produced a high L/V ratio that exceeded derailment criterion. Isolated locomotives not equipped with either alignment blocks or alignment control couplers present a higher risk of derailment.

Any non-CN locomotives without alignment control couplers must be retrofitted with coupler alignment blocks, and for GP trucks, the bolster stop must be used to permit movement.
