**RAILWAY INVESTIGATION REPORT
R10W0123**

CROSSING ACCIDENT

**CANADIAN PACIFIC RAILWAY
FREIGHT TRAIN 290-14
MILE 13.85, EMERSON SUBDIVISION
GRANDE POINTE, MANITOBA
14 JUNE 2010**

Report Number R10W0123

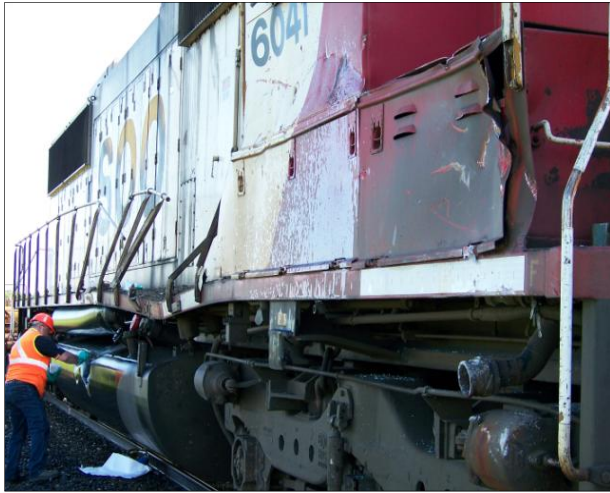
Photo 1. Locomotive SOO 6041

The right (west) side of locomotive SOO 6041 sustained impact damage (see Photo 1). The right front step sill and grab iron were damaged and there was a large dent near the mid-point of the locomotive frame and fuel tank. The first 5 car bodies behind the locomotives derailed upright, straddling the west rail. This was followed by a gap of about 240 feet which led up to an additional 17 car bodies that had derailed in various positions (see Figure 2).

unable to stop before impacting the second locomotive (i.e., west side of SOO 6041). The impact pushed the locomotive eastward but did not derail it. However, the force of the impact canted the east rail eastward which allowed the lead wheels of the first car behind the locomotive to drop into gauge, about 10 feet north of the crossing, causing the derailment.

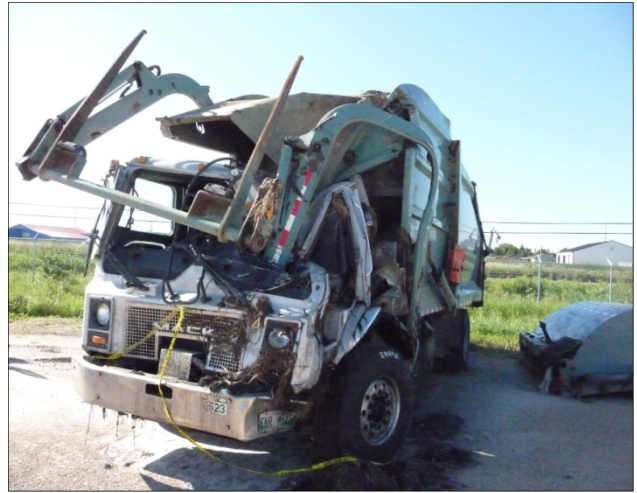
Photo 2. Mack Garbage Truck

The truck was essentially destroyed (see Photo 2). The front driver side of the cab was crushed and the bottom corner of the driver side rear tail gate was damaged. Gouges, scrapes and black paint marks were observed on both the front and rear of the truck.

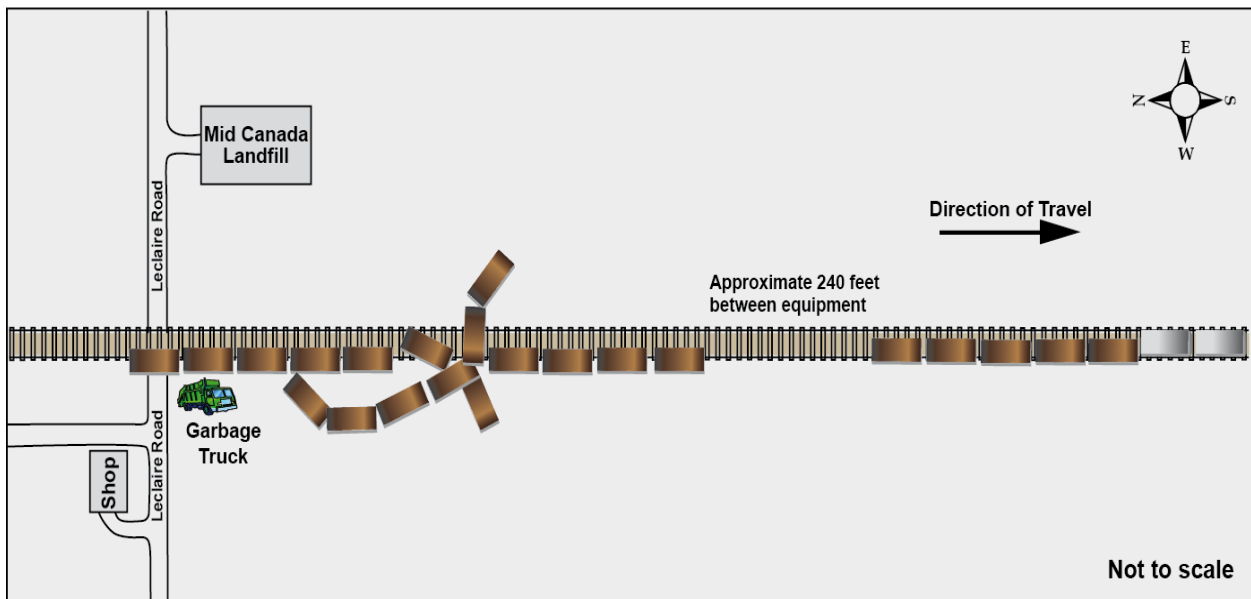
Figure 2. Site diagram

Approximately 10 feet north of the crossing, wheel marks were observed along the web of the east rail, extending southward into the crossing. The crossing and about 520 feet of track to the south were destroyed and an additional 500 feet of track further south was damaged. Beyond the destroyed track, wheel impact marks were observed between the rails, and just west of the west rail, on the ties leading up to the point where the locomotives came to rest.

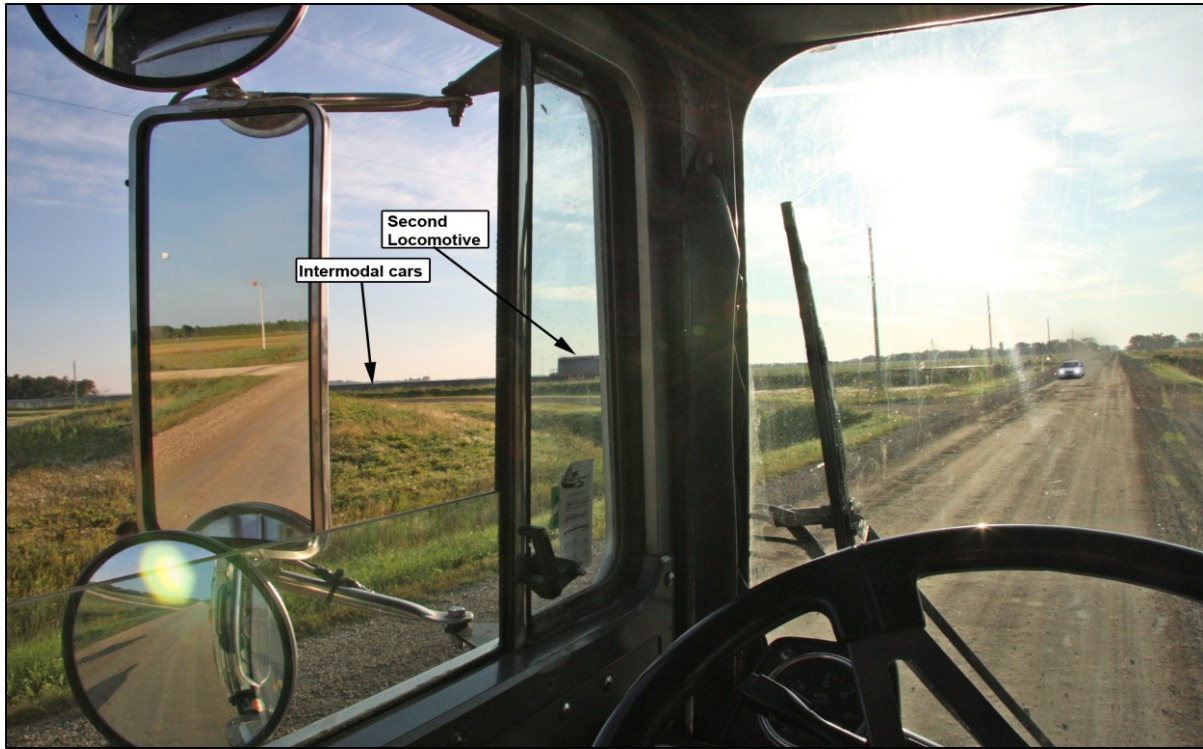
- The measured sightlines met the TC *Minimum Railway/Road Crossing Sightline Requirements For All Grade Crossings Without Automatic Warning Devices (G4-A)*.
- The average ambient noise in the truck cab driving on the gravel road without the radio playing was in excess of 95 dB(A).
- The pillar between the truck's windshield and side window, the side mirrors and window frame obstructed the driver's field of view to the north (see Photo 3).
- With the position of the sun at the time of the accident, the empty intermodal cars at the head-end of the train blended into the background which made it difficult to distinguish the train from other features on the horizon.

Photo 3. Simulated view approaching the crossing. The precise position of the vehicles and the environmental conditions may not be identical to those of the accident.

The presence of the building on the northwest corner of the crossing limited the amount of time that the driver had available to notice the train. Furthermore, similar to other TSB investigations, the TSB accident simulation determined that the pillar between the truck's windshield and side window, the large side mirrors and window frame obstructed the driver's field of view to the left. Similar arrangements are common on many North American trucks.
