**RAILWAY INVESTIGATION REPORT  
R10E0056**

**CROSSING COLLISION**

**VIA RAIL CANADA INC.  
PASSENGER TRAIN NUMBER 1  
MILE 10.76, EDSON SUBDIVISION  
WINTERBURN, ALBERTA  
04 MAY 2010**

Report Number R10E0056

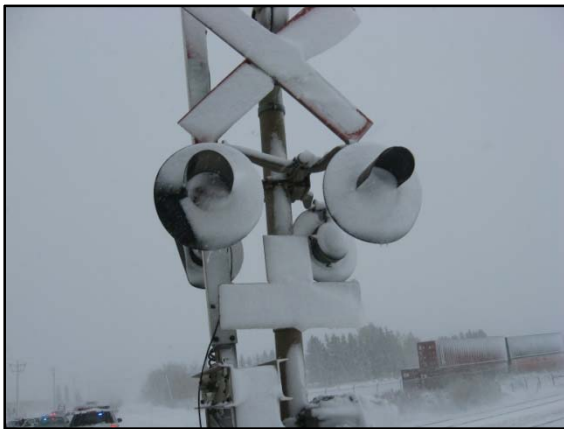
**Photo 1.** North signal, northward-facing lights

- For southbound vehicles, the presence of ice and snow was noted on the northward-facing warning lights, gate lights, and reflectorized materials. With the crossing protection operating, it was difficult to see light emitted from the northward-facing signals.<sup>14</sup>

On 18 May 2010, CN replaced the DC crossing protection system at Winterburn Road with a constant warning system with LED lights. Data from the new crossing protection system was examined. It was determined that nuisance operations at this crossing were significantly reduced as no warning times greater than 1 minute were recorded over a 2-week period. In comparison, approximately 36% of the warning times were greater than 1 minute prior to the installation of the new system

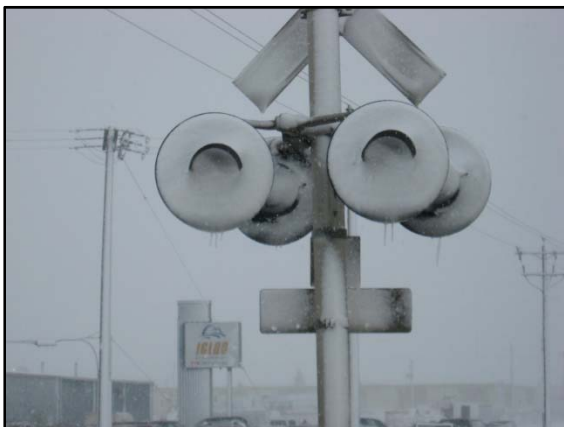
**Photo 2.** South signal, northward-facing lights

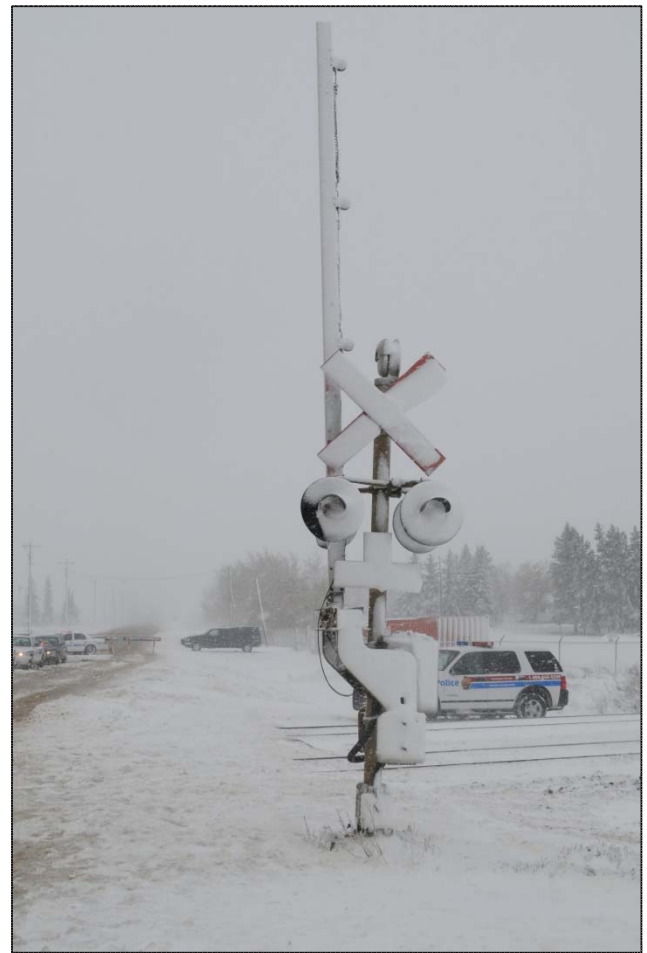
**Photo 3.** Northward-facing signals and gate

- An inspection of the north gate did not show any indication of recent damage or contact with a vehicle.
- Upon completion of the activated crossing inspection, the test switch was closed and the remaining operational tests were conducted in accordance with company maintenance procedures (i.e., S&C GI-301(Q), SCP-701 and Western Canada S&C Operational Test Procedures).

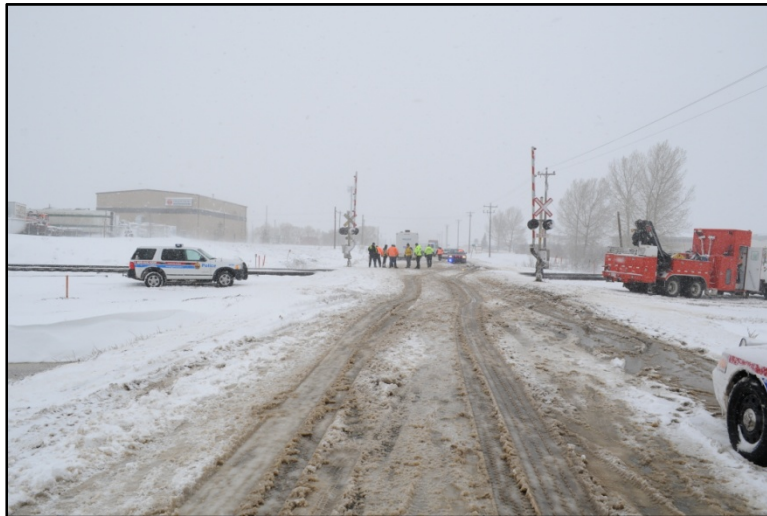
At the time of the accident, the temperature was just below freezing with high winds from the north to northwest at approximately 40 km/h, gusting up to 68 km/h with blowing and falling snow. It had rained throughout the night, turning into freezing rain and then snow in the early morning. Driving conditions and visibility were poor; the road surface was wet, slippery, and covered in fresh snow (see Photo 4). The crew reported that the north-facing right side window of the locomotive was iced up and covered with snow, and that the wipers had little effect in clearing the front window. Poor visibility prevented a clear view of the north side of the crossing.

**Photo 4.** Winterburn Road crossing, looking north

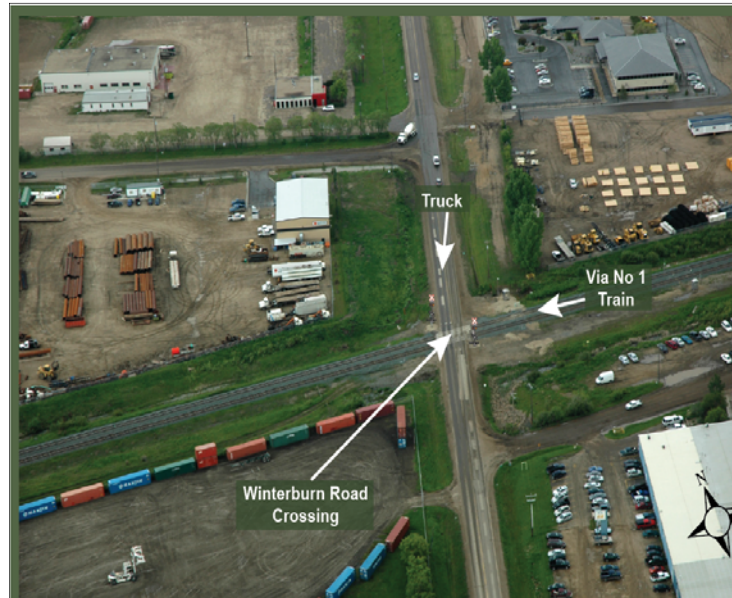
**Photo 5.** Winterburn Road crossing

Winterburn Road is a north-south, undivided two-lane arterial road that crosses the tracks at approximately 70-degrees on level grade (see Photo 5).
