**MARINE INVESTIGATION REPORT  
M10F0003**

**KNOCKDOWN AND CAPSIZING**

**SAIL TRAINING YACHT *CONCORDIA*  
300 MILES SSE OFF RIO DE JANEIRO, BRAZIL  
17 FEBRUARY 2010**

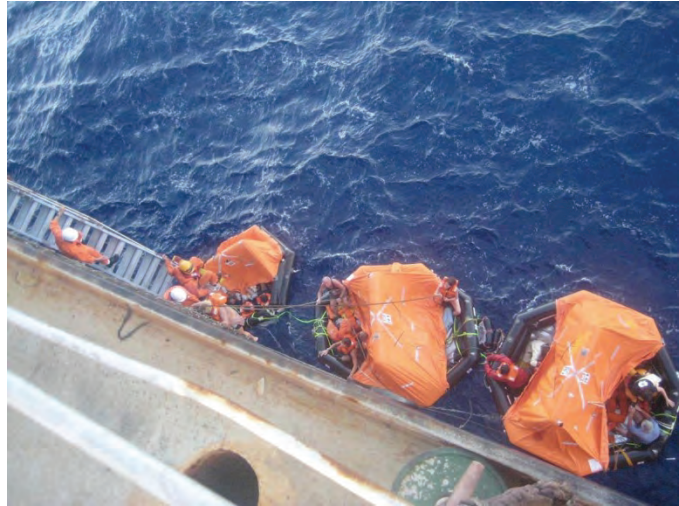
**Photo 2.** Liferafts alongside *Hokuetsu Delight*

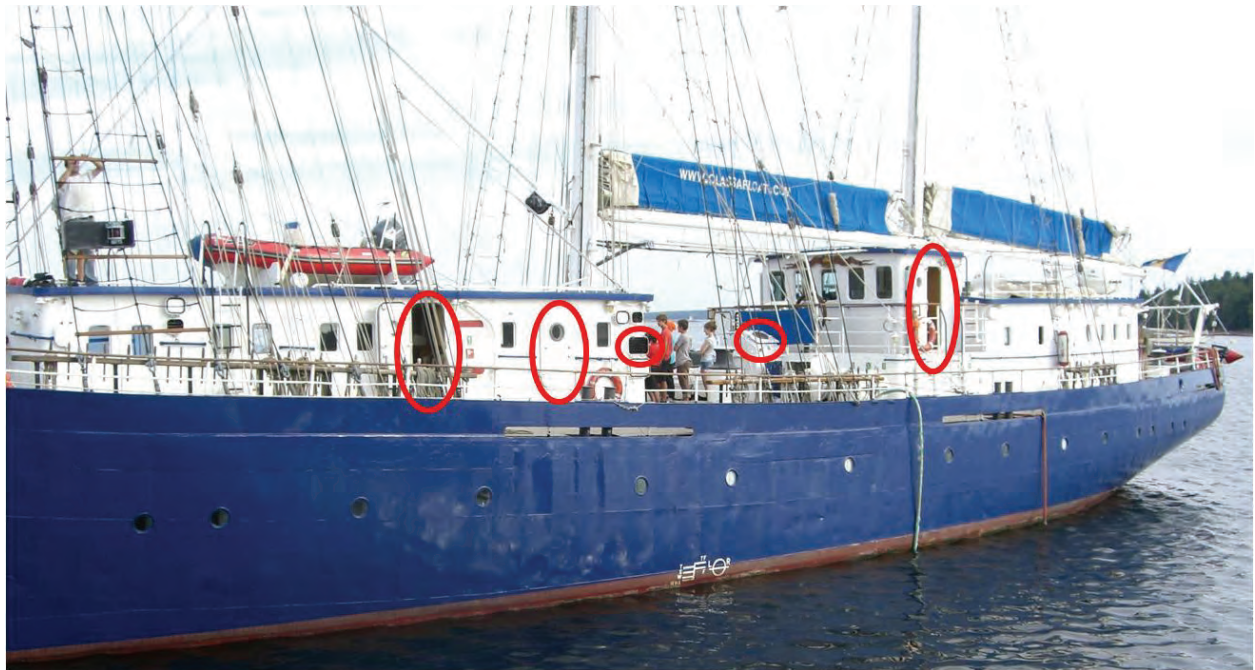
**Photo 3.** Some critical port side openings

Description	Angle of Immersion
Galley Door (forward deckhouse, port side)	56.5°
Mess Door (forward deckhouse, port side)	58.4°
Sanitary Exhaust Vent (forward deckhouse, port side) <sup>Note</sup>	65.0°
Radio Room Window (aft deckhouse, port side)	68.6°
Wheelhouse Door (aft deckhouse, port side)	74.2°
Chart room interior door	87.9°
Engine Exhaust (top of mizzen mast) <sup>Note</sup>	91.7°
Engine Room Skylight (forward of wheelhouse, offset to starboard) <sup>Note</sup>	100.5°
Mess Stairway (inside forward deckhouse) <sup>Note</sup>	116.5°

Note: Immersion of these openings would lead to downflooding of the hull.

Circled from forward to aft: mess room door, galley door, sanitary exhaust vent, engine room skylight and wheelhouse door.

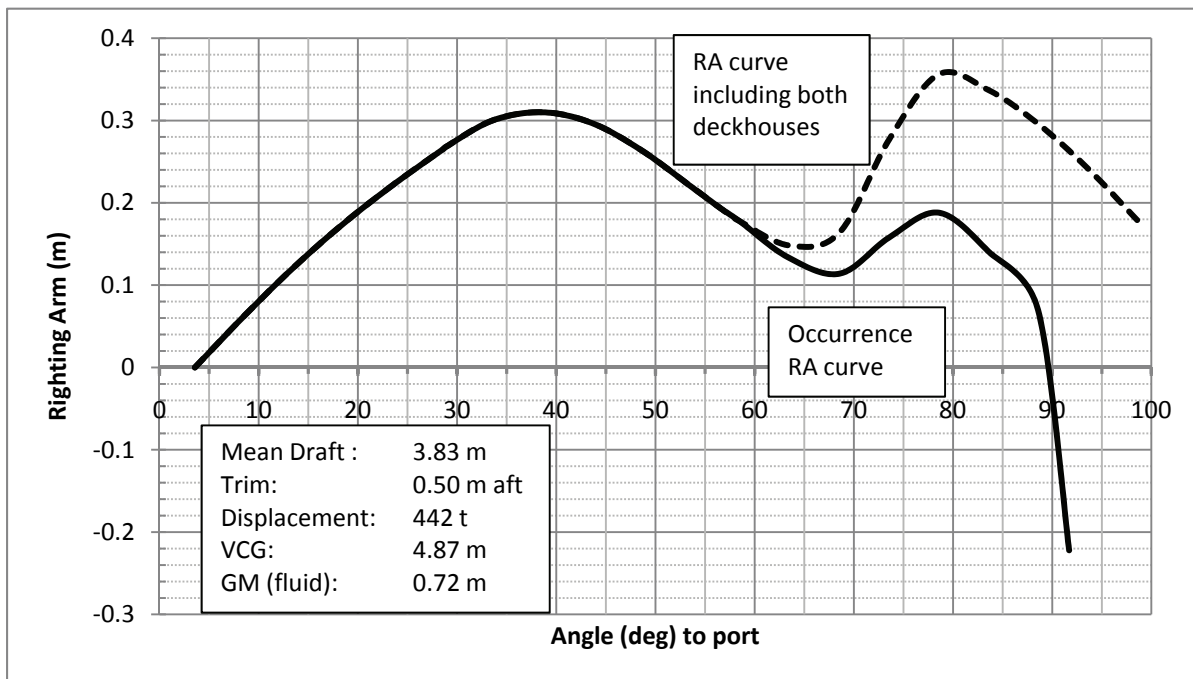
Figure 5. Occurrence righting arm (RA) curve<sup>63</sup> showing the effect of lost buoyancy from the deckhouses

The RA curves presented in *Concordia's* stability booklet are based on the assumption that the weathertight doors in the 2 deckhouses are secured closed, and thus that the deckhouses contribute to the vessel's buoyancy. The resulting effect on the vessel's righting ability can be seen as a second 'bump' in the RA curve beyond angles of around 60° (see Figure 5).

As mentioned previously, the deckhouse doors on the port side were open at the time of the occurrence. The resulting effect on the vessel's righting ability was modelled by eliminating the buoyancy contribution of the relevant deckhouse beyond those angles which would immerse its door(s) as shown in Table 3—the forward deckhouse was discounted after about 58 degrees and the aft deckhouse after about 88 degrees. The RA curve at the time the occurrence was thereby derived and is shown in Figure 5 below.

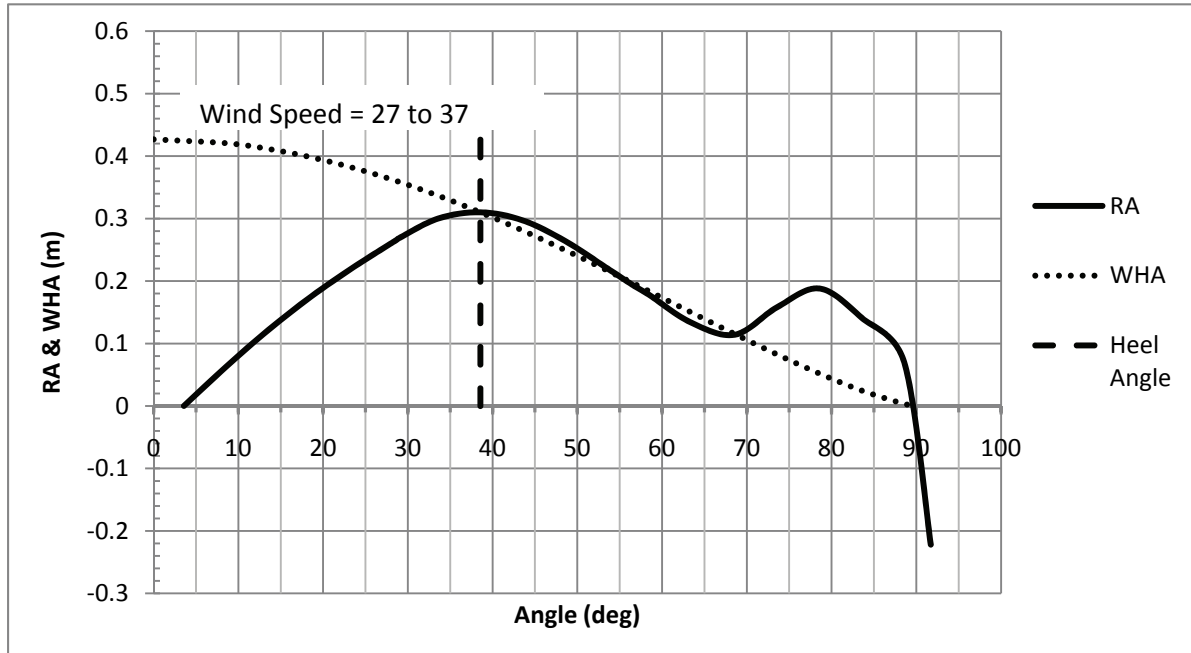
Figure 6. Occurrence righting arm (RA) / wind heeling arm (WHA) curves

It can also be seen in Appendix G that to induce wind heel angles beyond 70° or so, the necessary apparent wind speeds increase significantly to the point where winds in excess of 60 knots would be required to knock the vessel down to an angle in the range of 80°.

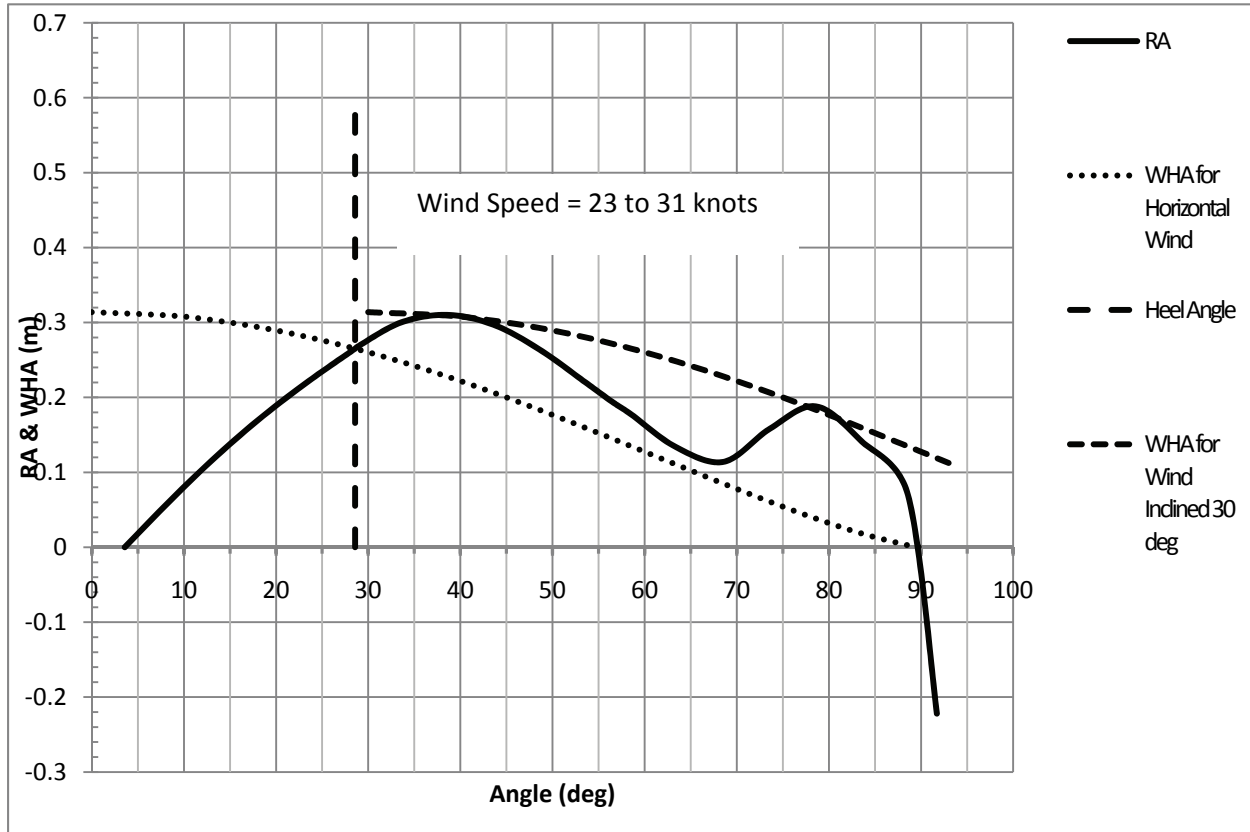
Figure 7. Wind heeling arm curve for wind inclined 30 ° from the horizontal

Figure 7 demonstrates this effect on the *Concordia's* righting ability. First, it is assumed that the vessel is heeled to an angle around 28° due to a horizontal wind. According to the relationship between apparent wind speed and heel angle shown in Appendix G, horizontal winds of between 23 and 31 knots would be sufficient to induce this heel angle. Then, the heeling arm curve is shifted 30° to the right, assuming the winds have shifted to 30° from the horizontal. As can be seen in Figure 7, the vessel's righting ability would be completely overcome by this combination of wind speed and inclination.

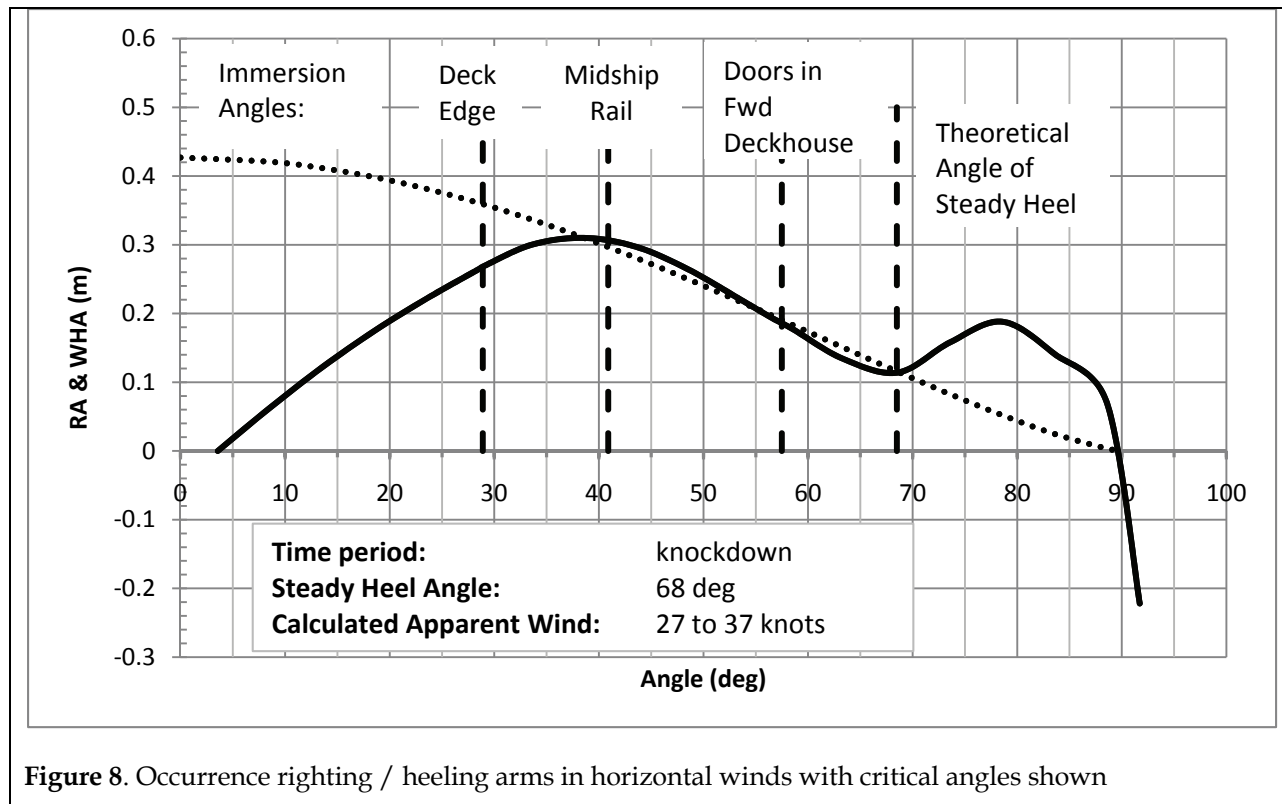
As Figure 8 indicates, although the vessel would theoretically take up a steady heel angle of almost 70° in such winds, water would have begun entering at various critical points before that angle was reached – first, via the open doors in the forward deckhouse (56.5°), then shortly thereafter via the sanitary exhaust vent, which was just aft of that (65°). With all of the doors on the port or lee side, as well as the ventilators and engine room skylight in the open position at the time of the knockdown, there was nothing to prevent or mitigate the downflooding that followed, progressing until the vessel ultimately lost all stability, rolled over, and capsized. The vessel’s ability to recover would have been further hindered by the weight of water entrained in the sails as they submerged, in addition to the possible shifting of weights/equipment.

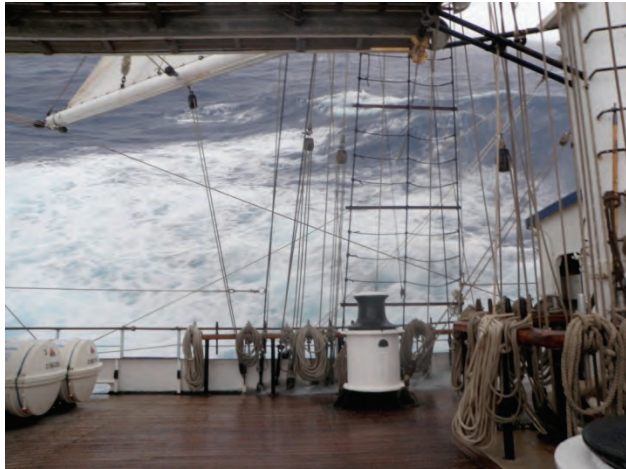
**Photo 4.** Port deck edge immersed at 29°

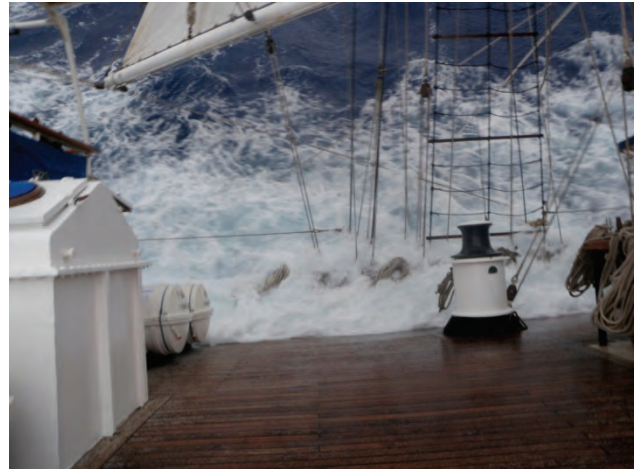
**Photo 5.** Port rail immersed at 41°
