Development and Assessment of Crawl Space Remediation Strategies

CMHC External Research Program (ERP) Project

Figley Consulting Associates Ltd.
Saskatoon, SK

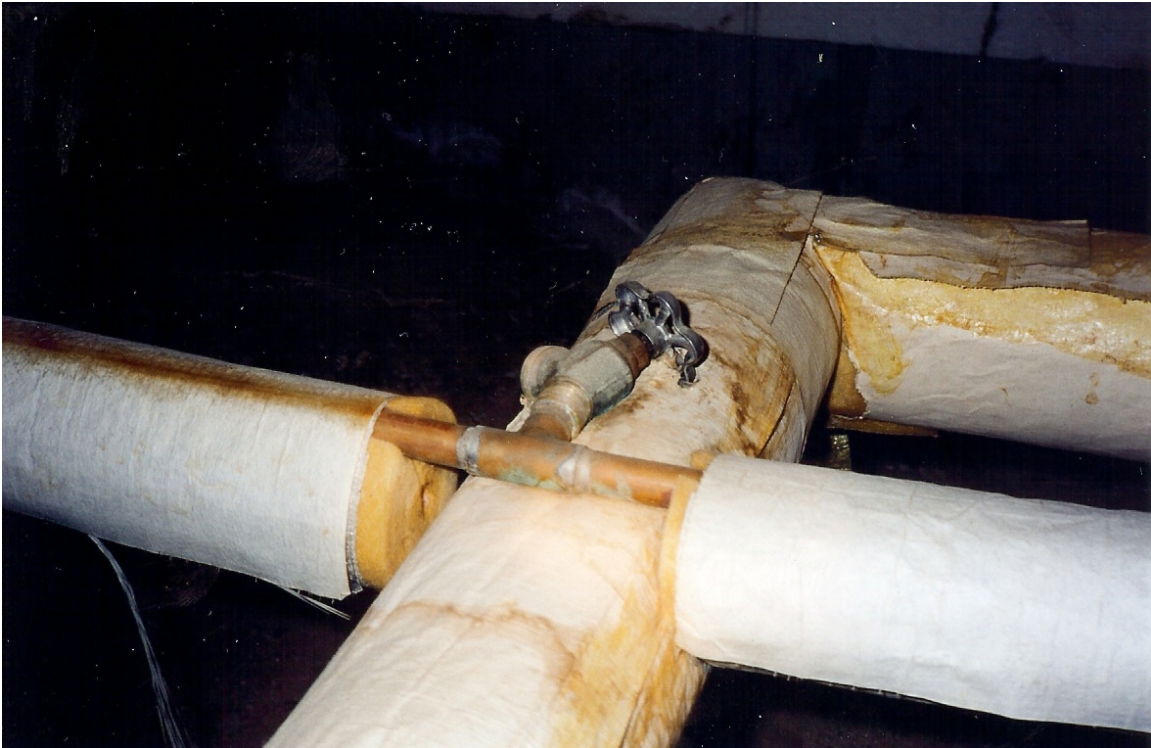
Photo 1: Deteriorated, leaking plumbing and piping in the crawl space.

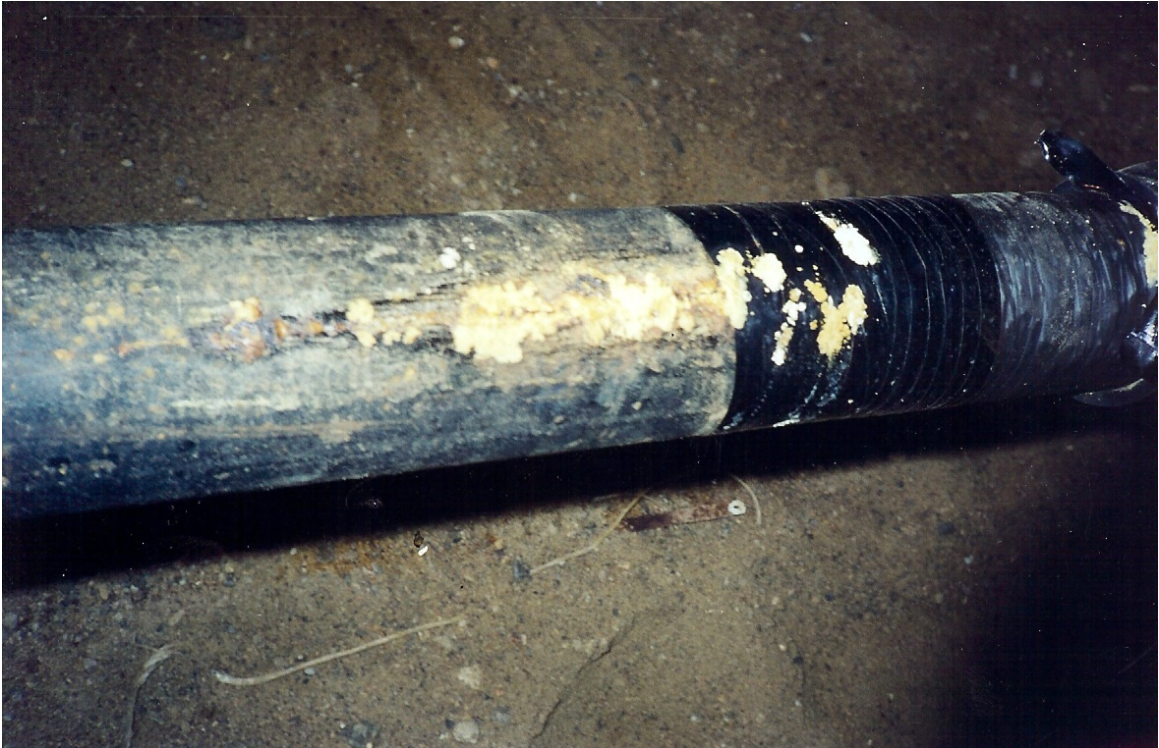
Photo 2: Longitudinal crack in the sewer piping in the crawl space area (repaired by wrapping with electrical tape).

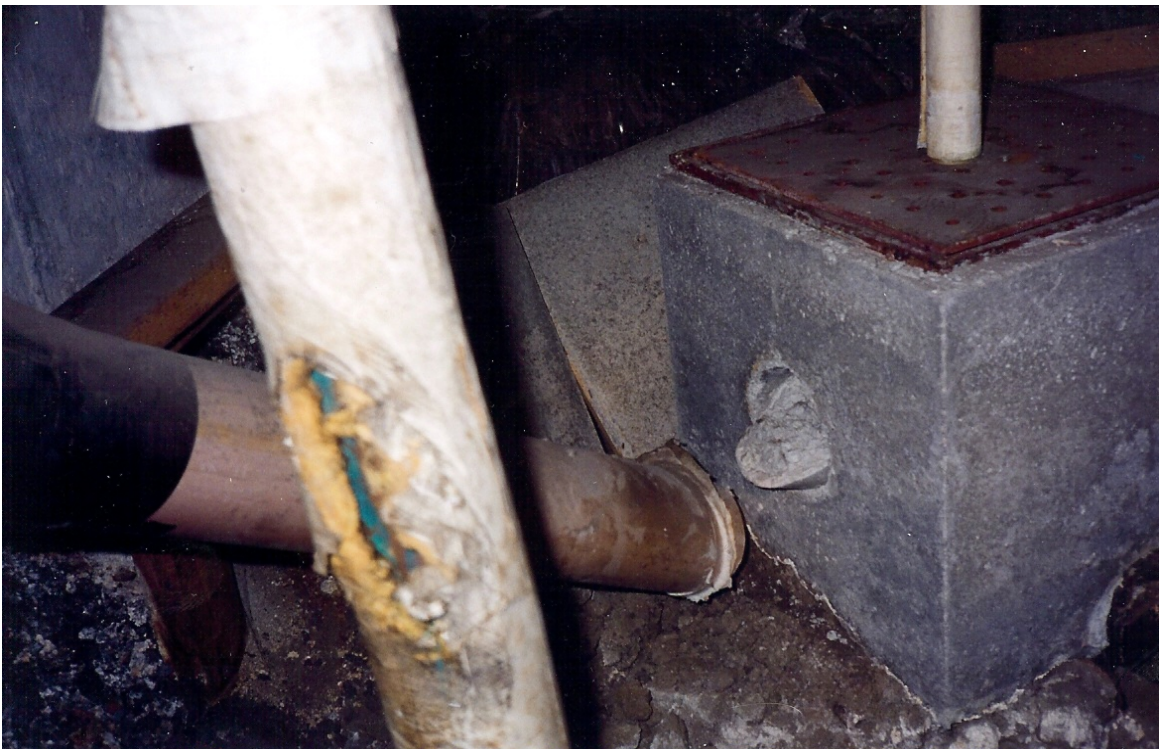
Photo 3: Deteriorated piping. Sump pump piping was disconnected and drained water onto the crawl space floor (note the concrete sump well never had an opening for foundation drainage piping to discharge properly).

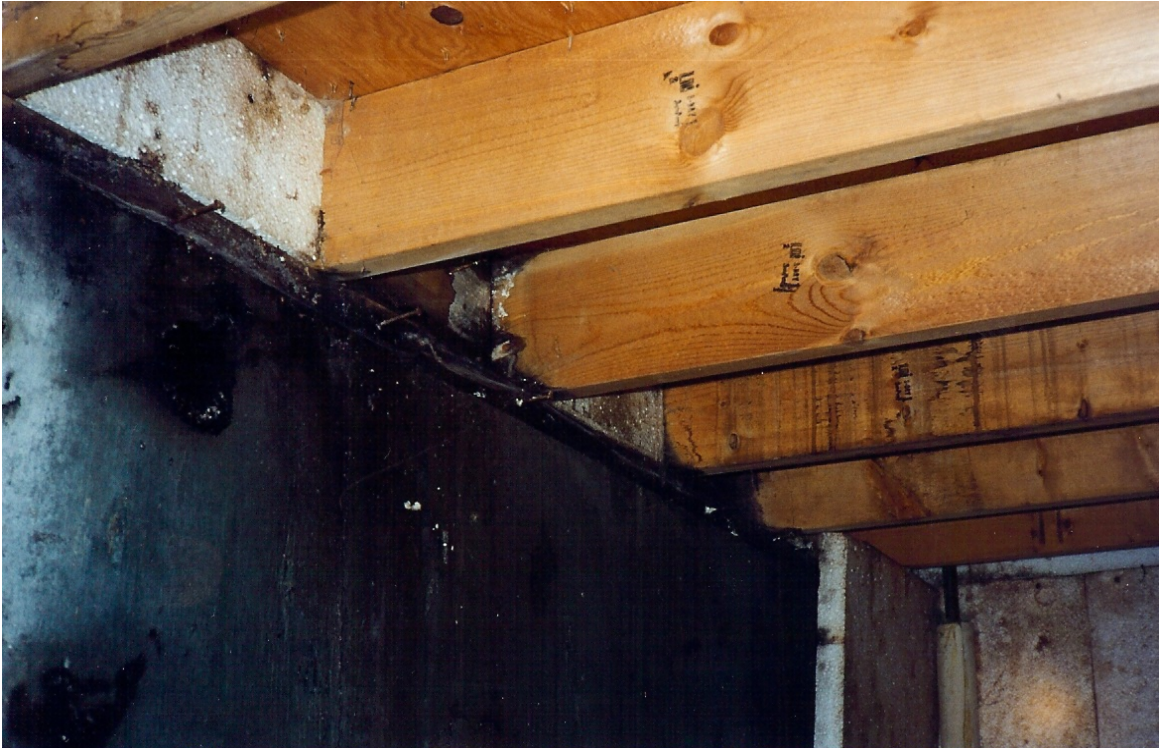
Photo 4: Ends of the rim joists were rotten, moldy and deteriorated. Bead board insulation was present on the interior side of the exterior walls in the crawl space. The insulation was poorly installed, the edges were not sealed and many sections were missing.

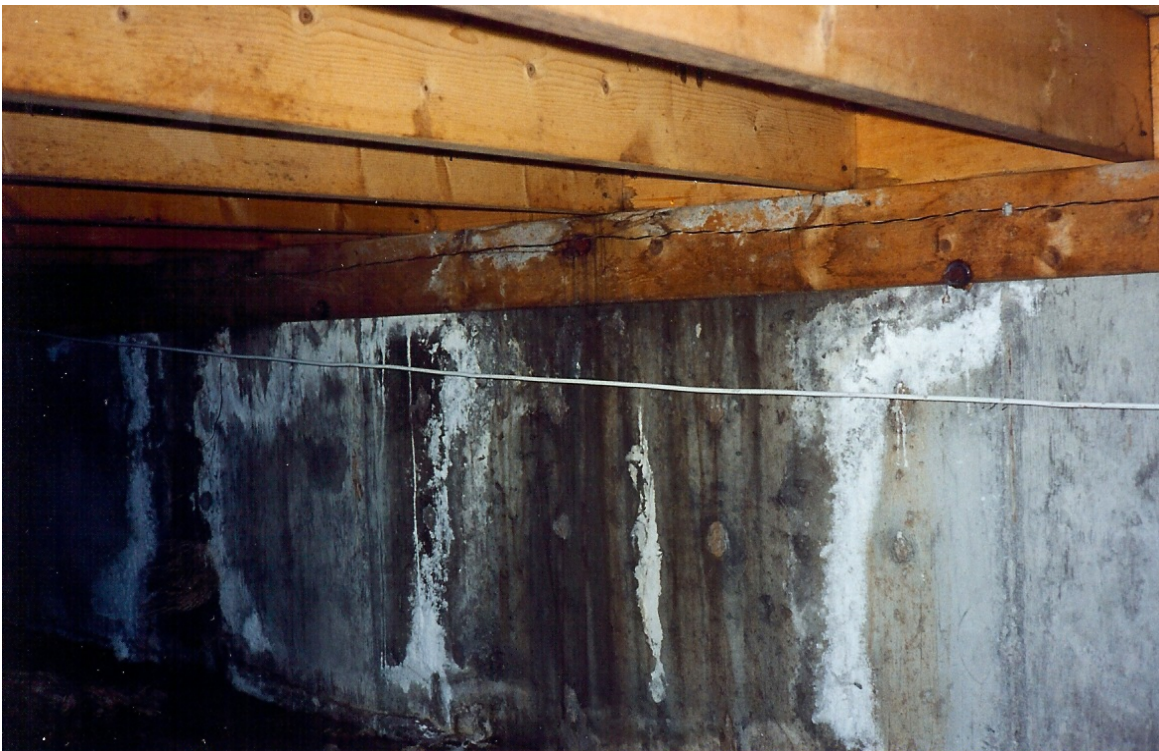
Photo 5: Exterior concrete wall of the crawl space was dirty and stained. Extensive mineral deposits indicated chronic water entry. The wood joists were moldy and deteriorated.

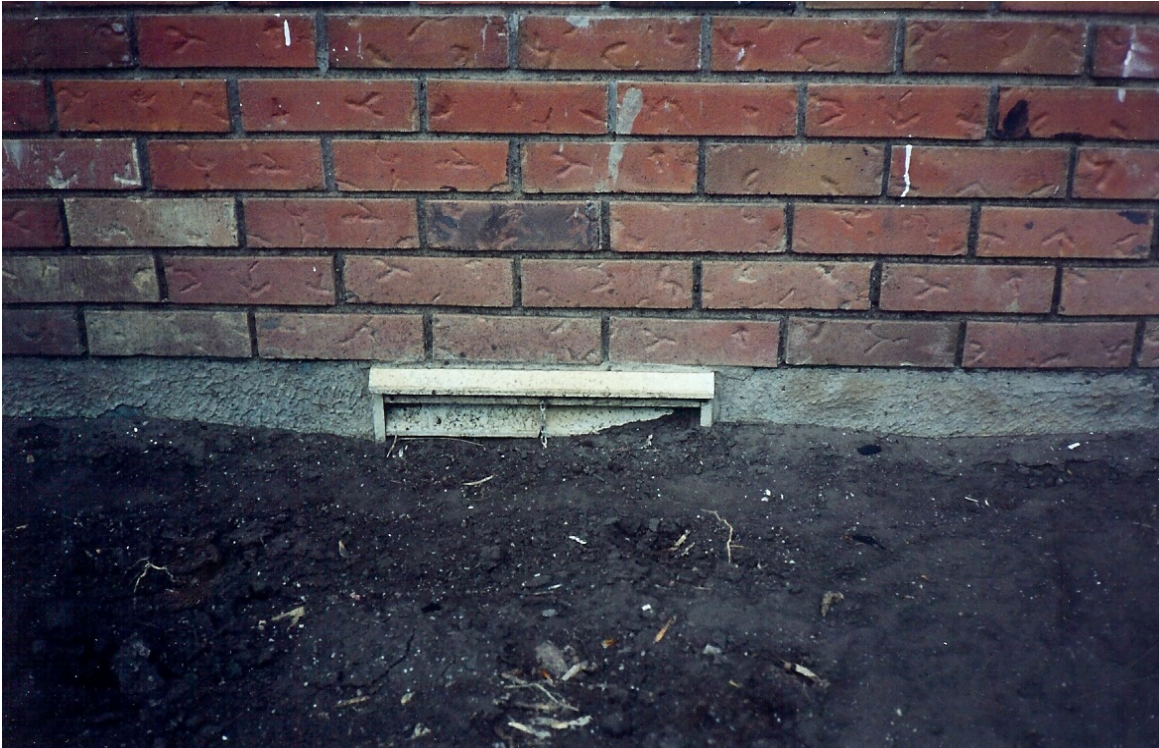
Photo 6: Perimeter of building had poor landscaping. Soil built-up to improve drainage but was above the appropriate level for the building configuration. Ground level vents were open and allowed entry of debris into the crawl space area.

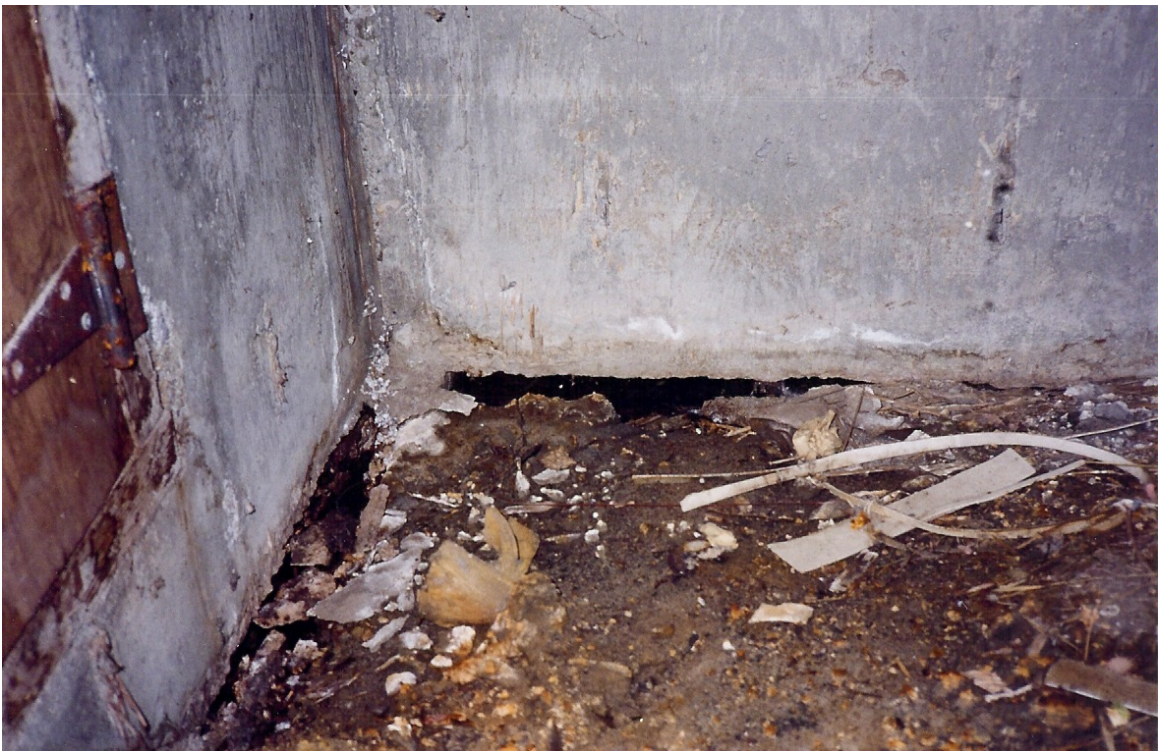
Photo 7: Crawl space floor is sand/gravel. The floor was wet and covered with debris. The “floor barrier”, which consisted of sheets of poly laid around the general floor area, was unsealed and incomplete.

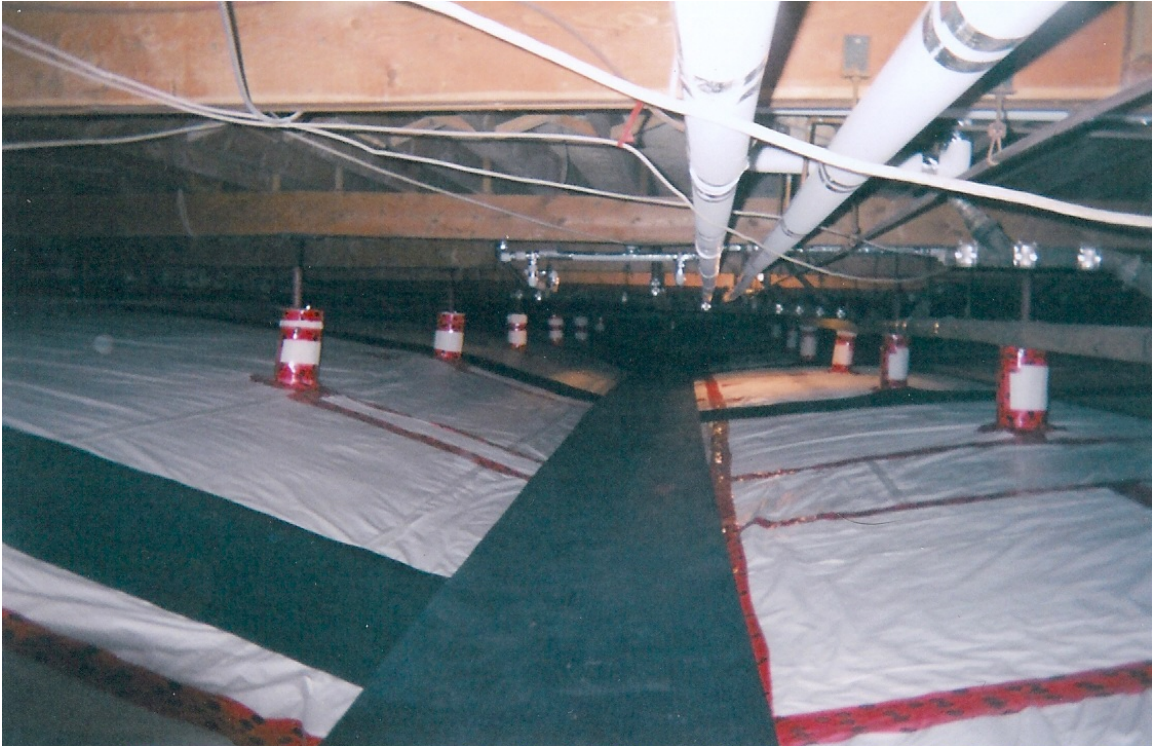
Photo 8: Clean, durable crawl space floor. Floor barrier is sealed at all connections and extends up the concrete piles. Black rubber floor mats provide floor barrier protection and are easily moved/removed for cleaning.

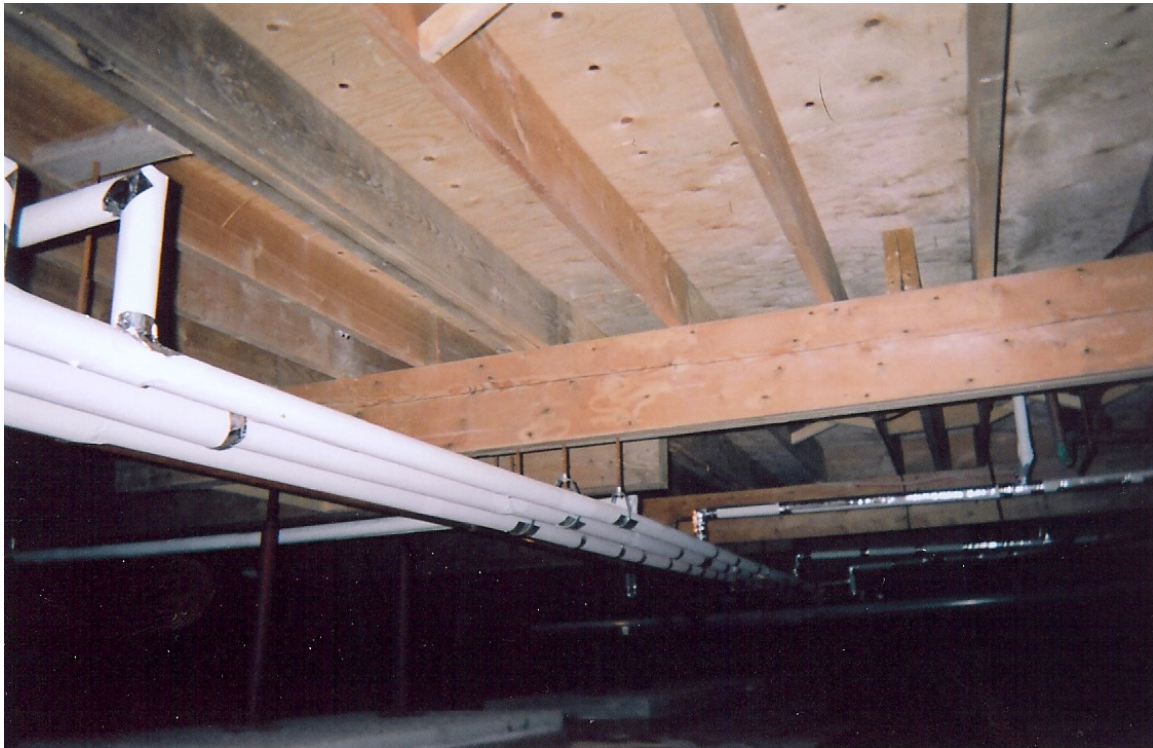
Photo 10: Mold from the floor joists has been physically removed by grinding, sanding and scraping followed by washing and HEPA vacuuming. Piping and pipe insulation have been repaired and properly sealed.

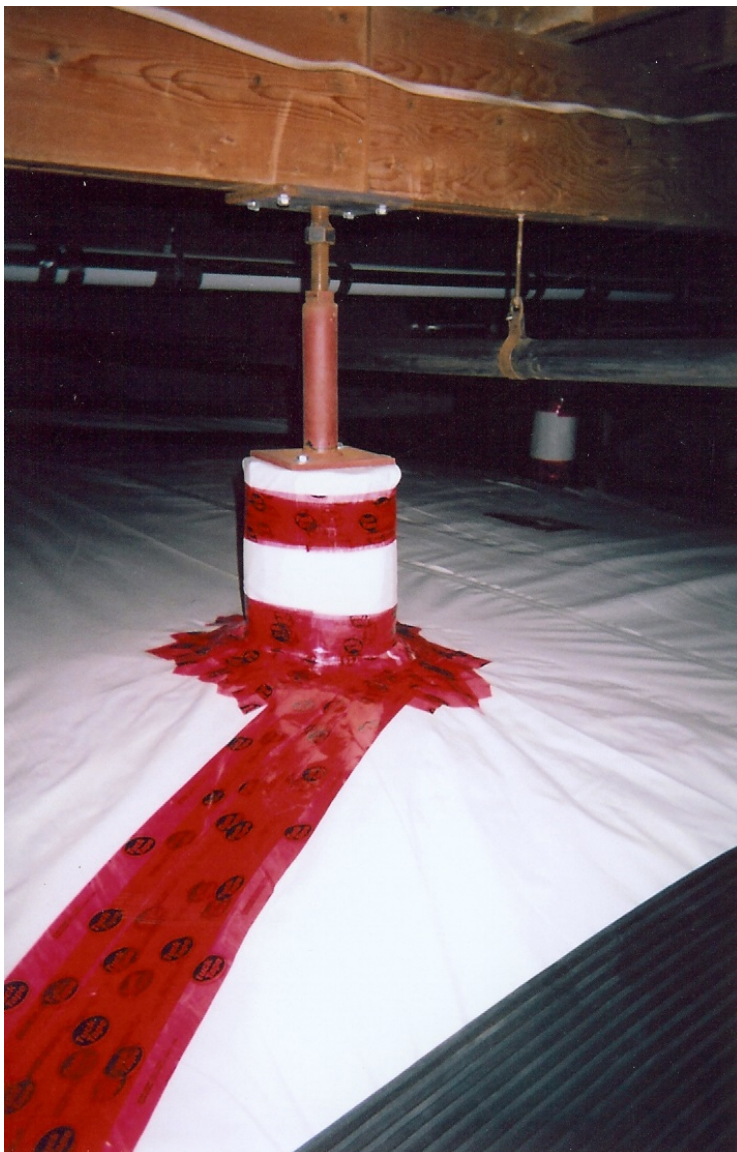
Photo 11: Floor barrier extends up and over the creosote treated wood piles. Floor barrier is properly sealed. Over time, contractors became more adept at taping without over-taping.

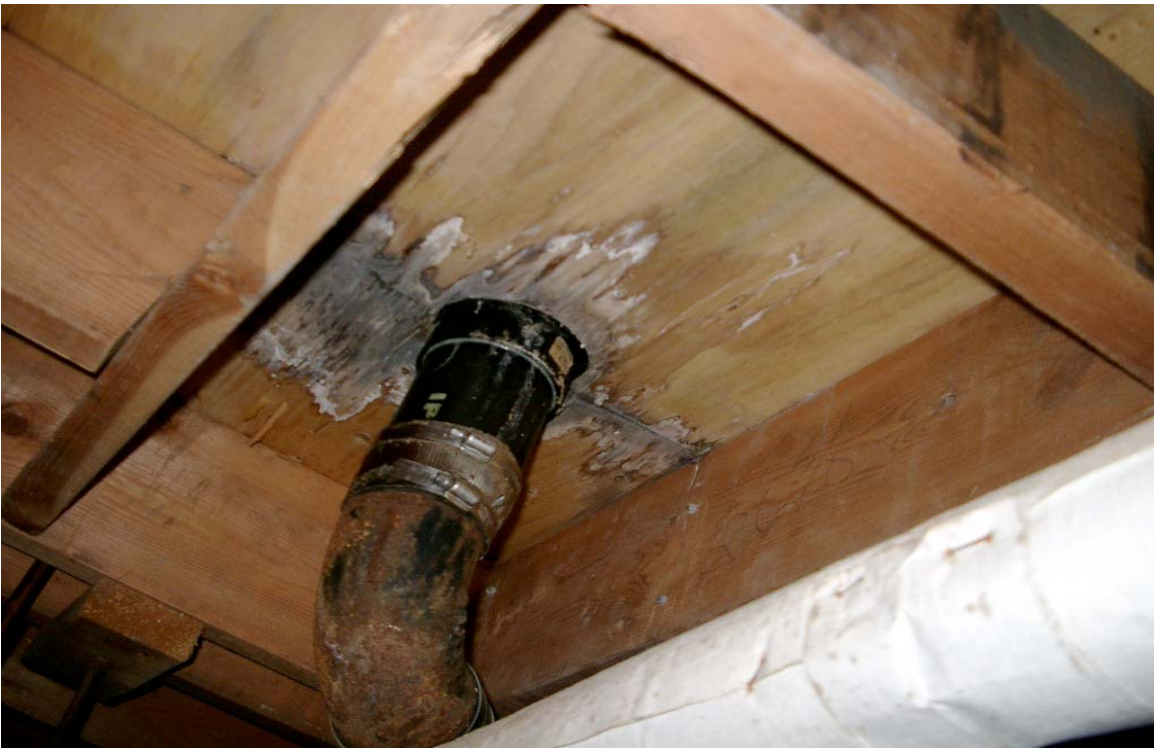
Photo 1: Visible mold and discoloration on the subflooring and floor joists.

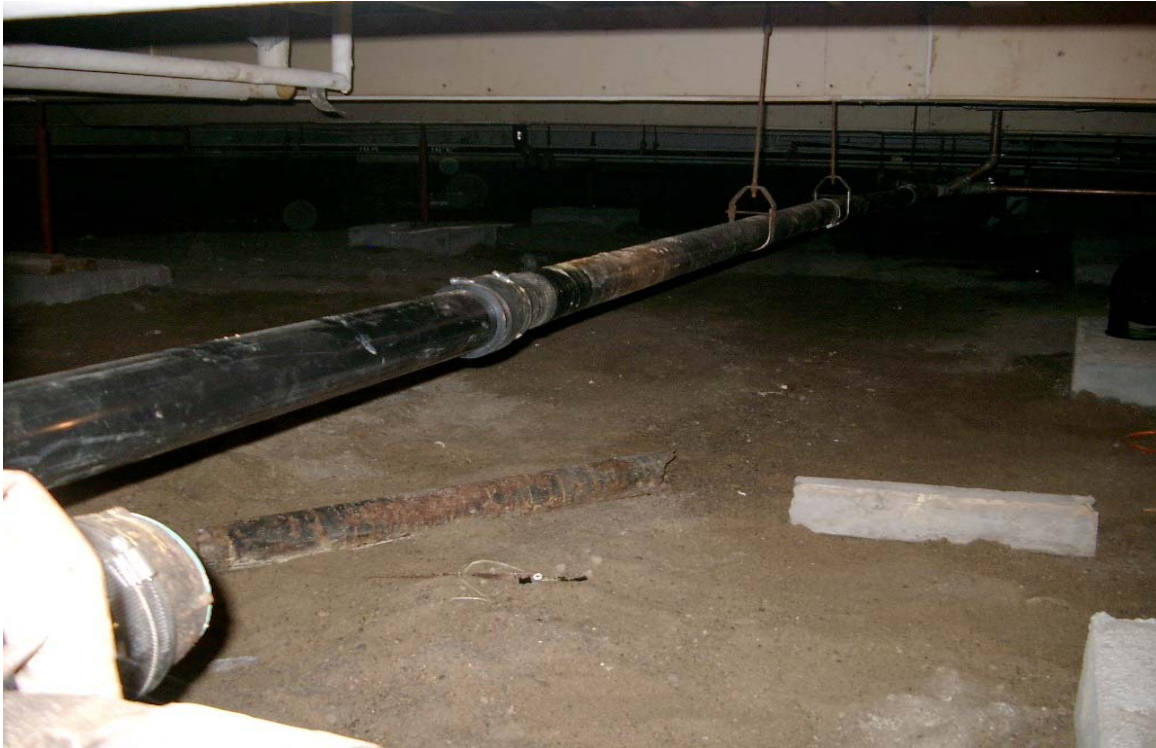
Photo 2: Debris (including garbage and deteriorated piping) was on the crawl space floor. In many areas, no floor barrier was present and the exposed sand/soil floor was damp.

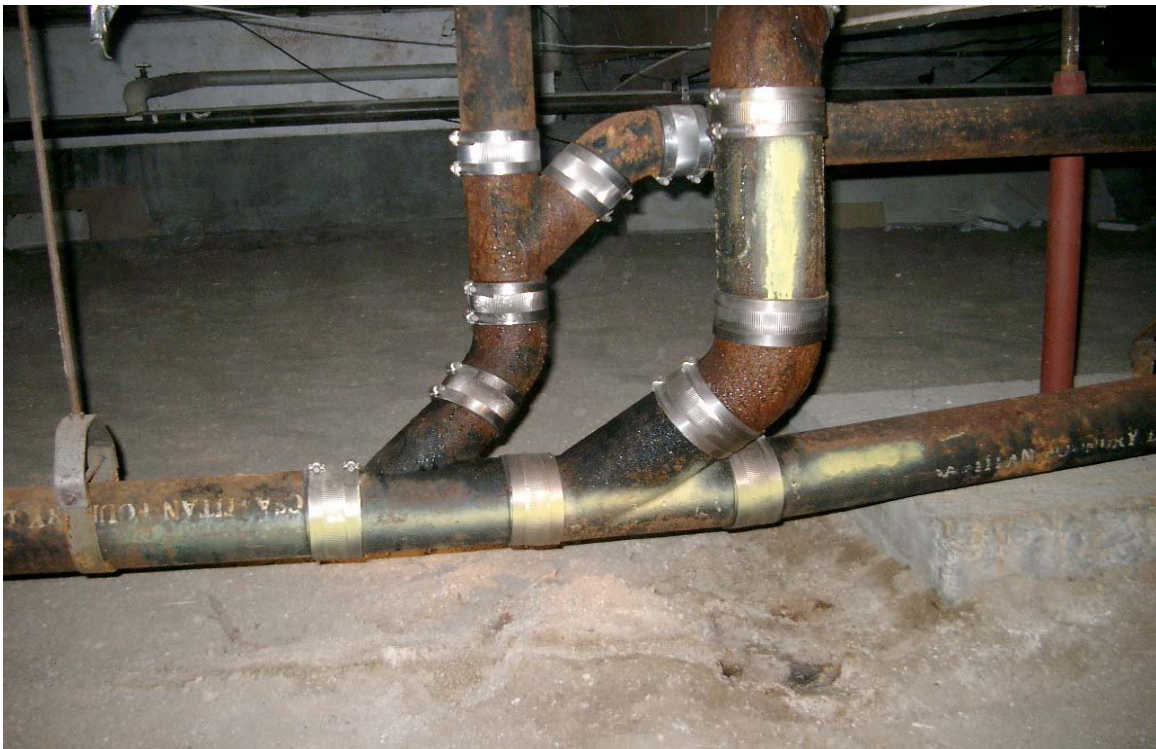
Photo 3: Piping/plumbing within the crawl space area showed signs of extensive rusting and deterioration. Perimeter insulation was poorly installed or missing.

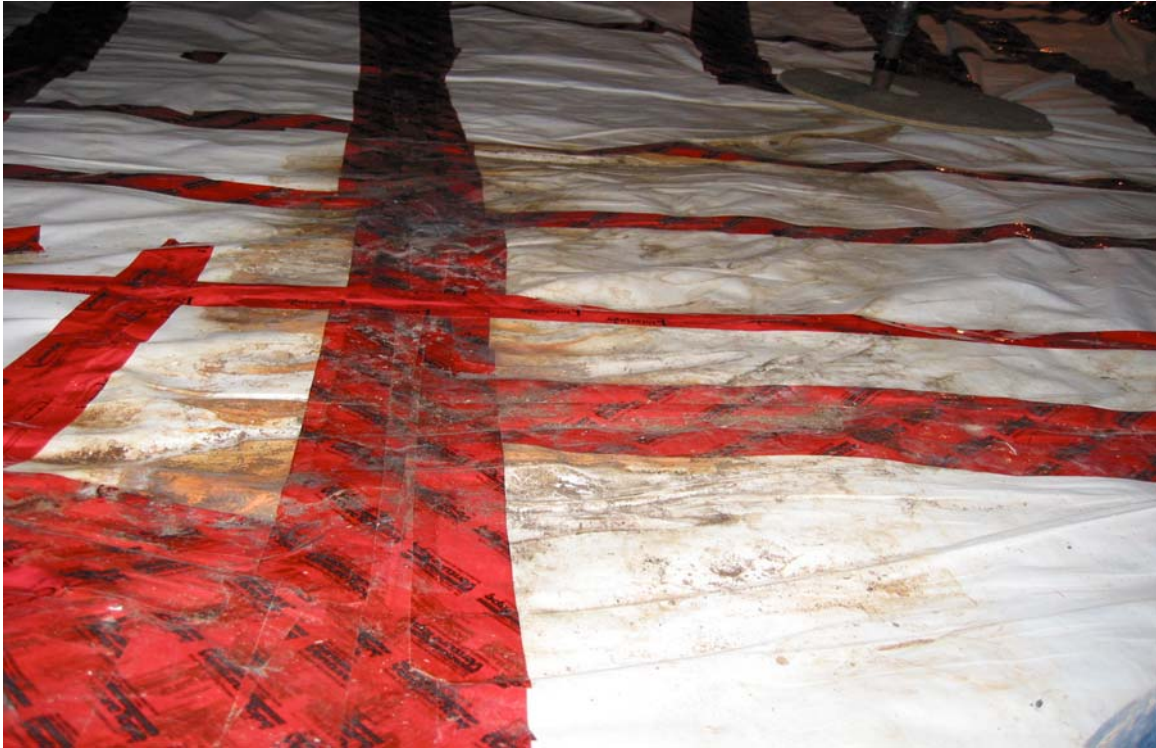
Photo 4: Crawl space floor is dirty and shows evidence of water entry from the main floor.

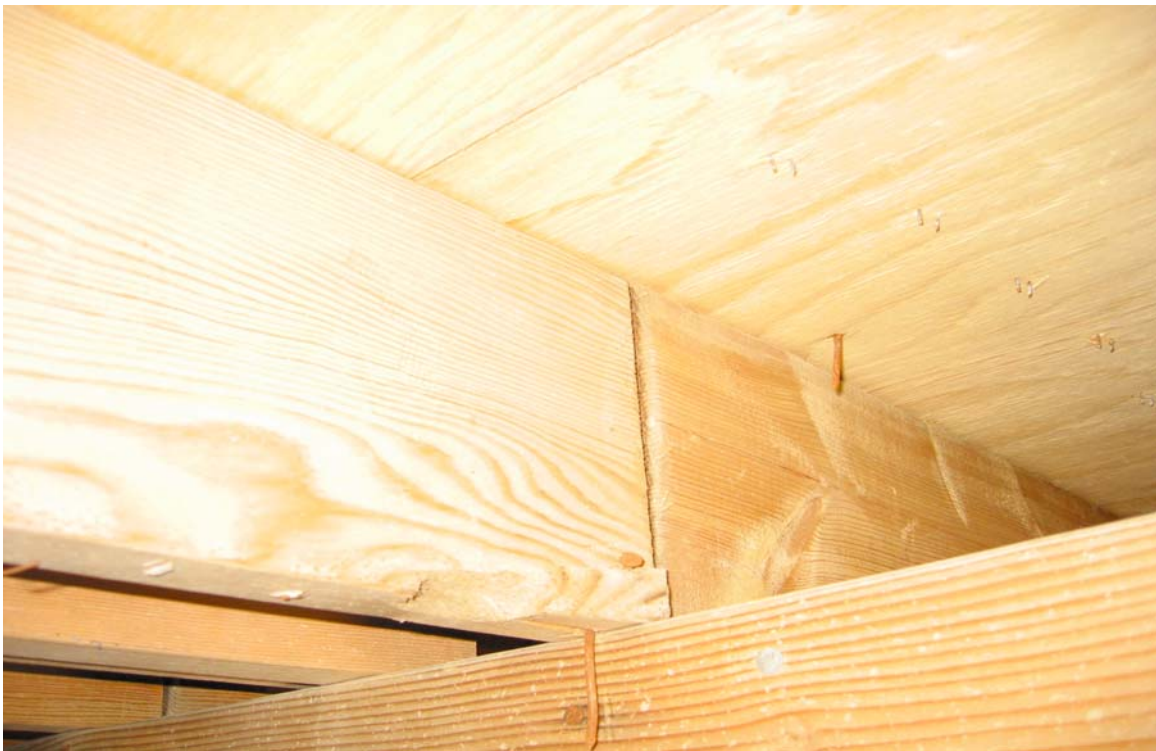
Photo 5: Floor joists and plywood subfloor are in good condition and show no signs of mold re-growth.

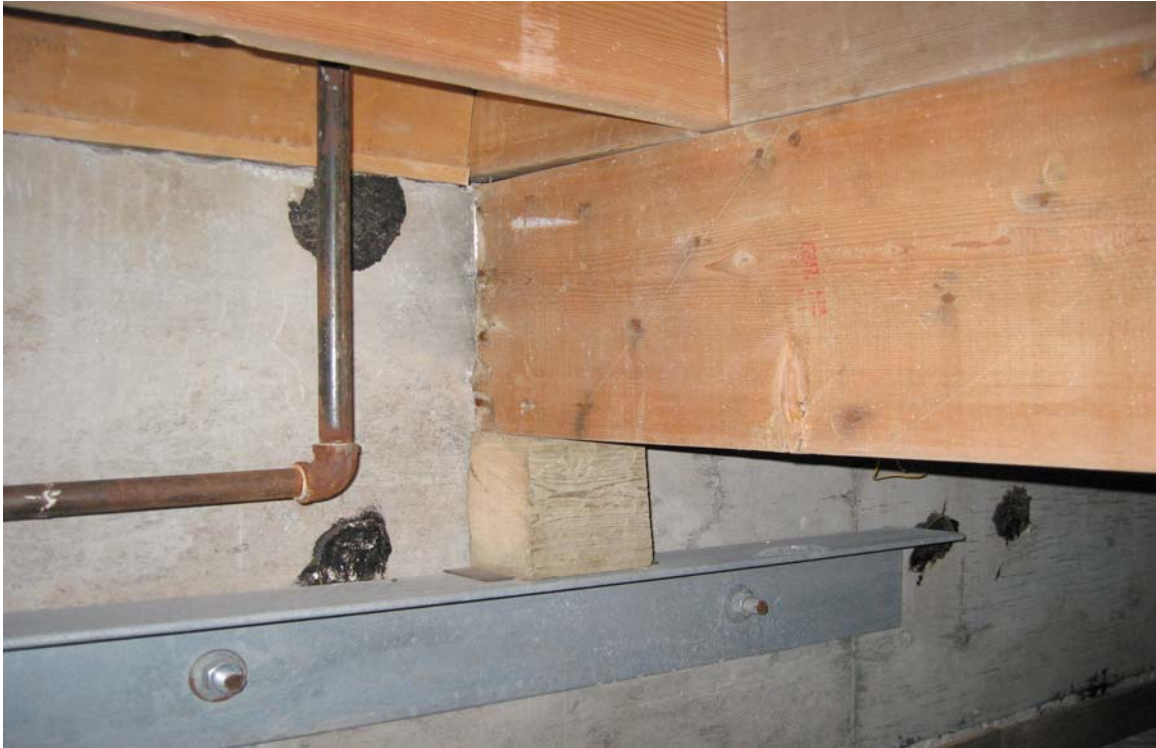
Photo 6: Additional structural supports are in good condition and functioning properly.

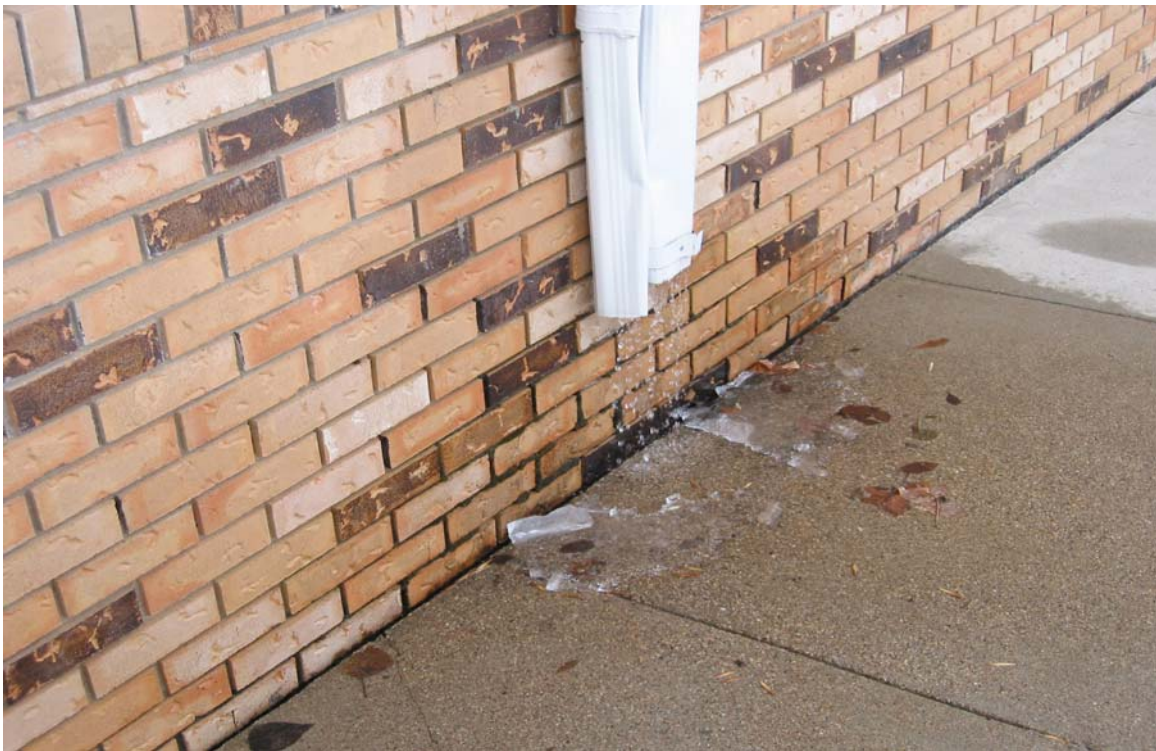
Photo 7: Some downspout extensions are missing and water is not moved away from the exterior walls of the crawl space.

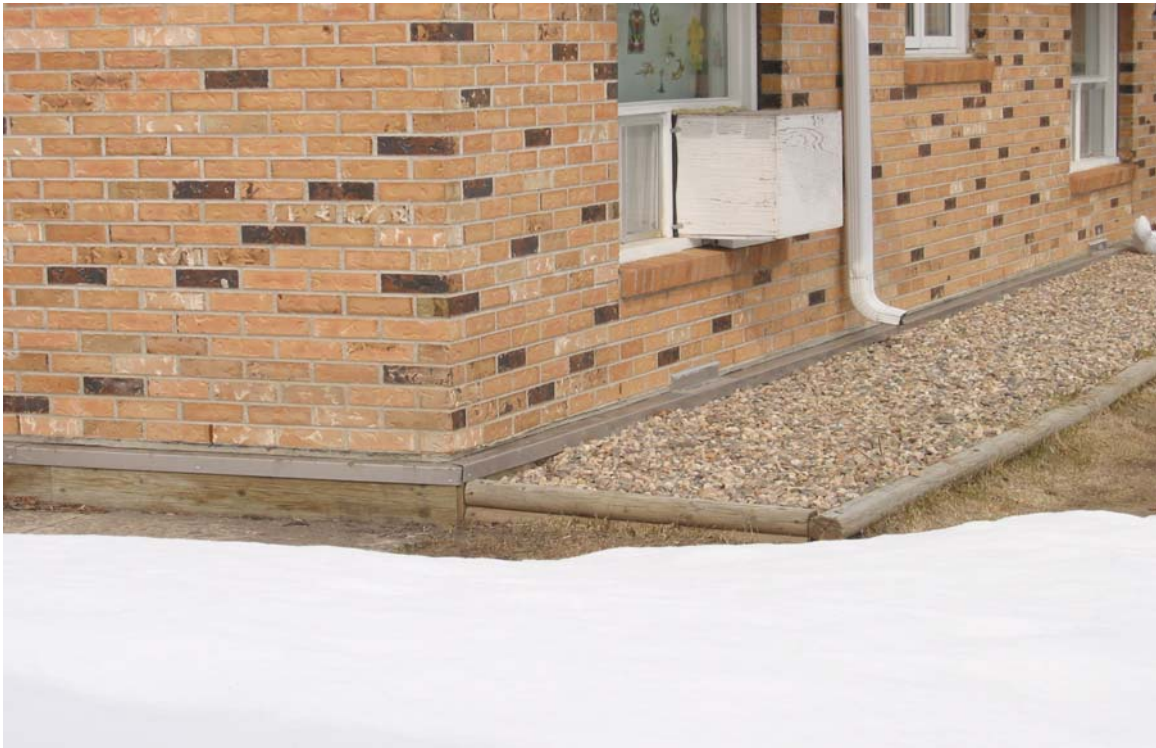
Photo 8: Exterior insulation and metal flashing are in good condition. The exterior landscaping and downspouts have been helpful in keeping water away from the crawl space exterior.

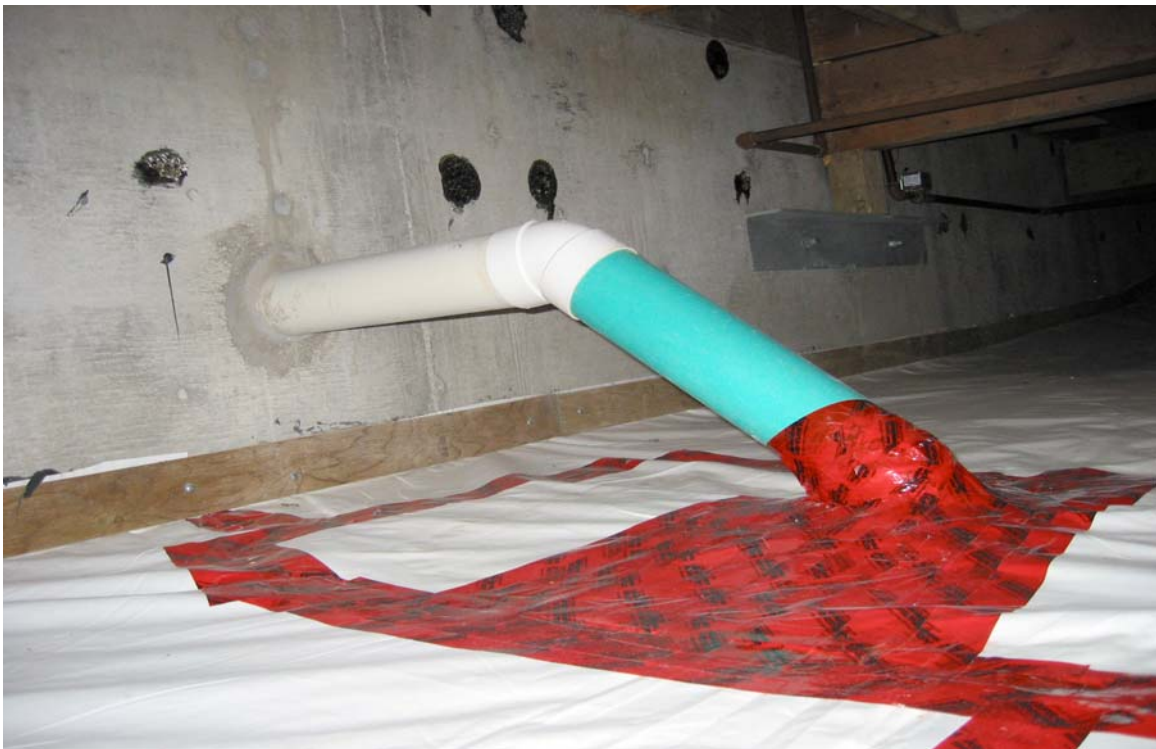
Photo 9: Floor barrier is well attached to the exterior walls and is sealed around all columns, piping and other floor barrier penetrations.

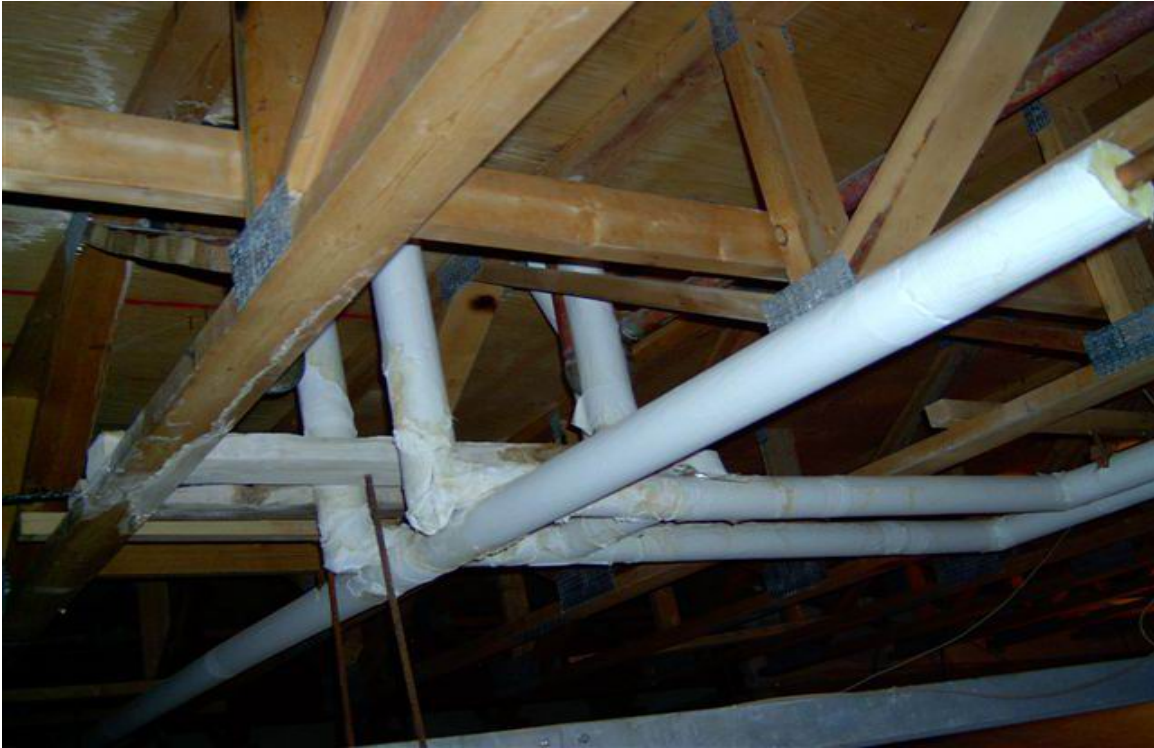
Photo 1: Water markings and staining are visible on the wooden components in the crawl space area. The pipe insulation also shows evidence of water damage.

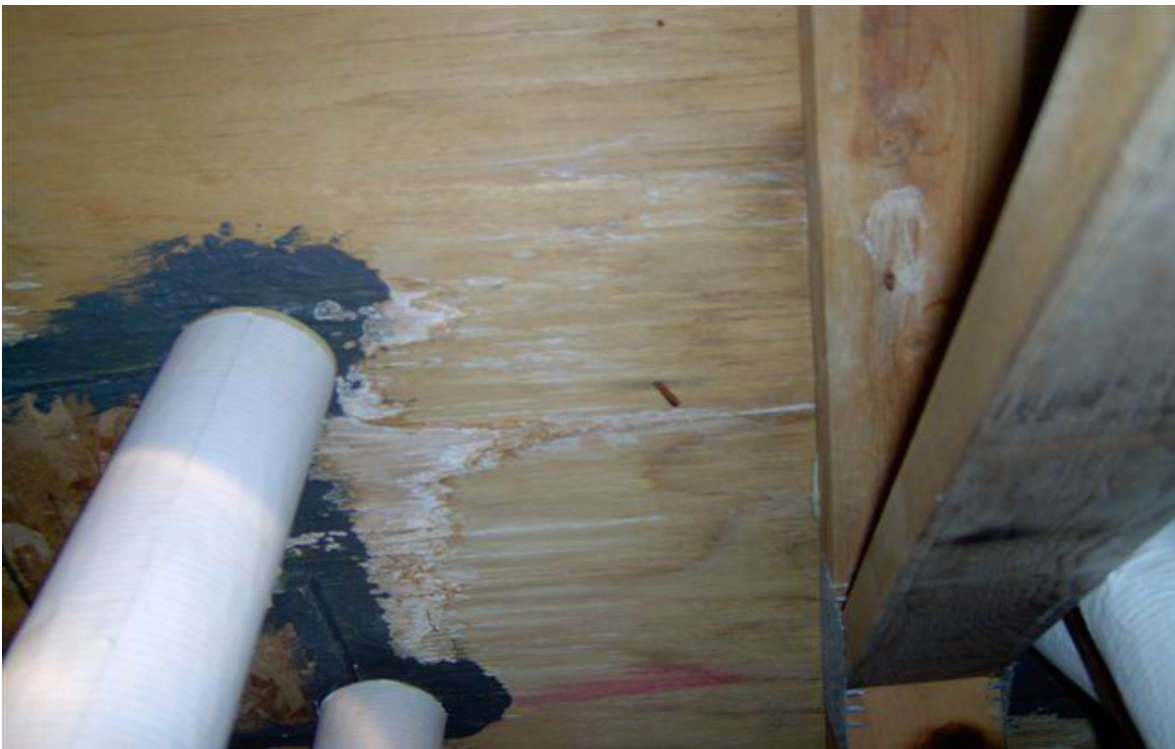
Photo 2: Water markings are visible on the subfloor and trusses.

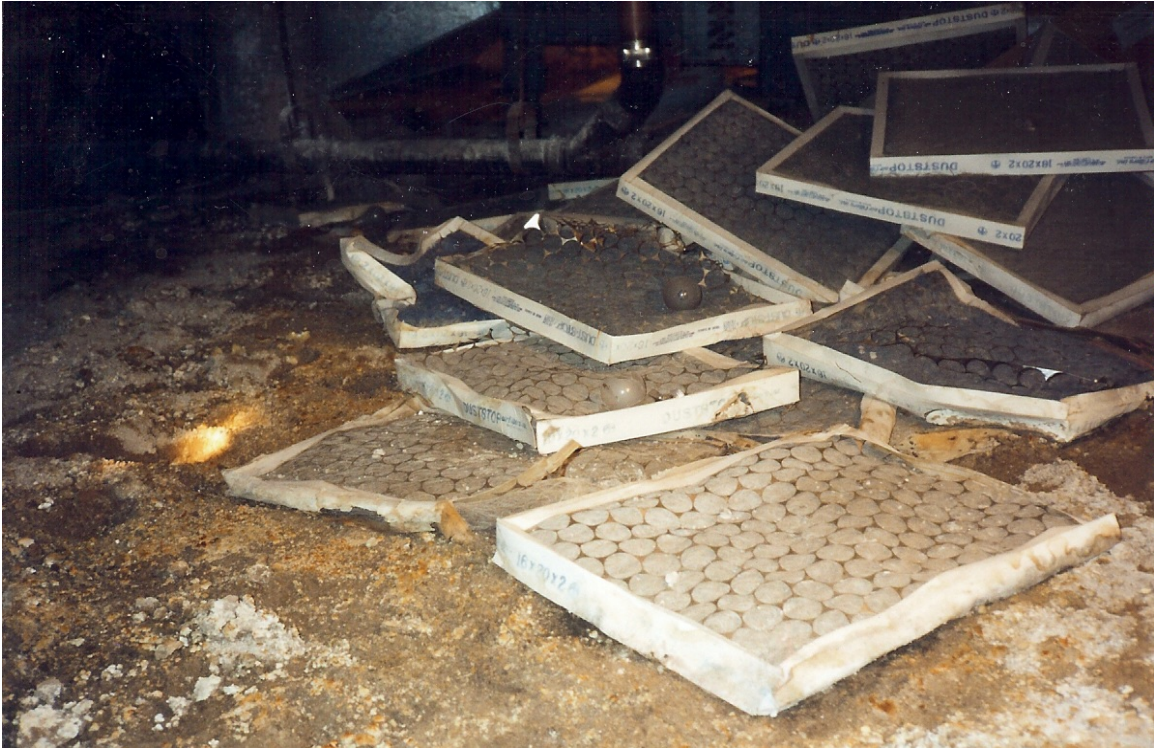
Photo 3: Dirty, moldy furnace filters, along with light bulbs and pieces of insulation, were on the dirt/sand crawl space floor.

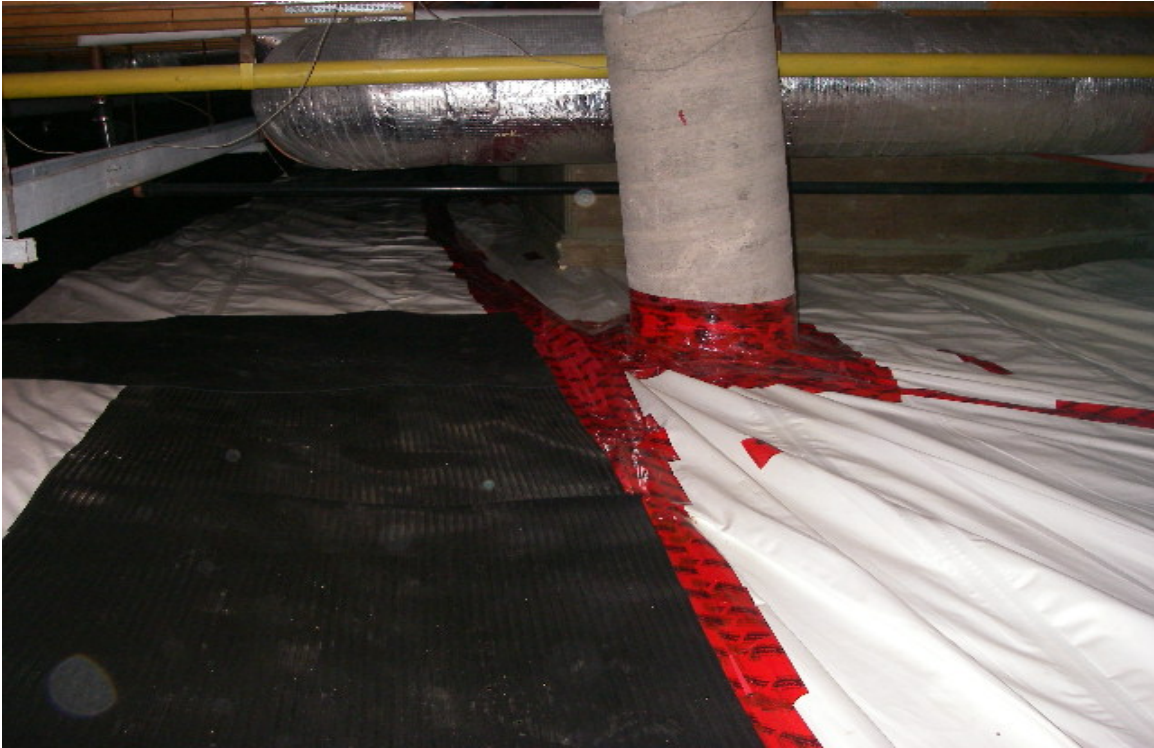
Photo 4: The Permalon™ floor barrier and tape are in good condition and have not required significant repairs (see photo 6). The floor barrier extends up concrete piles and is sealed around each column.

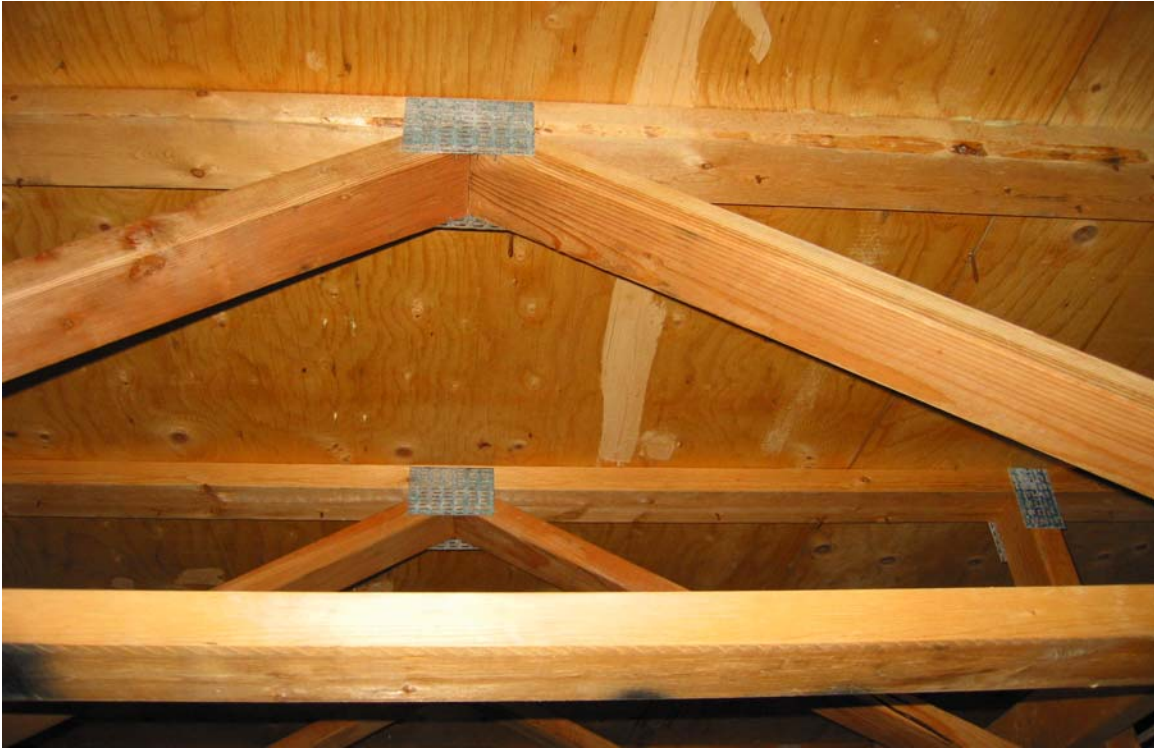
Photo 5: Trusses are in excellent condition with no signs of mold re-growth.

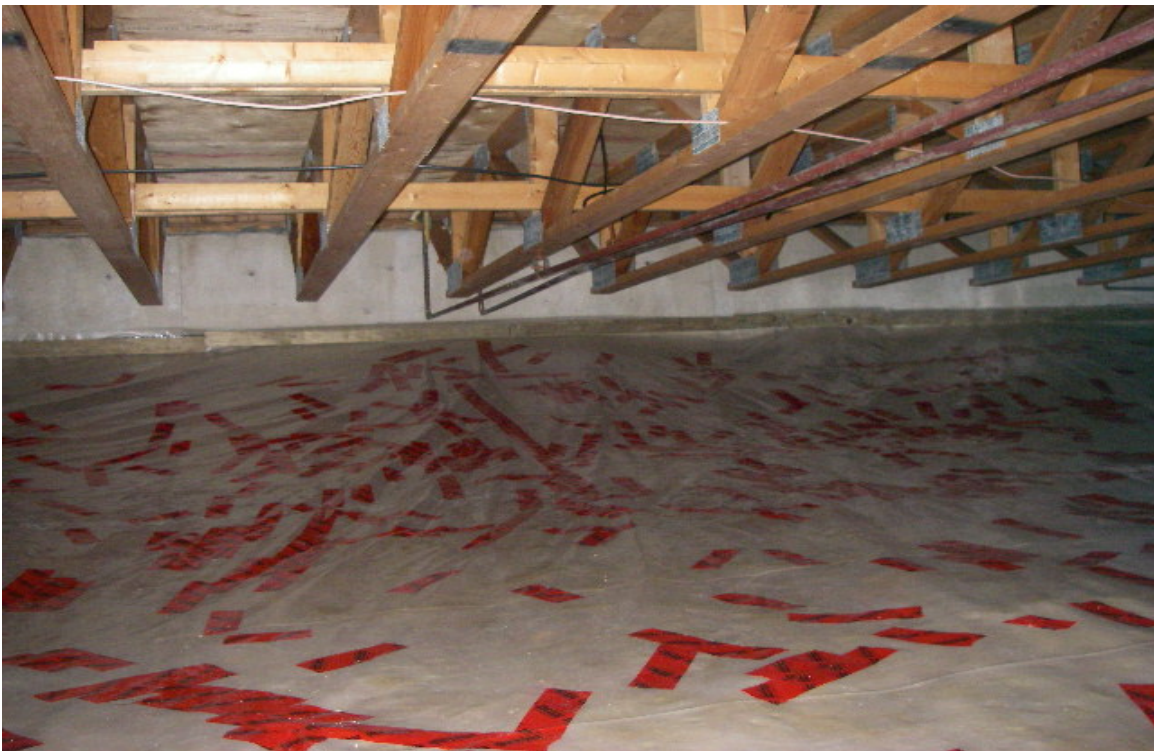
Photo 6: Sections of the poly floor barrier have required extensive patching to repair punctures and tears.
