Development and Assessment of Crawl Space Remediation Strategies

CMHC External Research Program (ERP) Project

Figley Consulting Associates Ltd.
Saskatoon, SK

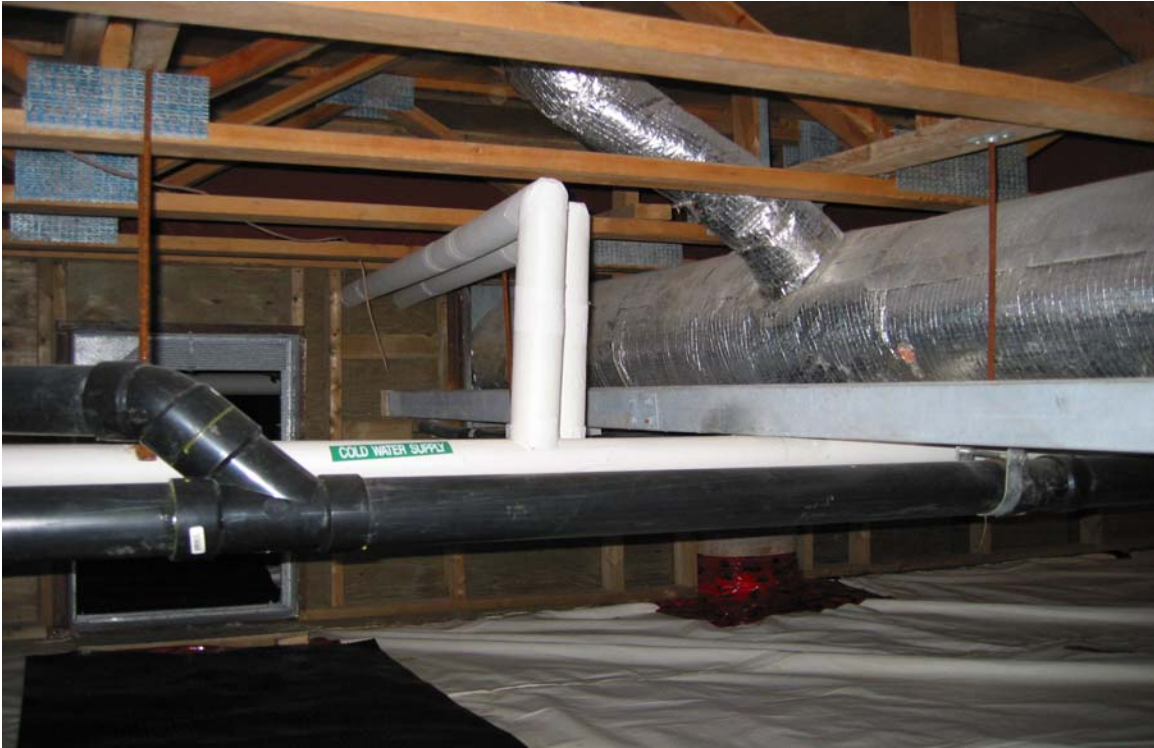
Photo 7: New plumbing, piping and ventilation equipment has been suspended above the floor barrier. The insulation around piping and ducting is well sealed and in good condition.

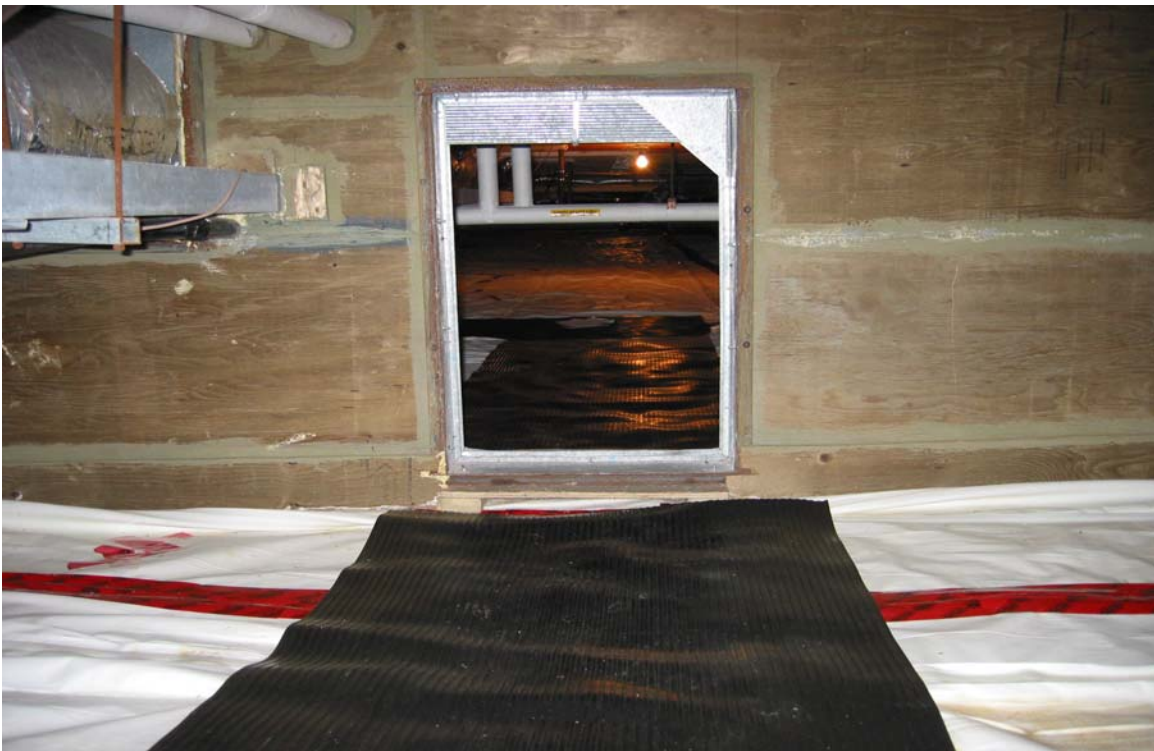
Photo 8: Smoke control walls and fire dampers have been installed to separate various crawl space areas.

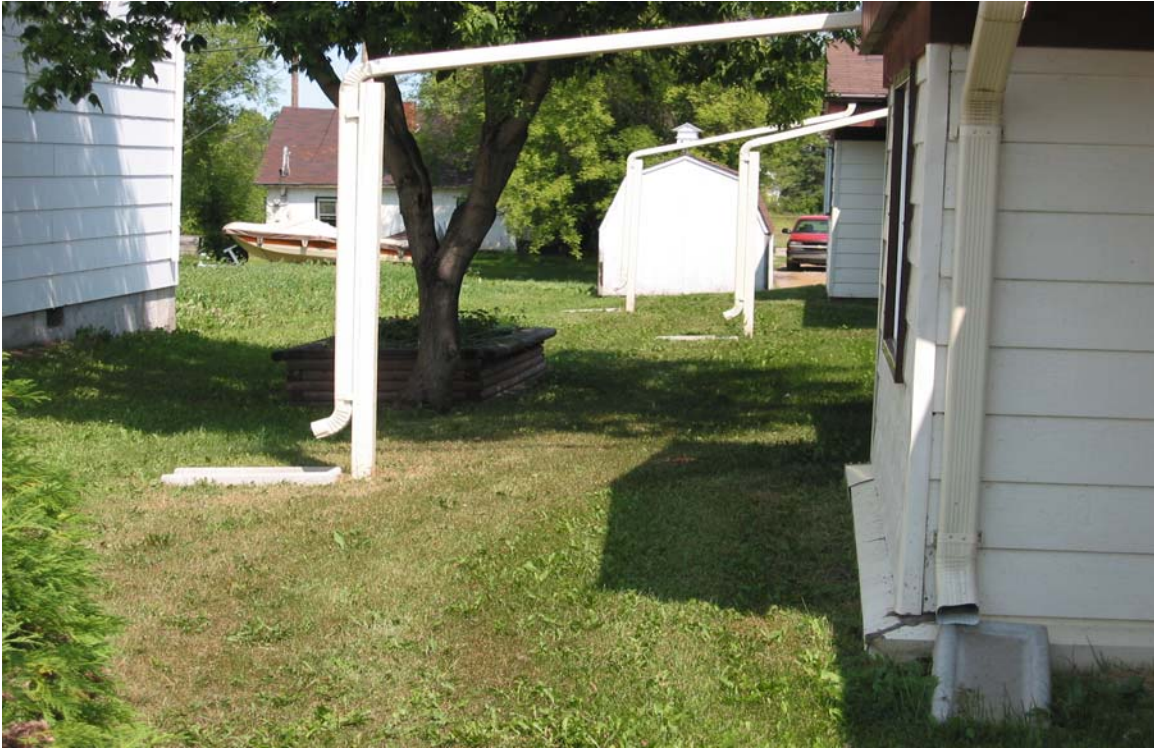
Photo 9: Landscaping and proper downspout attachments have prevented external water entry into the crawl space.

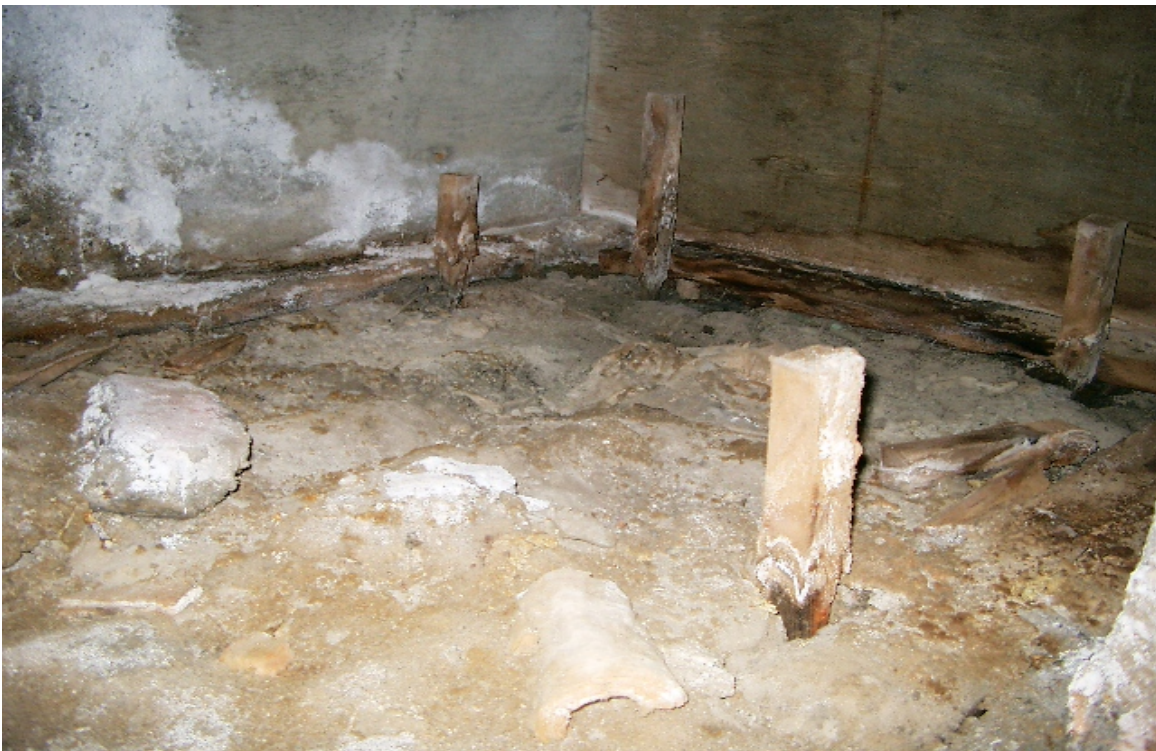
Photo 1: Original crawl space floor showed extensive water damage and deterioration.

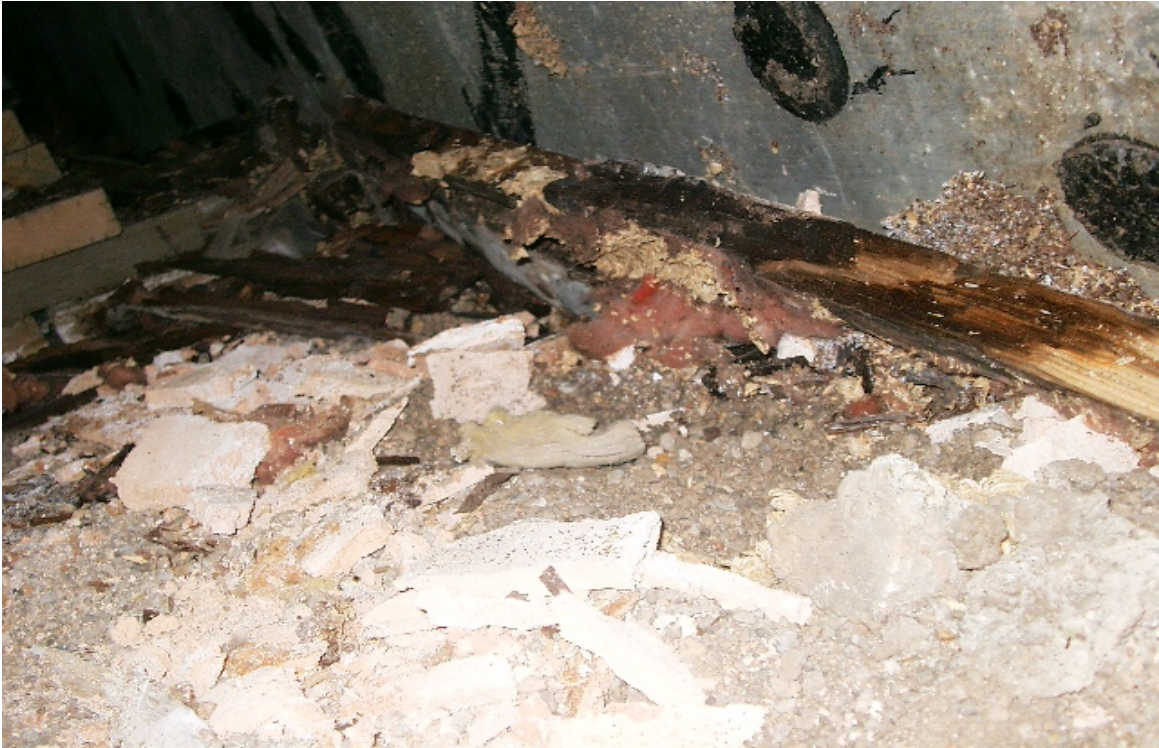
Photo 2: Crawl space floor was littered with debris and garbage.

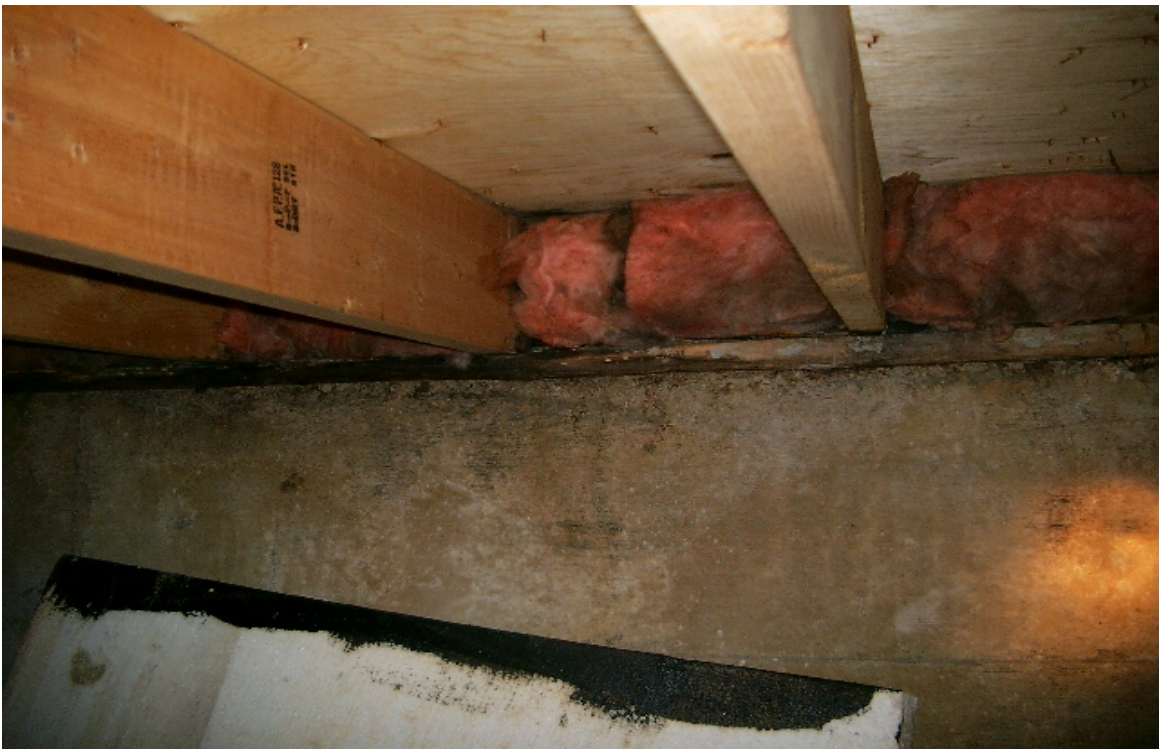
Photo 3: Exterior walls were insulated from the interior side of the crawl space. Joist ends were moldy and deteriorated.

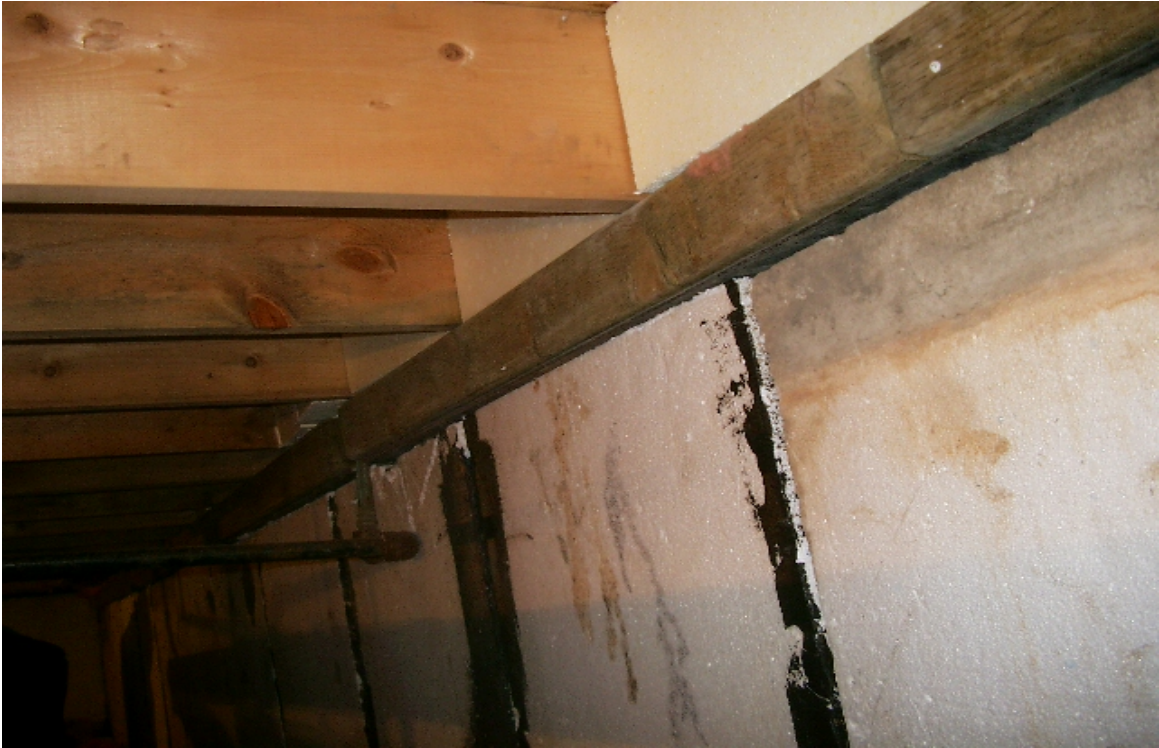
Photo 4: Exterior walls were insulated from the interior side of the crawl space.

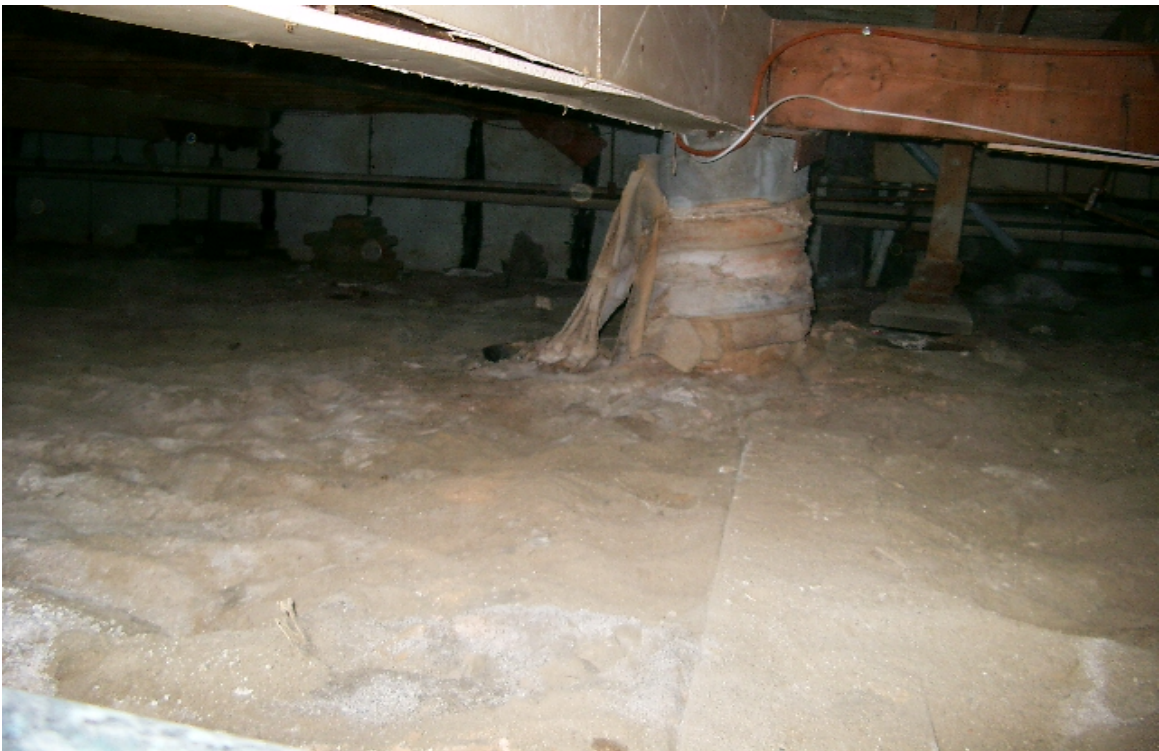
Photo 5: Crawl space floor is sand/gravel. Concrete piles were wrapped in deteriorated paper.

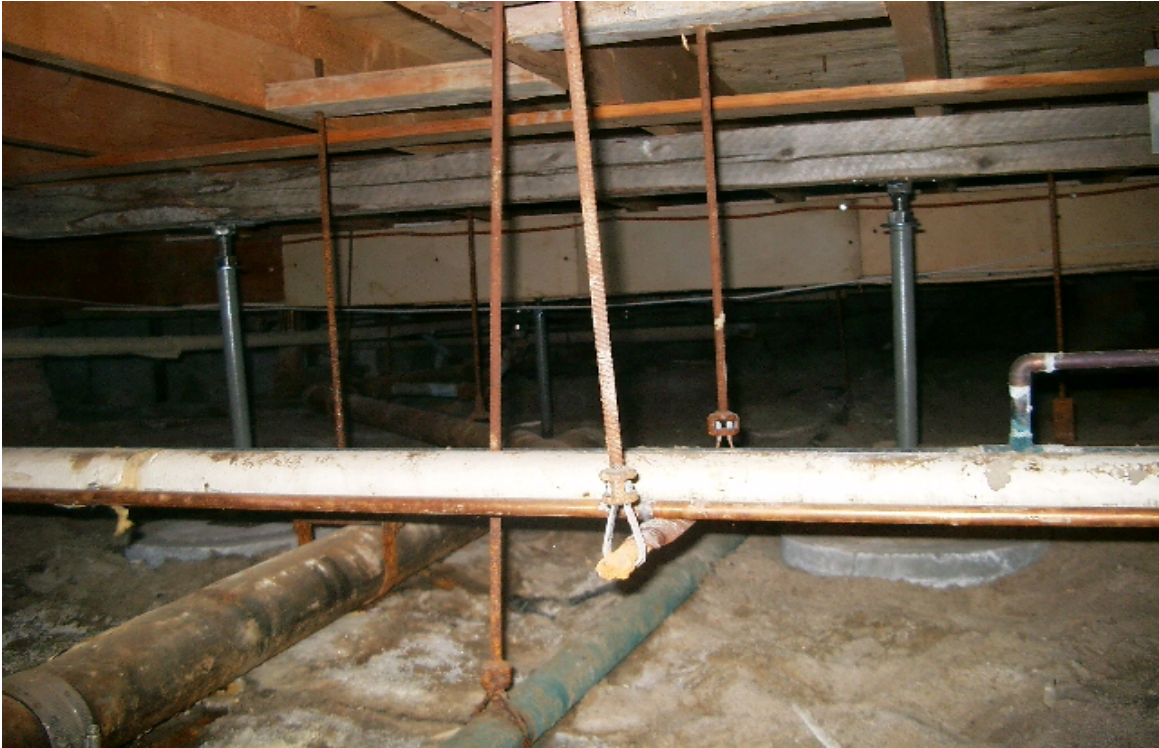
Photo 6: Old, corroded piping within the crawl space area.

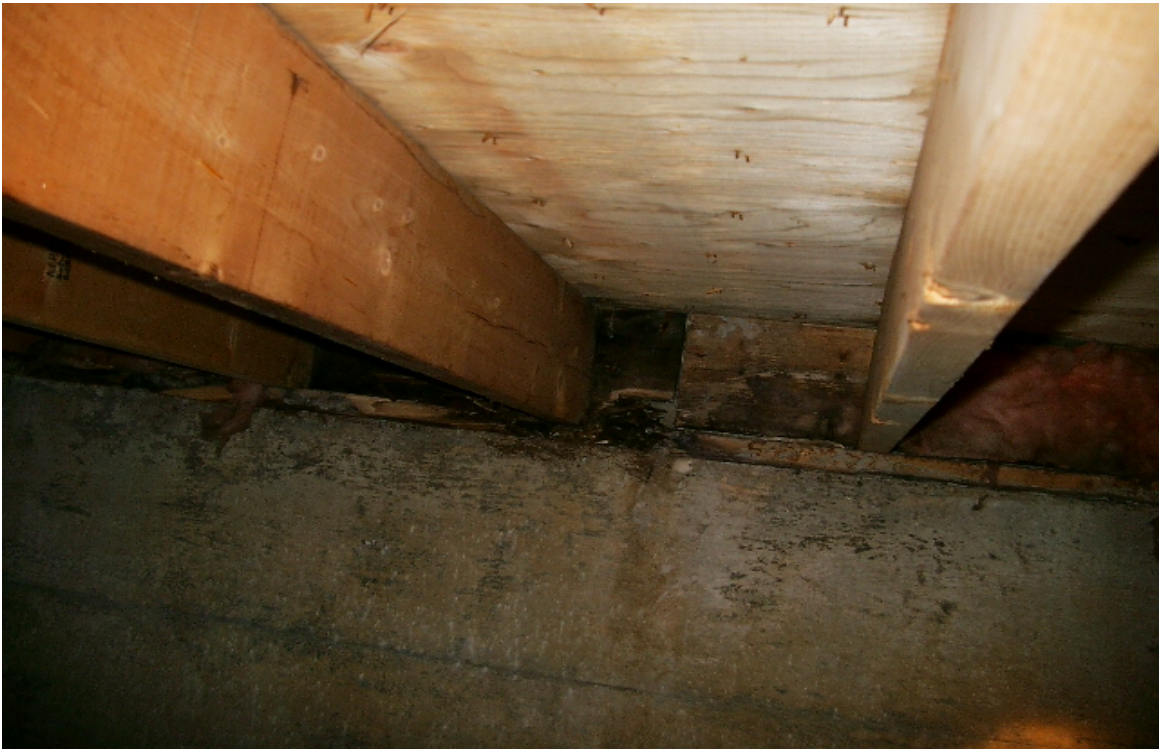
Photo 7: Visible mold and deterioration on the rim joists and ends of the floor joists.

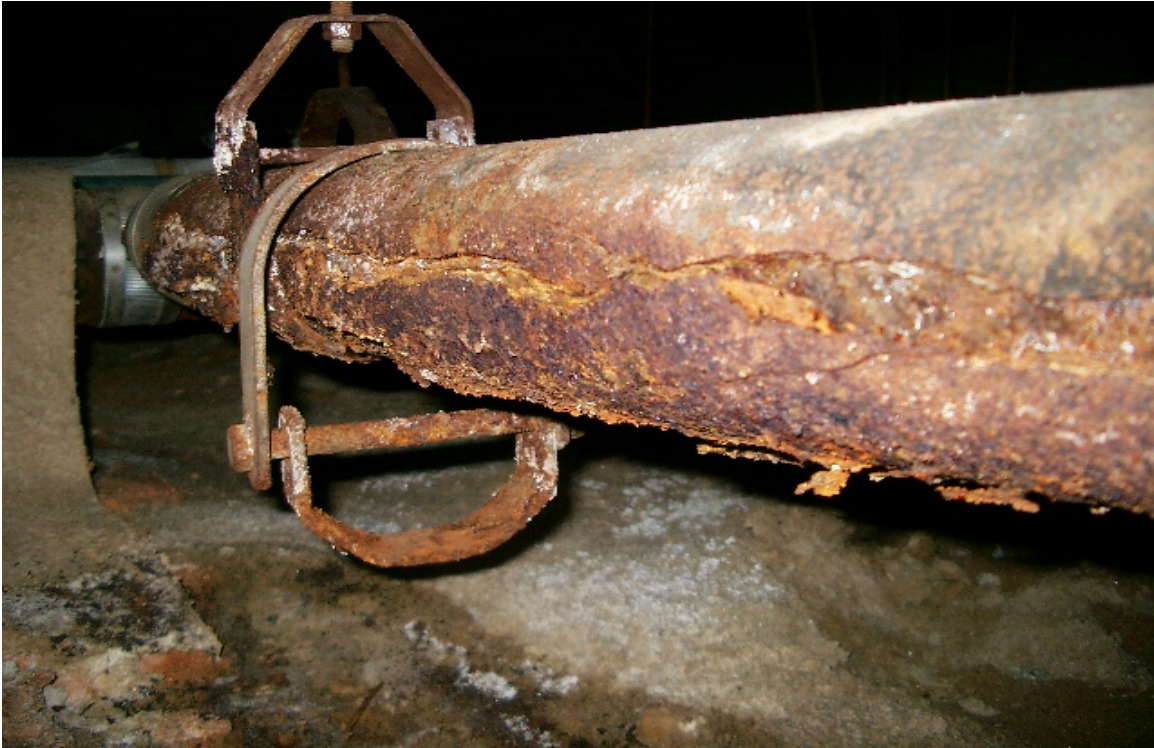
Photo 8: Old, corroded piping was the source of some water entry into the crawl space.

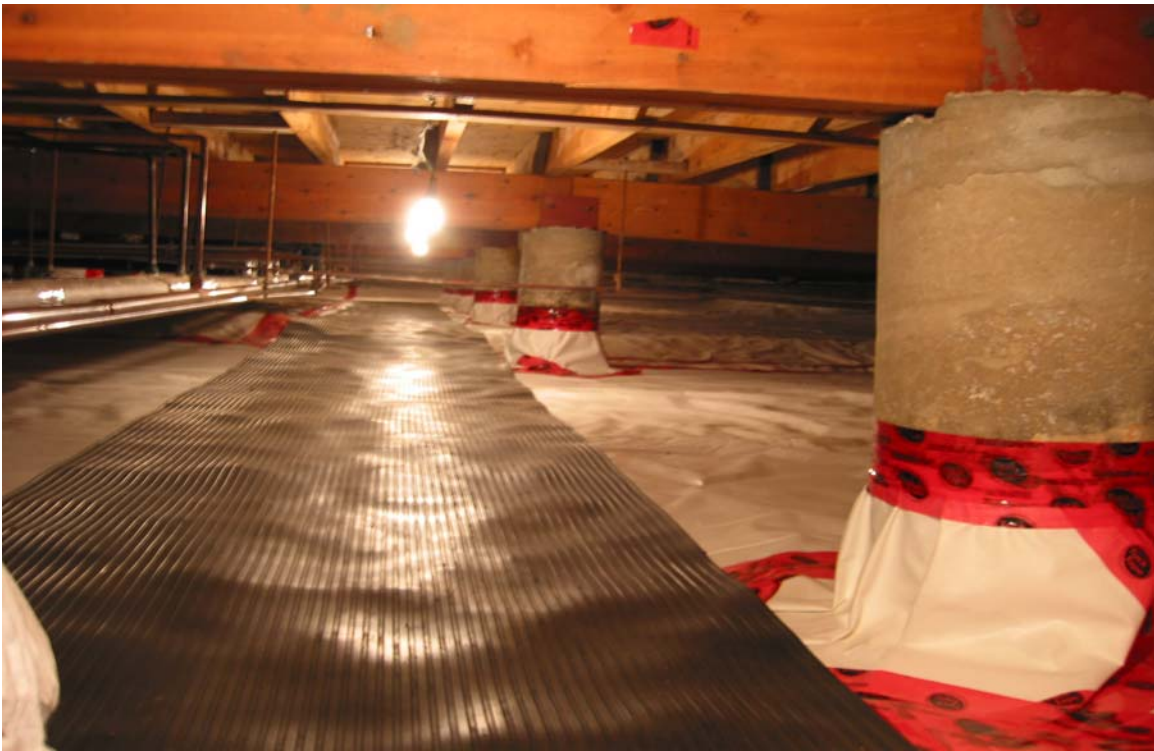
Photo 9: Floor barrier, tape and rubber mats are in excellent condition. Floor barrier extends up the concrete piles and is sealed to enclose the base of each column.

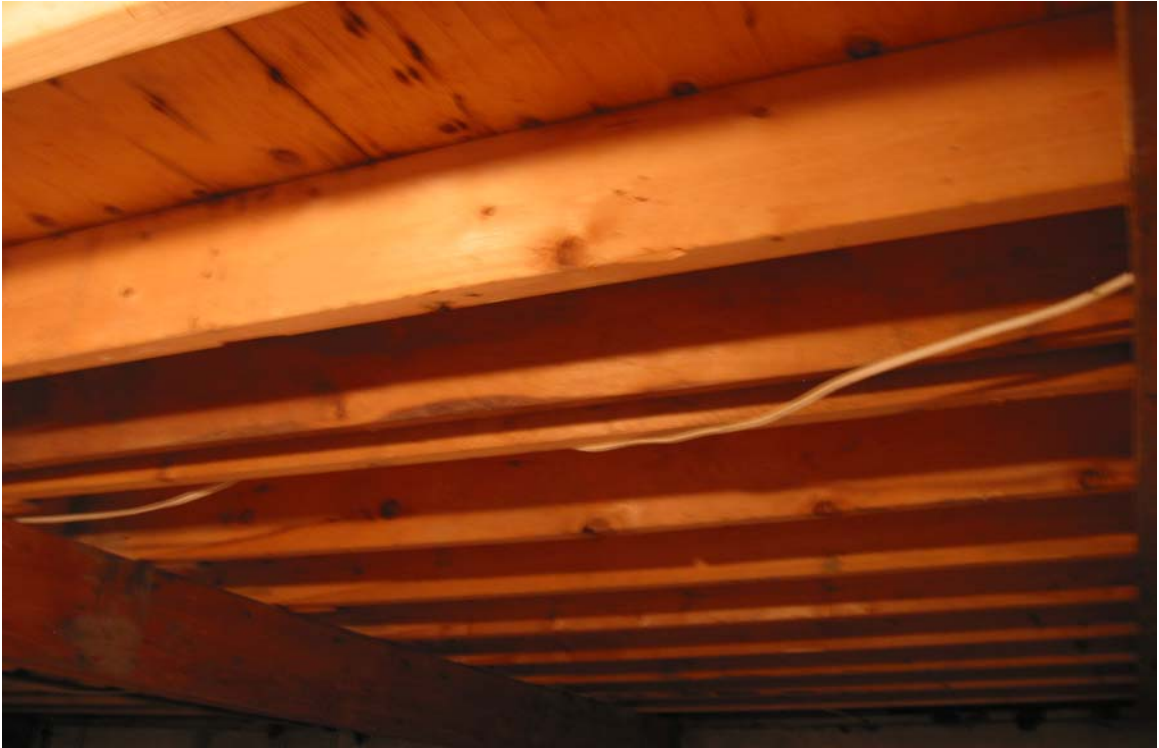
Photo 10: Plywood subfloor and floor joists are in good condition and show no evidence of mold re-growth.

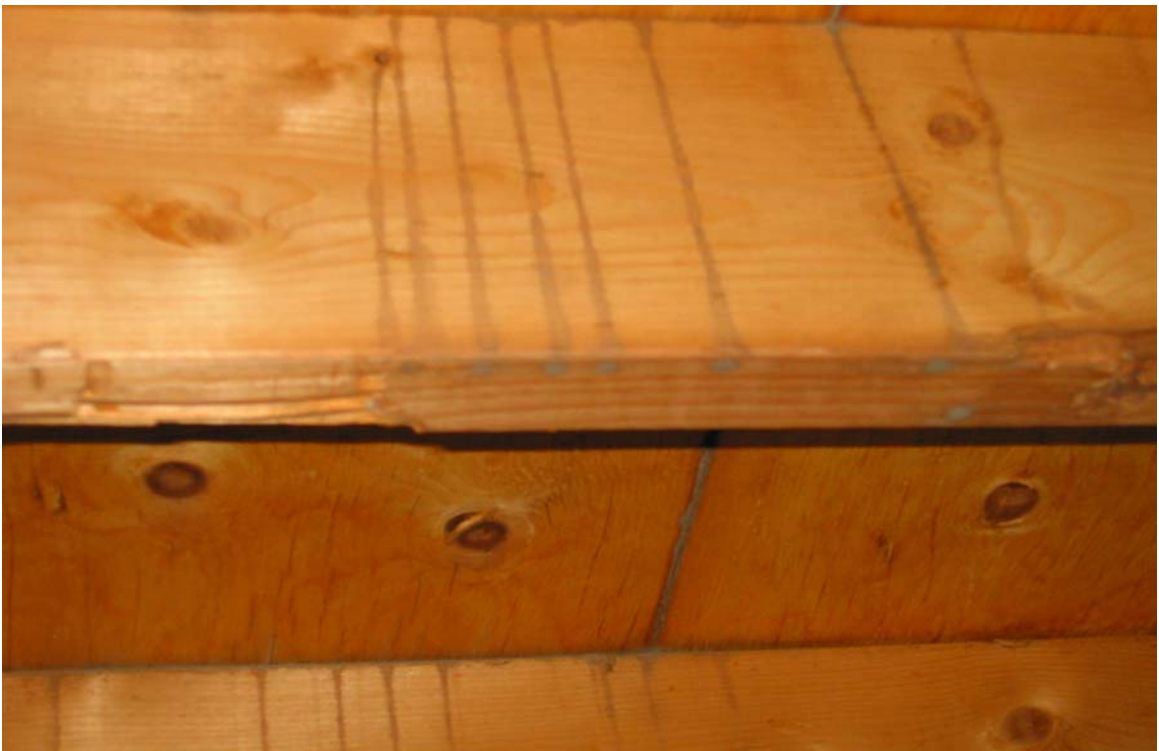
Photo 11: Some floor joists show signs of staining, which is most likely residual bleach.

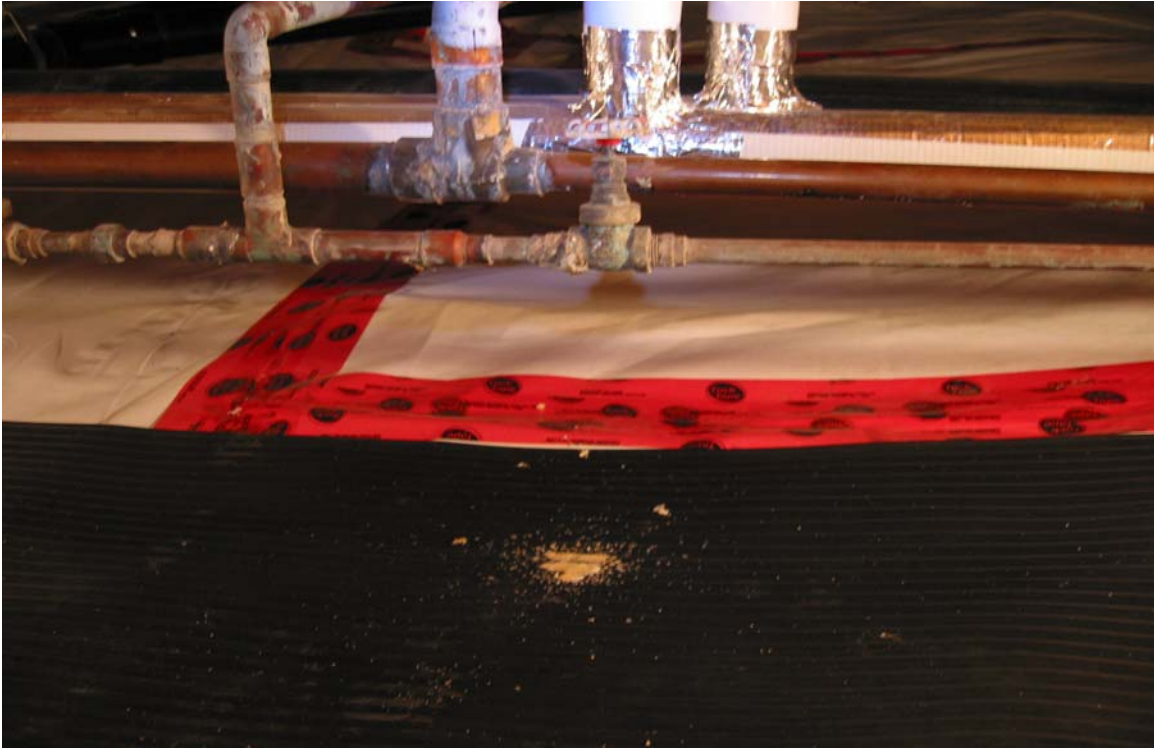
Photo 12: Water and sewer lines are suspended off the crawl space floor. The rubber mats and white floor barrier are helpful in identifying the location of leaks.

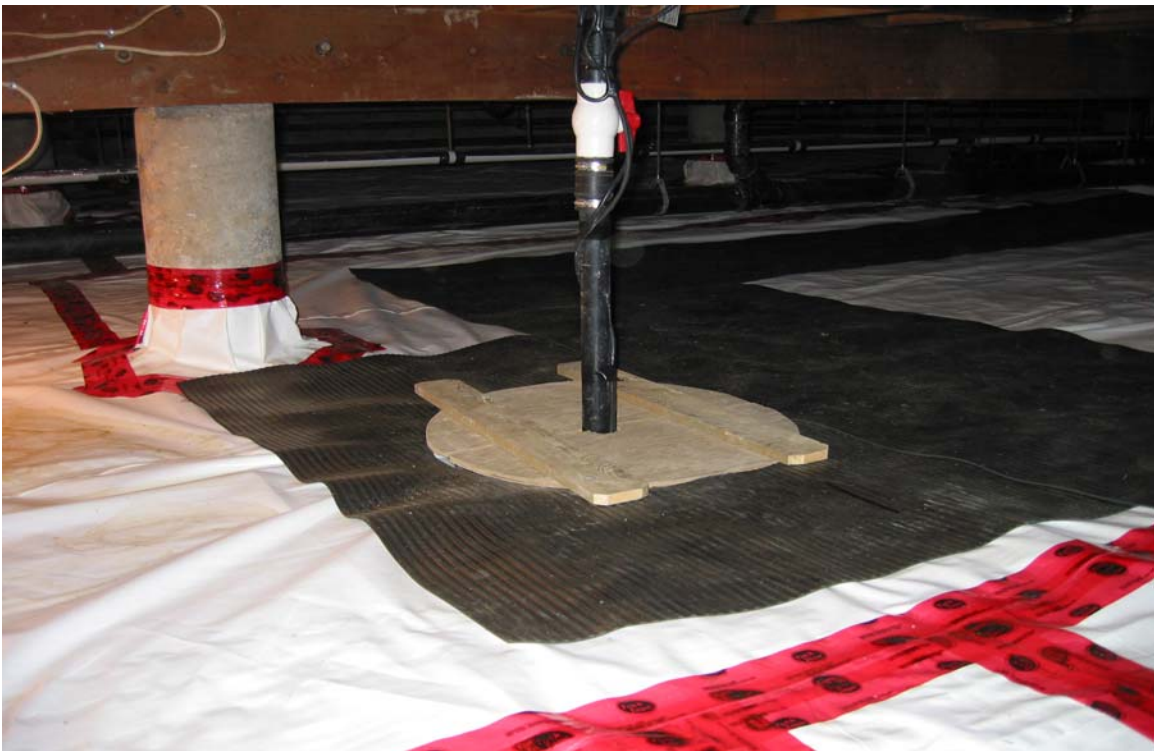
Photo 13: New sump pump installed at a low point in the crawl space.

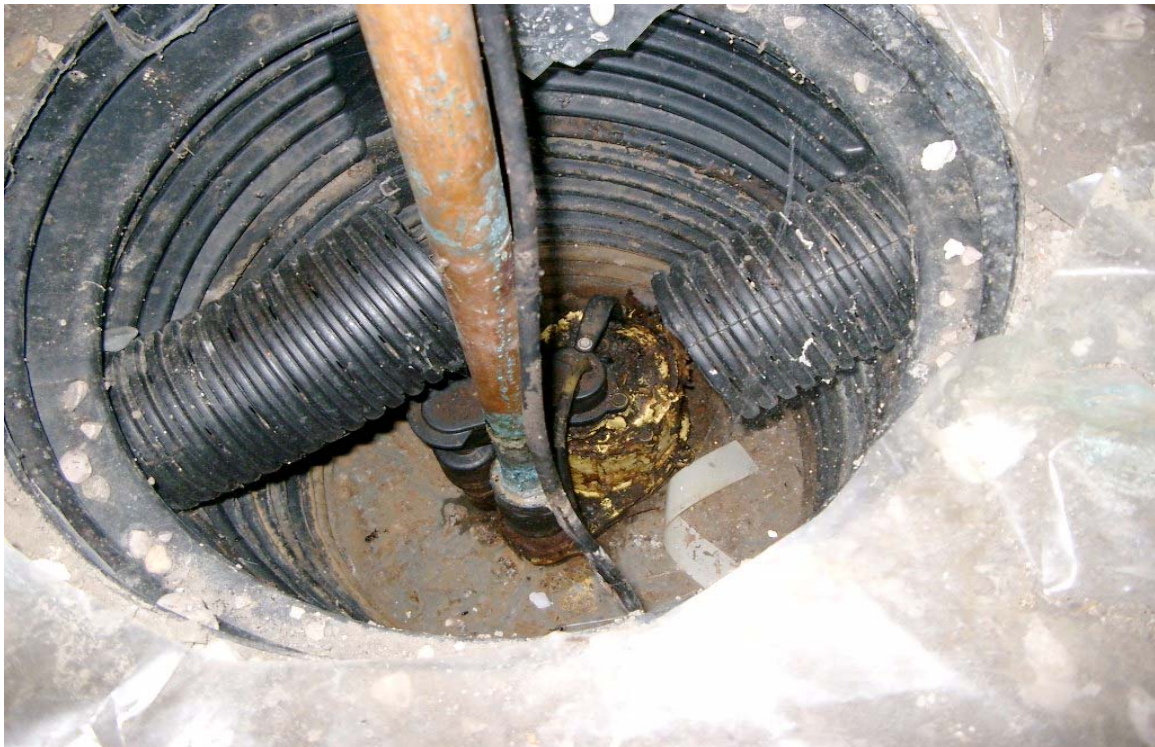
Photo 1: Existing sump pump was dirty and rusted and was not covered or sealed.

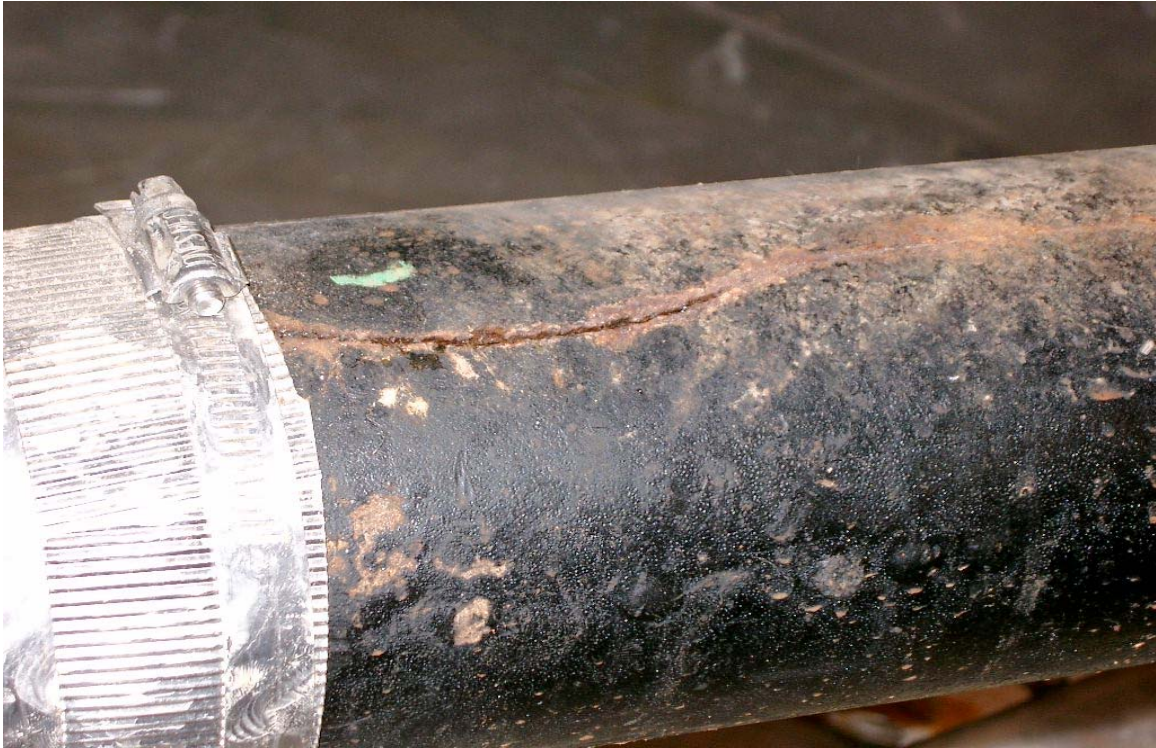
Photo 2: Longitudinal cracks were visible on some piping components. Piping was old, deteriorated and rusty.

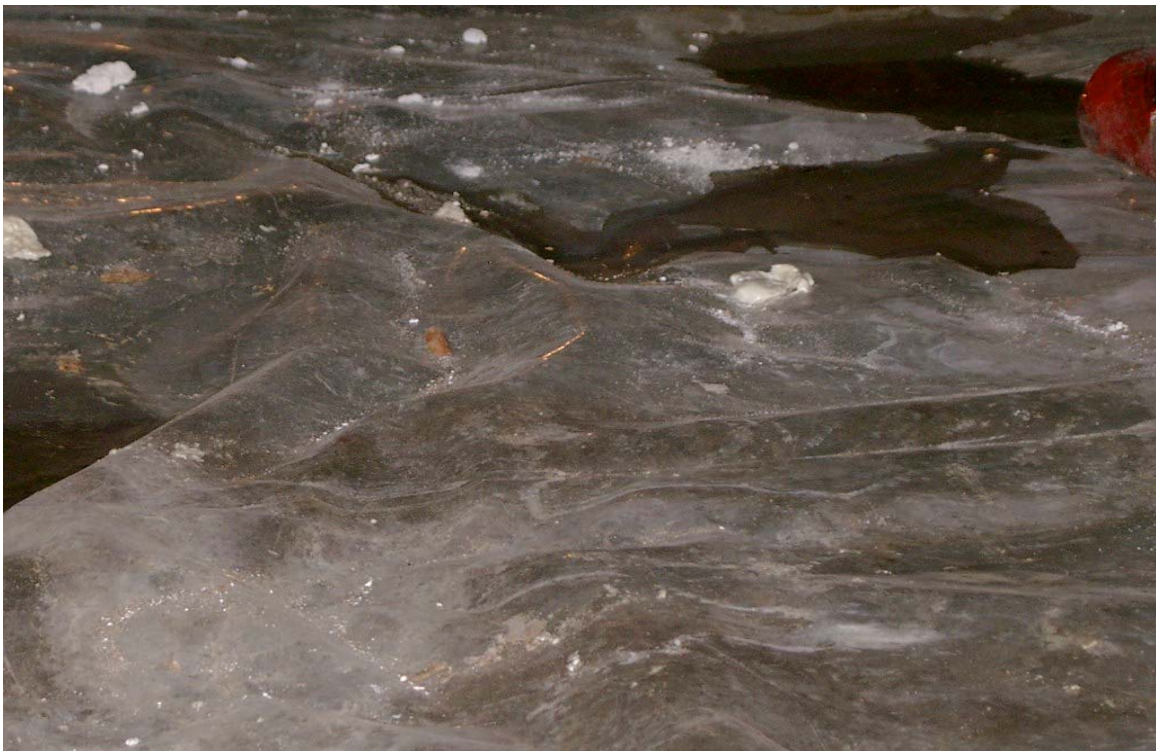
Photo 3: Debris and water were present on the surface of the existing polyethylene floor barrier.

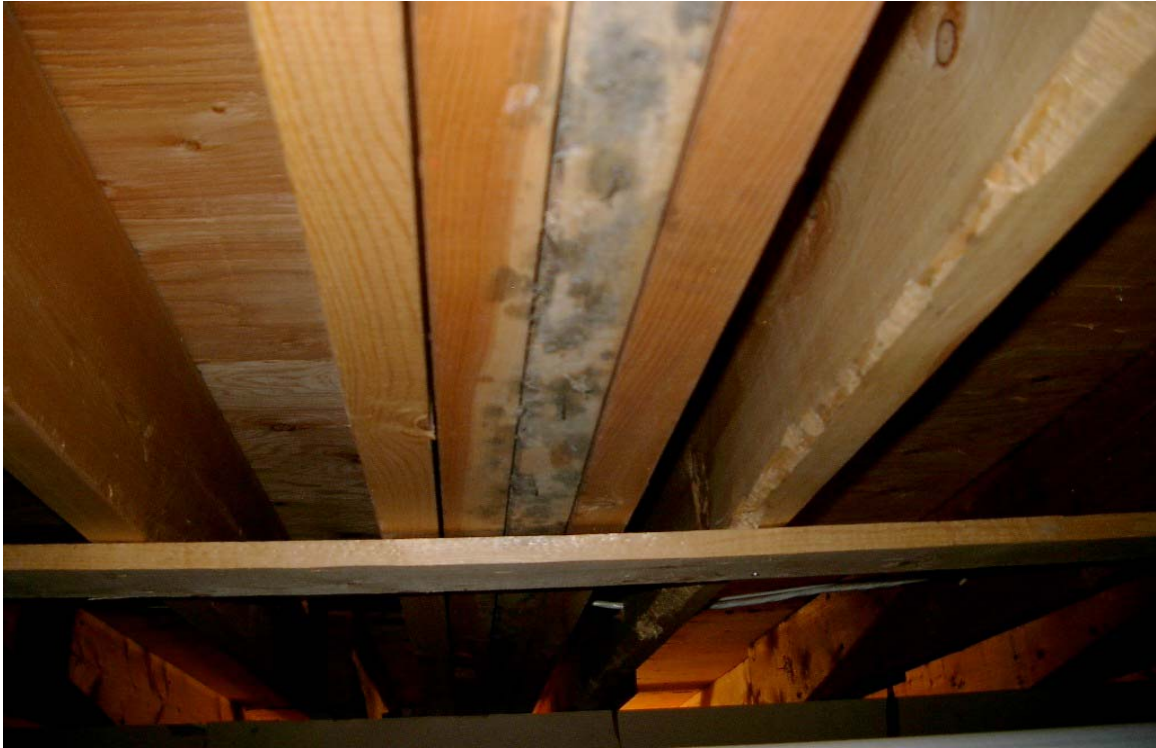
Photo 4: Mold was visible on some of the wooden components within the crawl space area.

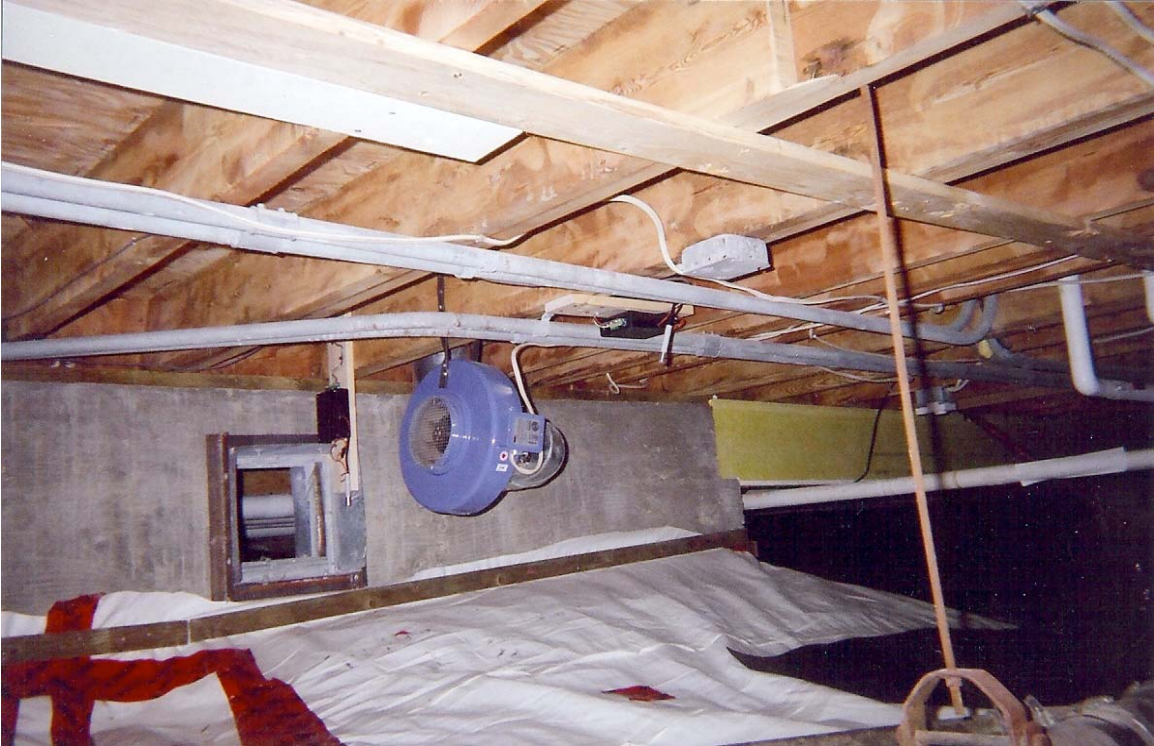
Photo 5: Dedicated crawl space exhaust fan provides a continuous negative pressure relative to the main floor of the facility. Fan discharge is ducted to a roof mounted exhaust hood through well sealed and insulated round metal ducting. Humidiguard™ humidity and temperature reference sensor located downstream of each crawl space zone to assess crawl space environment conditions.

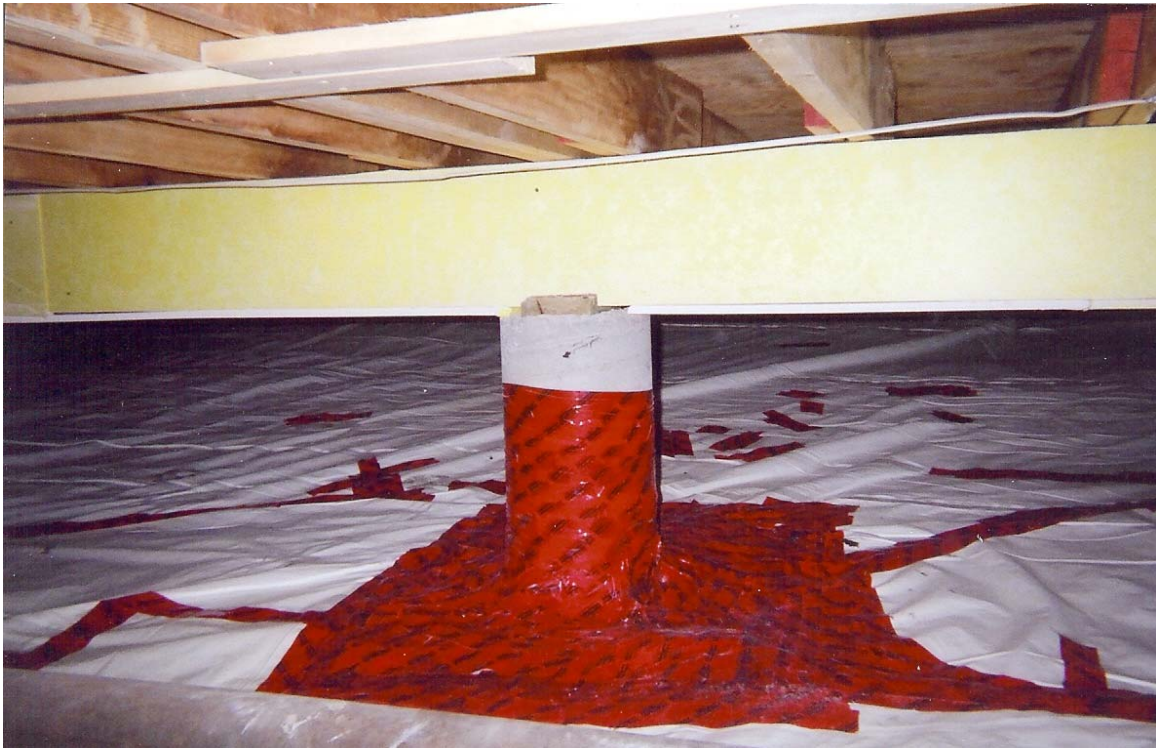
Photo 6: Floor barrier is in good condition and tape is well attached. Concrete piles are wrapped to provide a continuous barrier between the crawl space area and the soil. Densglass Gold™ gypsum fireguard installed on main built up beams.

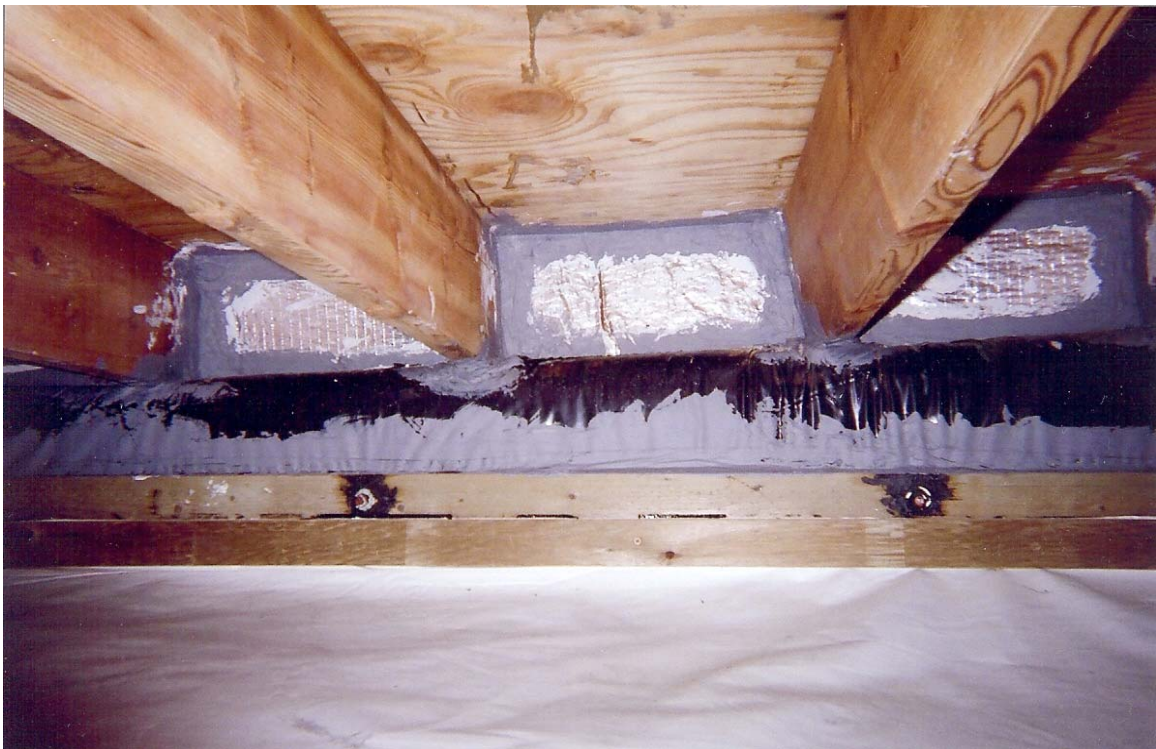
Photo 7: Foil faced insulation installed on the exterior rim joists. The plywood subfloor and the floor joists show no signs of mold re-growth or deterioration. Floor barrier is well attached and sealed to the existing glass fibre insulation system at the exterior wall.

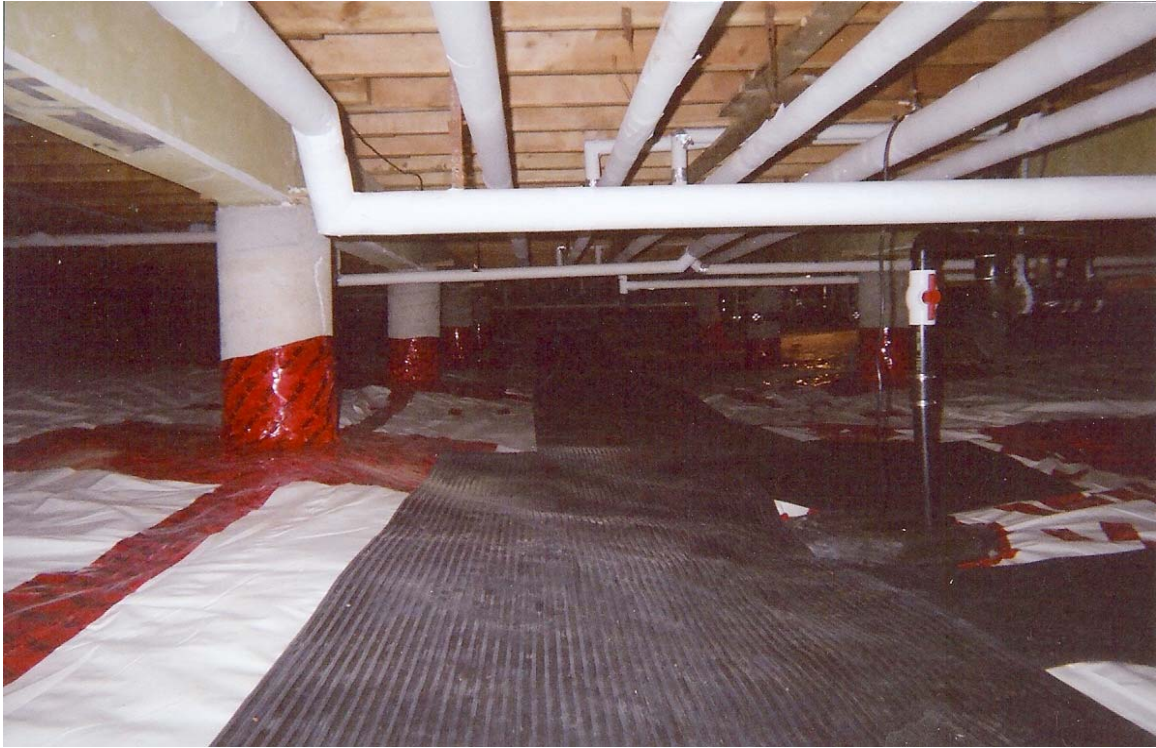
Photo 8: Rubber mats provide a pathway for maintenance personnel. Sump pumps are covered and sealed and are functioning properly. Piping is suspended off the floor and the pipe insulation is in good condition.

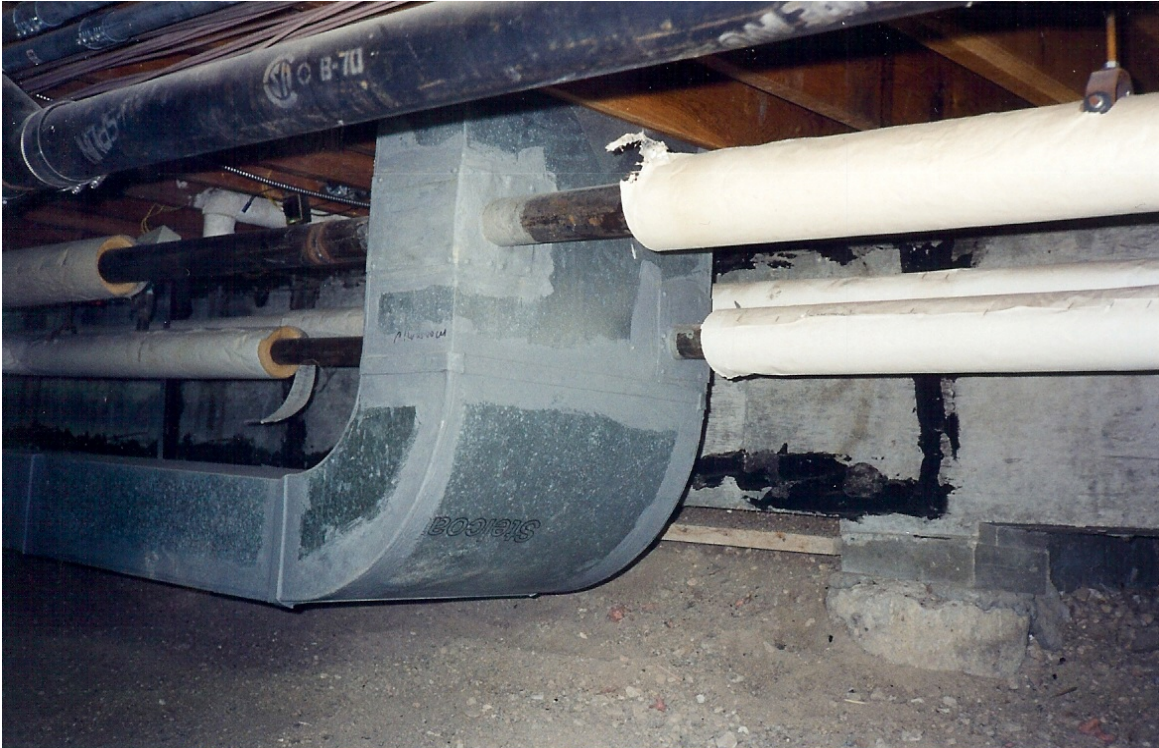
Photo 1: Ventilation ducting in crawl space area. Non-insulated sections of piping. Duct sealing was conducted as a final step in sealing and isolating the crawl space before other remediation was initiated.
