Development and Assessment of Crawl Space Remediation Strategies

CMHC External Research Program (ERP) Project

Figley Consulting Associates Ltd.
Saskatoon, SK

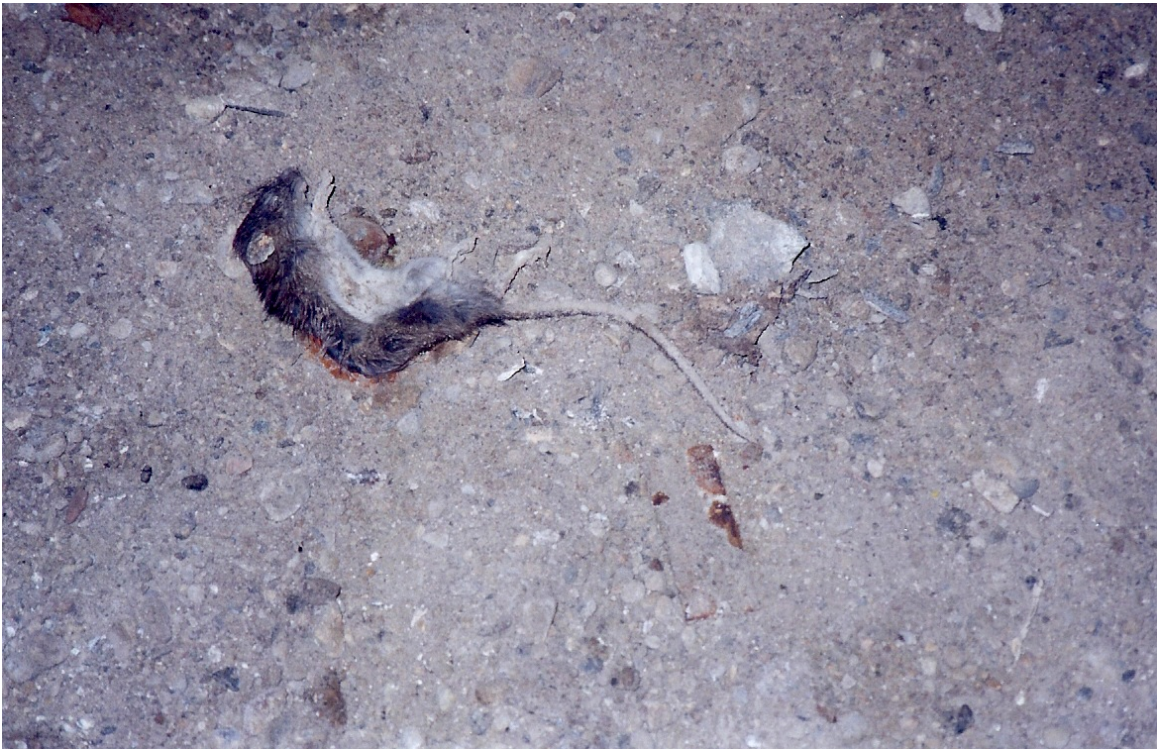
Photo 2: Rodent activity in crawl space area. Crawl space floor was dirty.

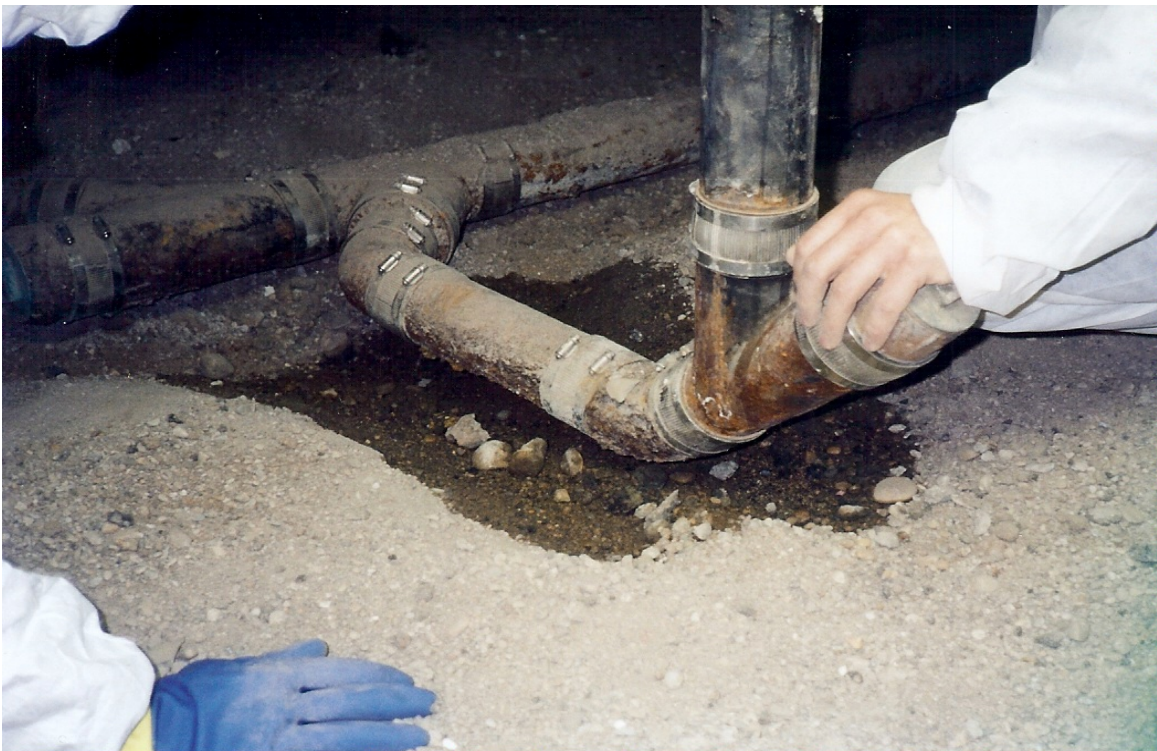
Photo 4: Old, corroded piping was a source of water entry into the crawl space.

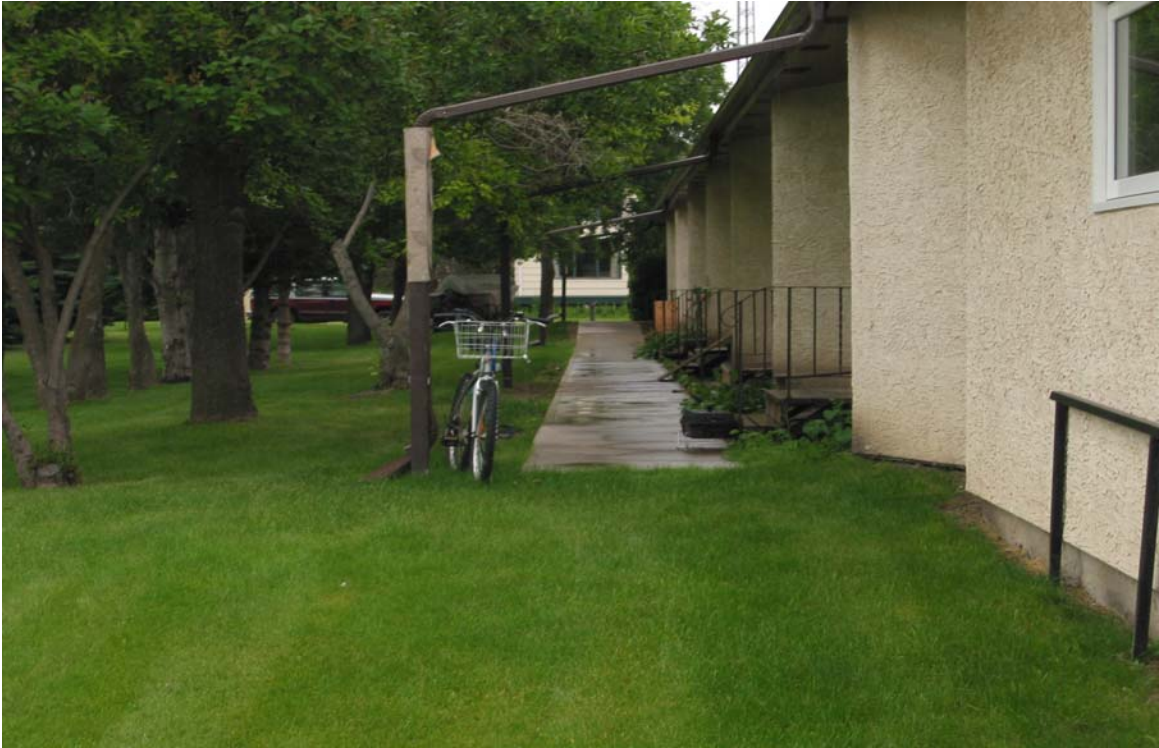
Photo 5: Landscaping around the building has been modified to move water away from the building perimeter.

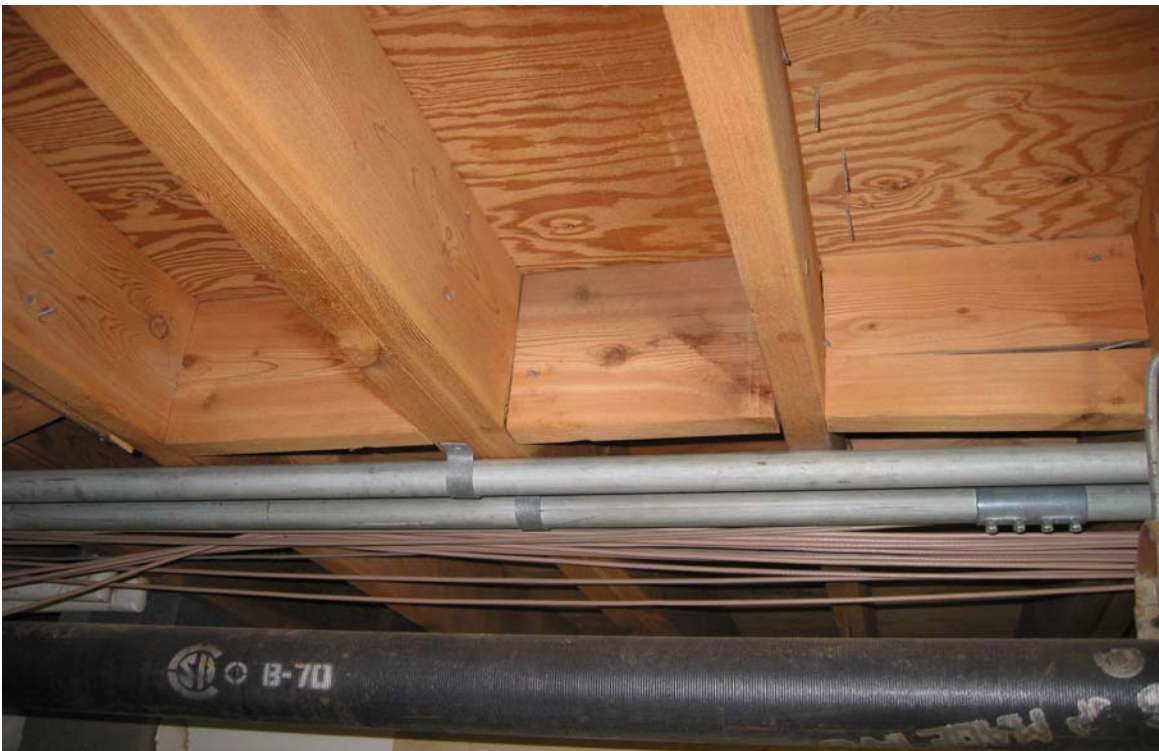
Photo 6: Floor joists and sub-flooring are in excellent condition after sand-blasting.

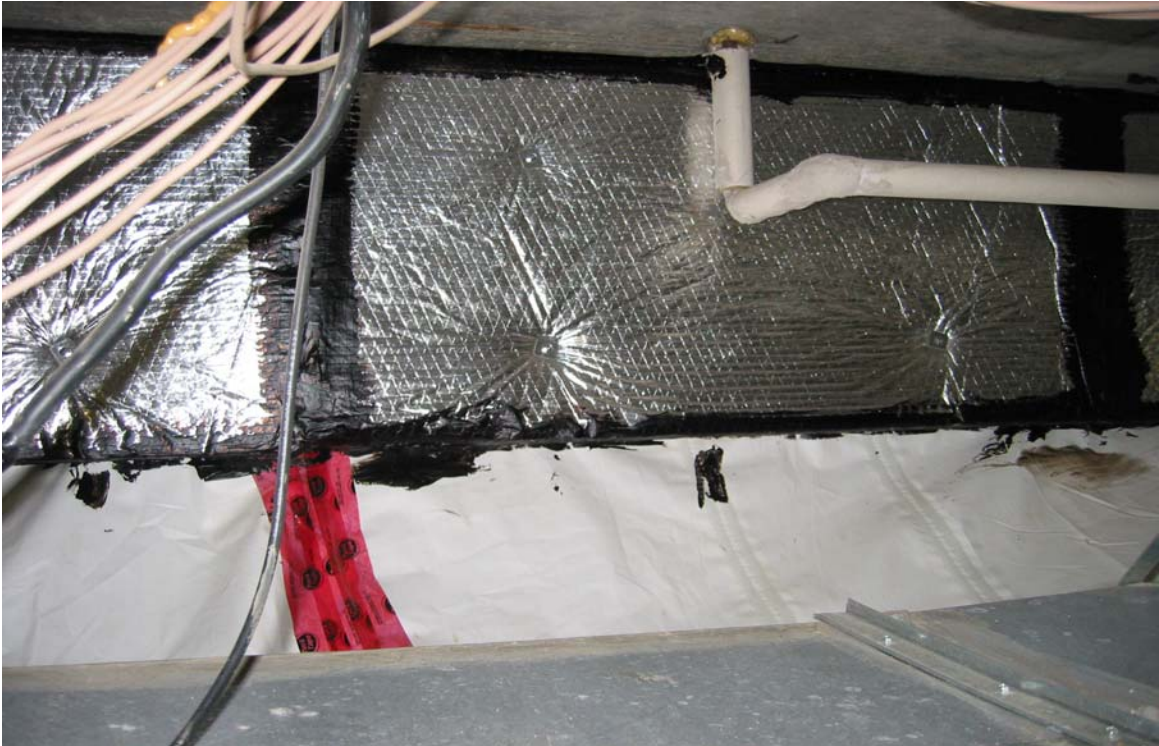
Photo 7: Exterior foil faced wall insulation is in good condition.

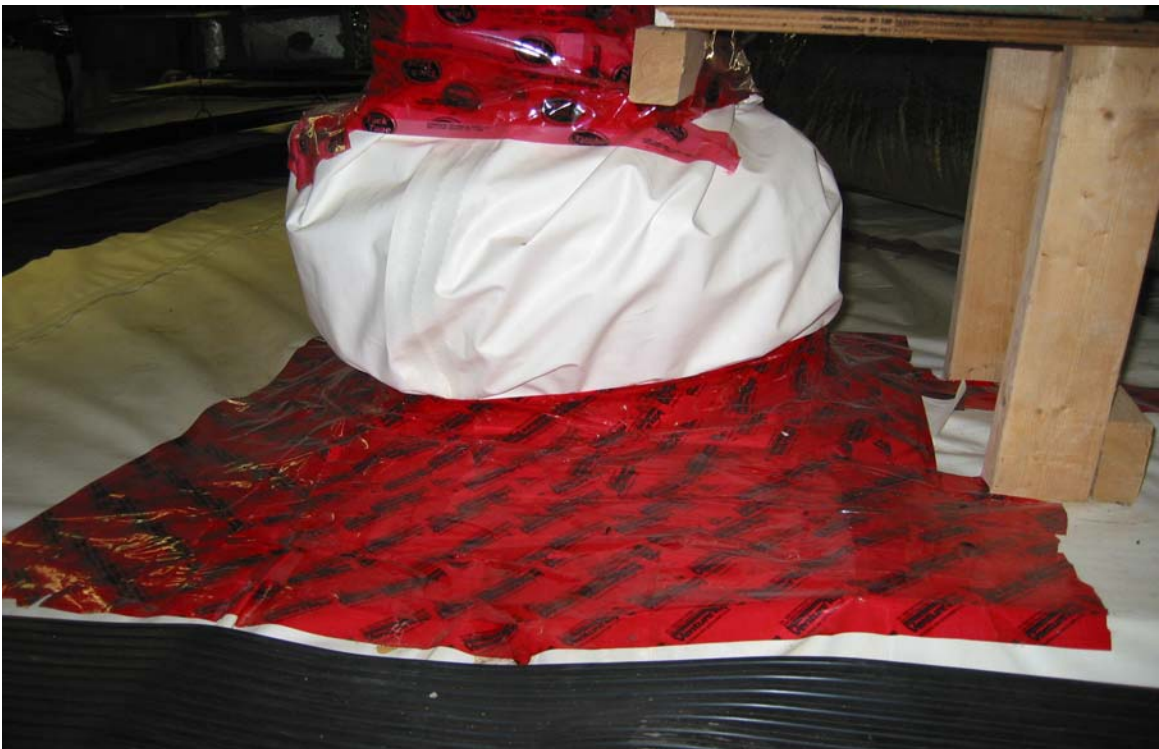
Photo 8: Tape is in good condition and has not detached from the floor barrier. The Permalon™ wrapping around the concrete piles is in excellent condition. Although crude looking, the wrapping of the piles provided a durable and well sealed system to isolate the piles.

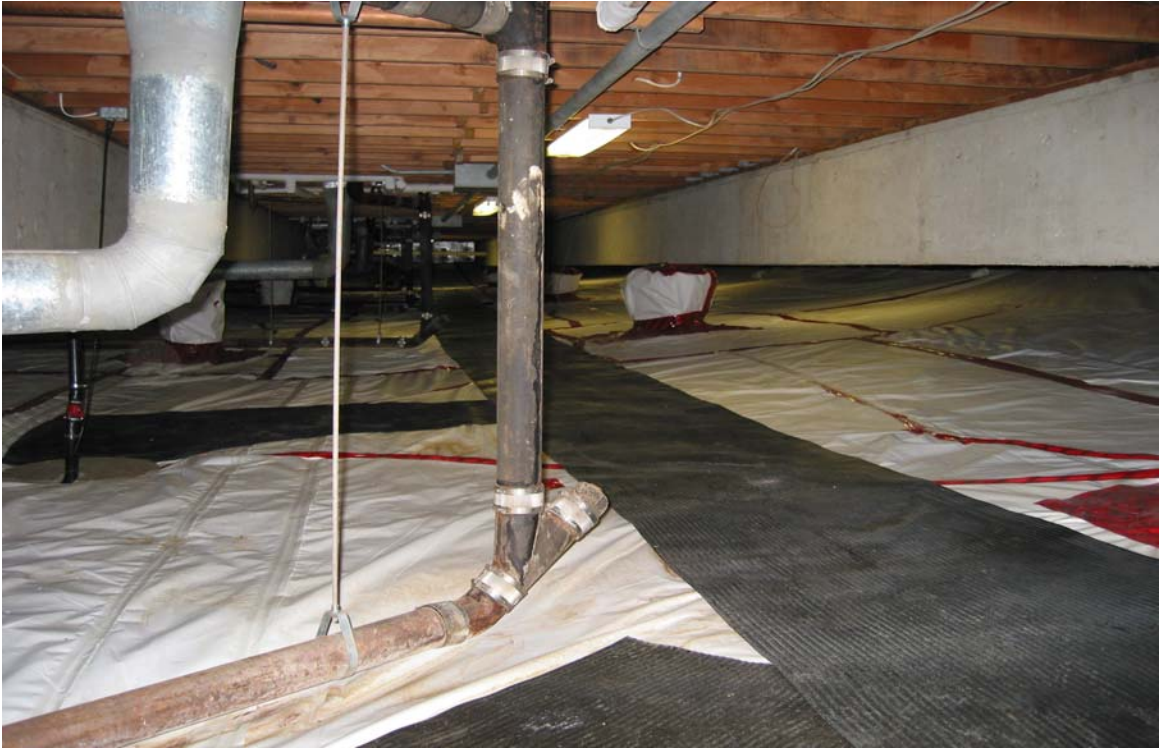
Photo 9: Crawl space area is clean, dry and easily accessible.

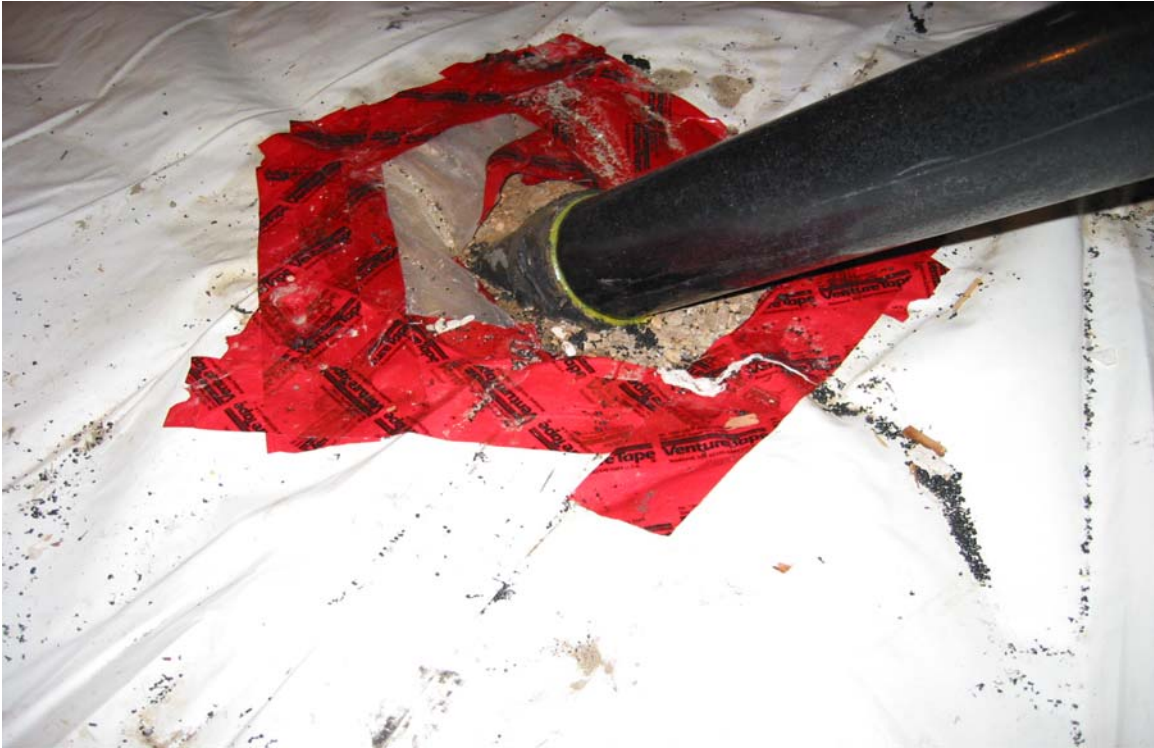
Photo 1: Floor barrier surrounding a new piping installation has not been sealed. Debris from the installation has not been removed and is scattered on the floor barrier.

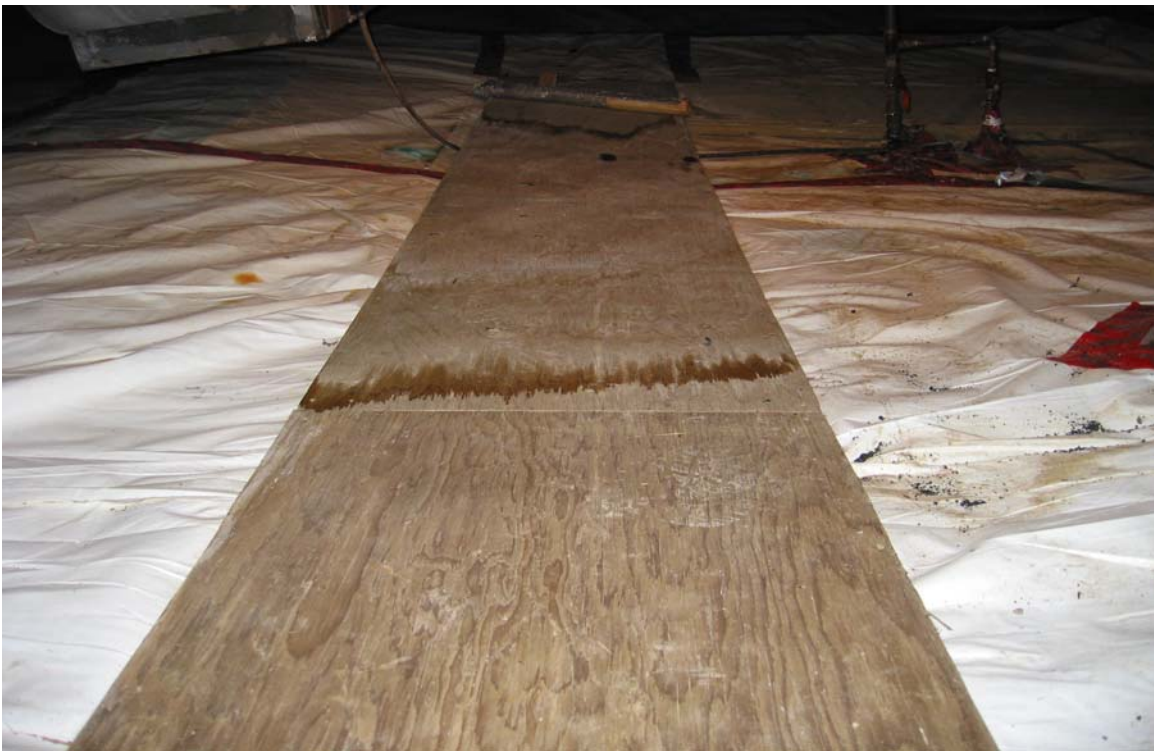
Photo 2: Wood pathways were installed for inspections and maintenance personnel, but are uncomfortable to kneel on and difficult to move for maintenance and cleaning. The floor barrier shows debris and a history of water entry.

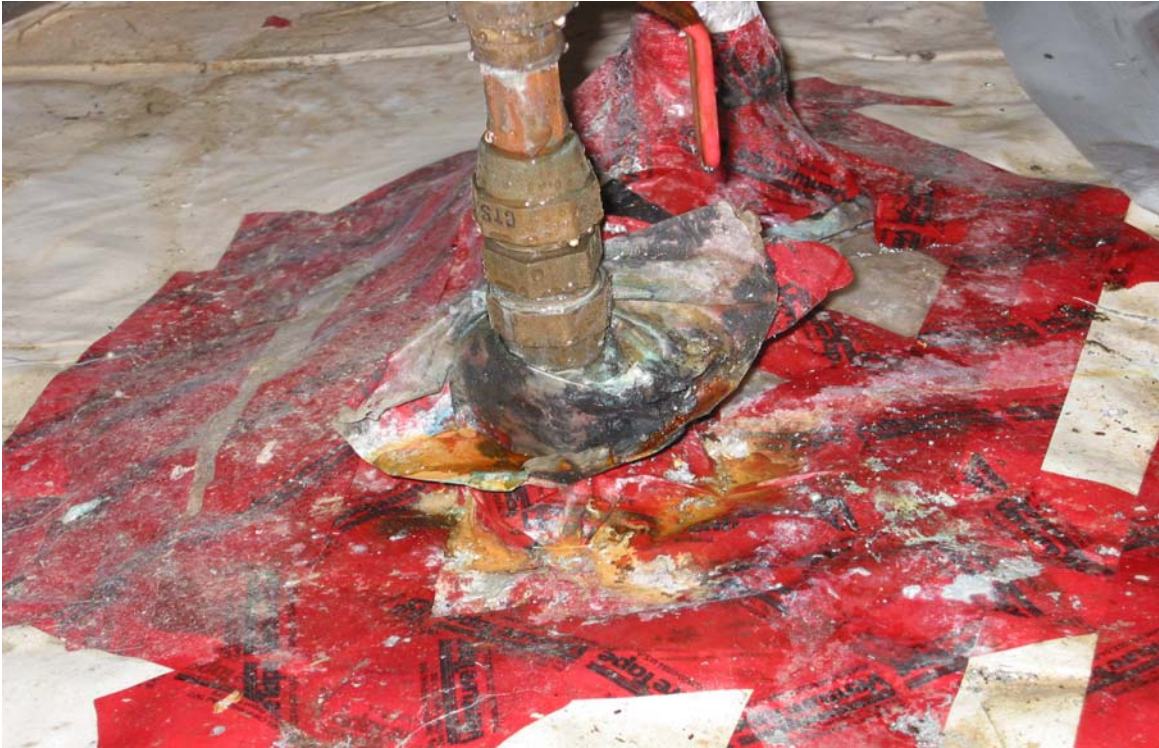
Photo 3: Extensive sweating on cold water pipes has caused stains on the floor barrier and has affected attachment of the tape.

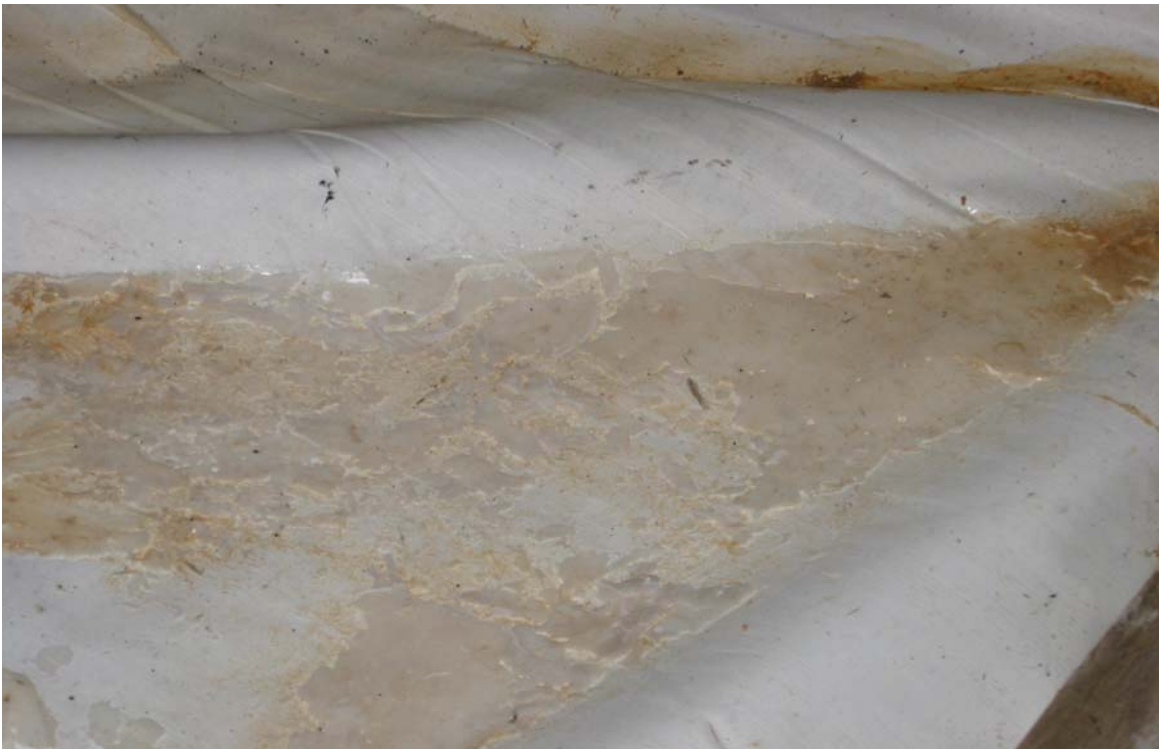
Photo 4: White crystals (either bleach residue or mineral deposits) are found on the floor barrier.

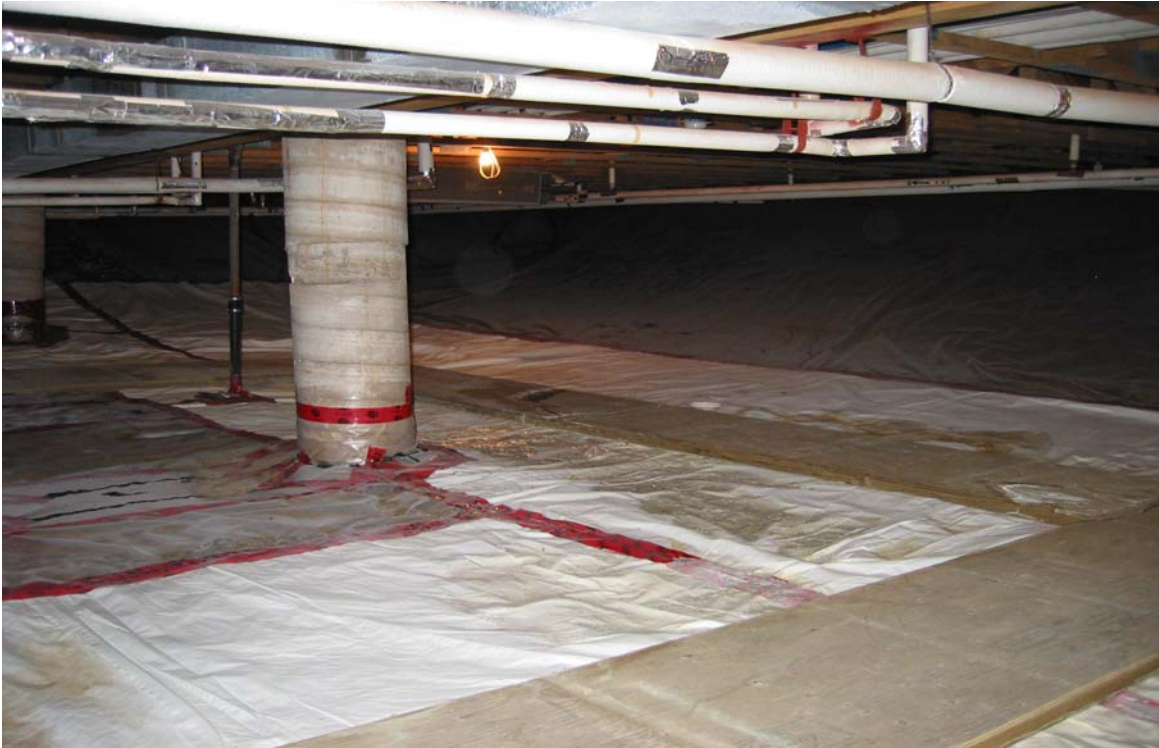
Photo 5: The floor barrier, with the exception of the stains and specifically damaged areas, is in good physical condition. The floor barrier is a mixture of Permalon™ and polyethylene.

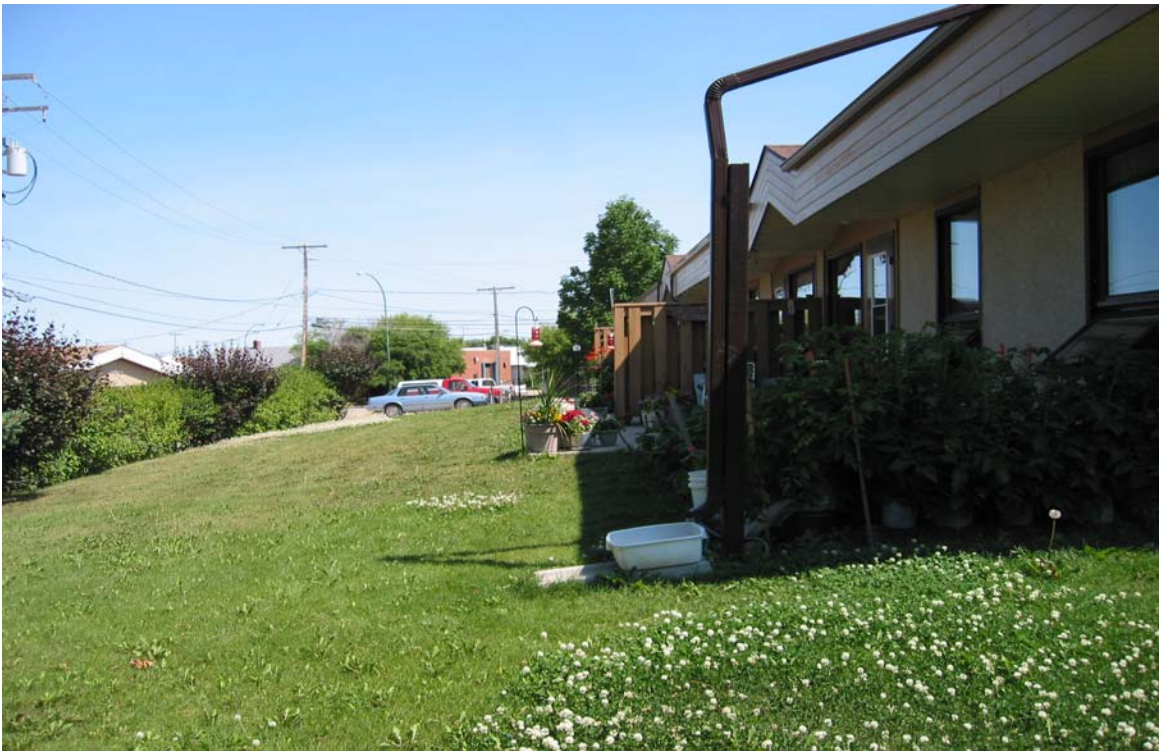
Photo 6: Exterior landscaping and downspouts have been effective in moving water away from the exterior of the building.

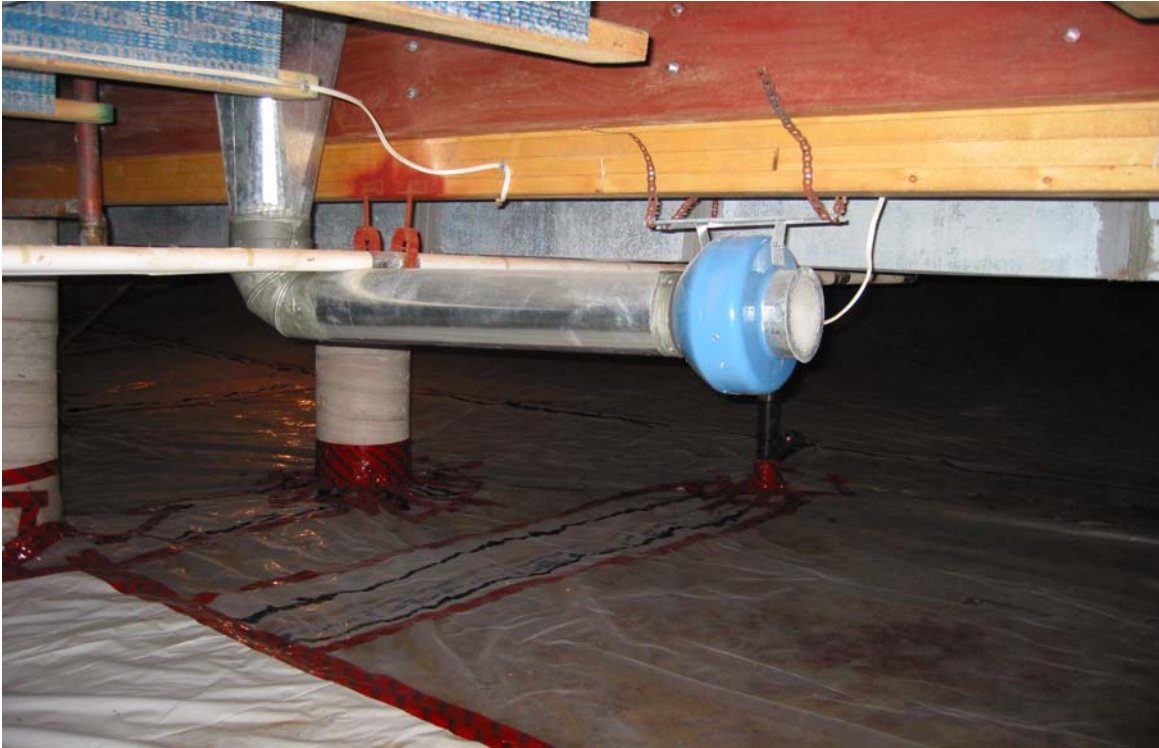
Photo 7: The crawl space has a dedicated exhaust fan installed to provide a continuous negative pressure in the area relative to the main floor. The fan discharge is ducted to a roof mounted exhaust hood through well sealed and insulated round/rectangular metal ducting.

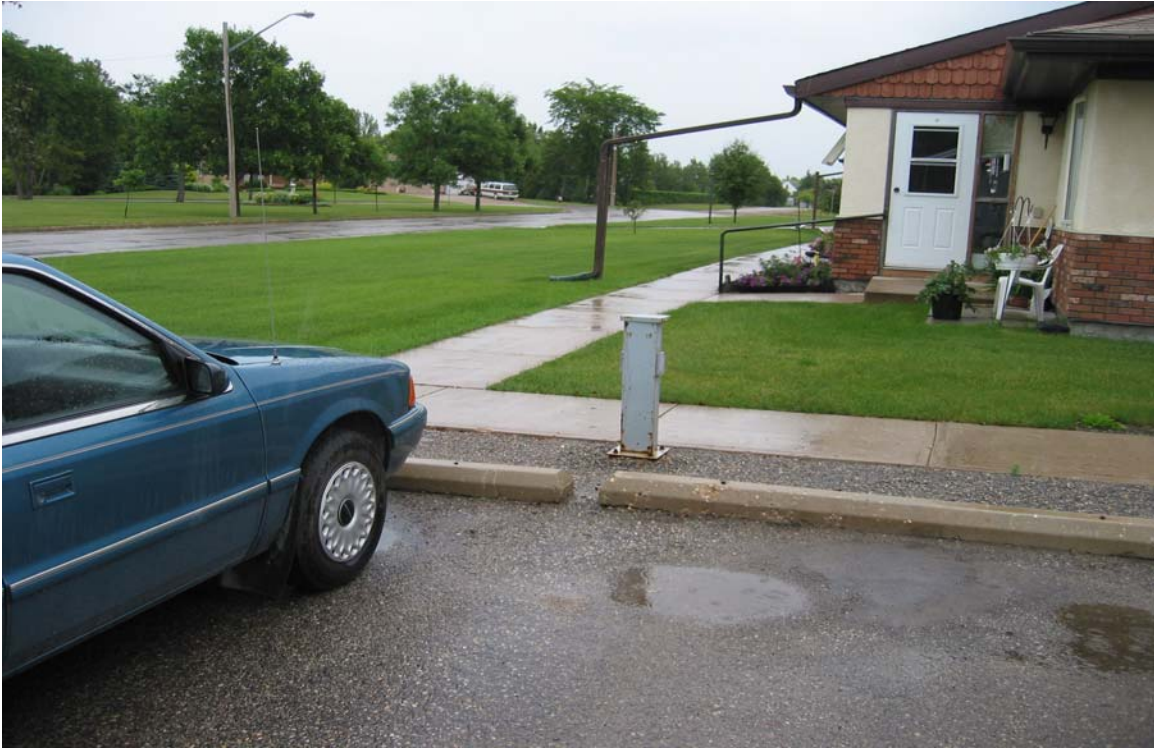
Photo 1: Exterior landscaping allows water to be moved away from the building exterior.

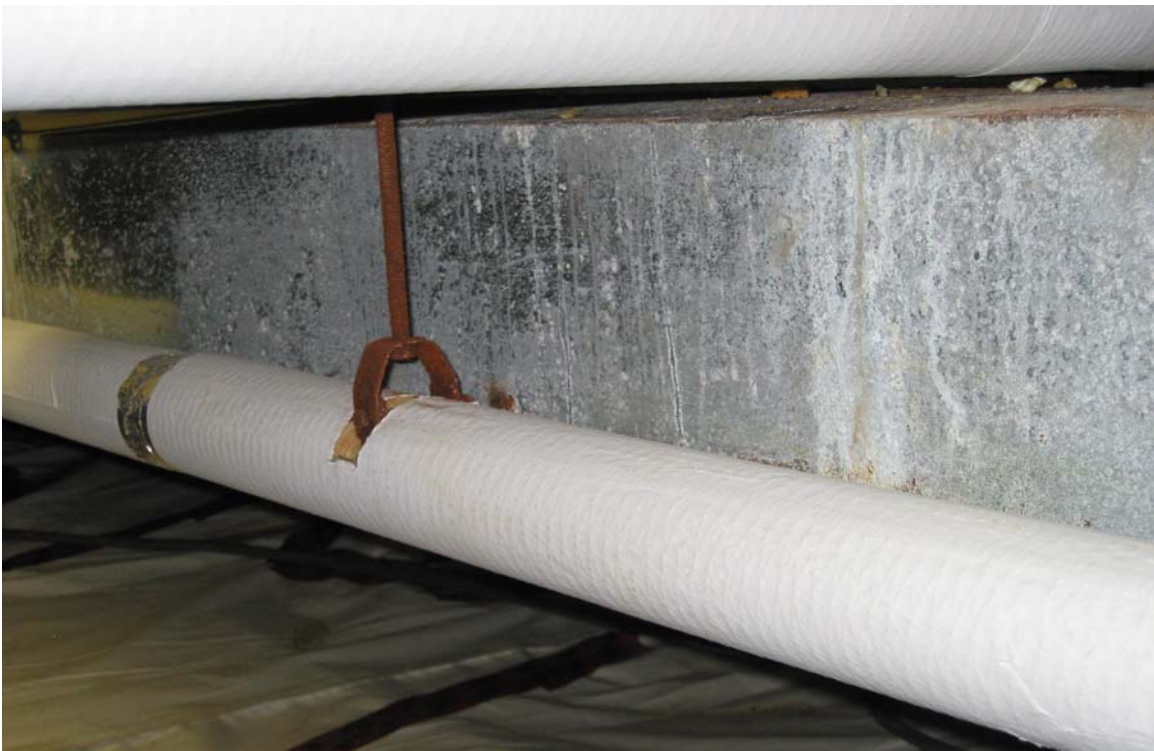
Photo 2: Bleaching of the wood joists has caused damage to the galvanized metal ducting within the crawl space area.

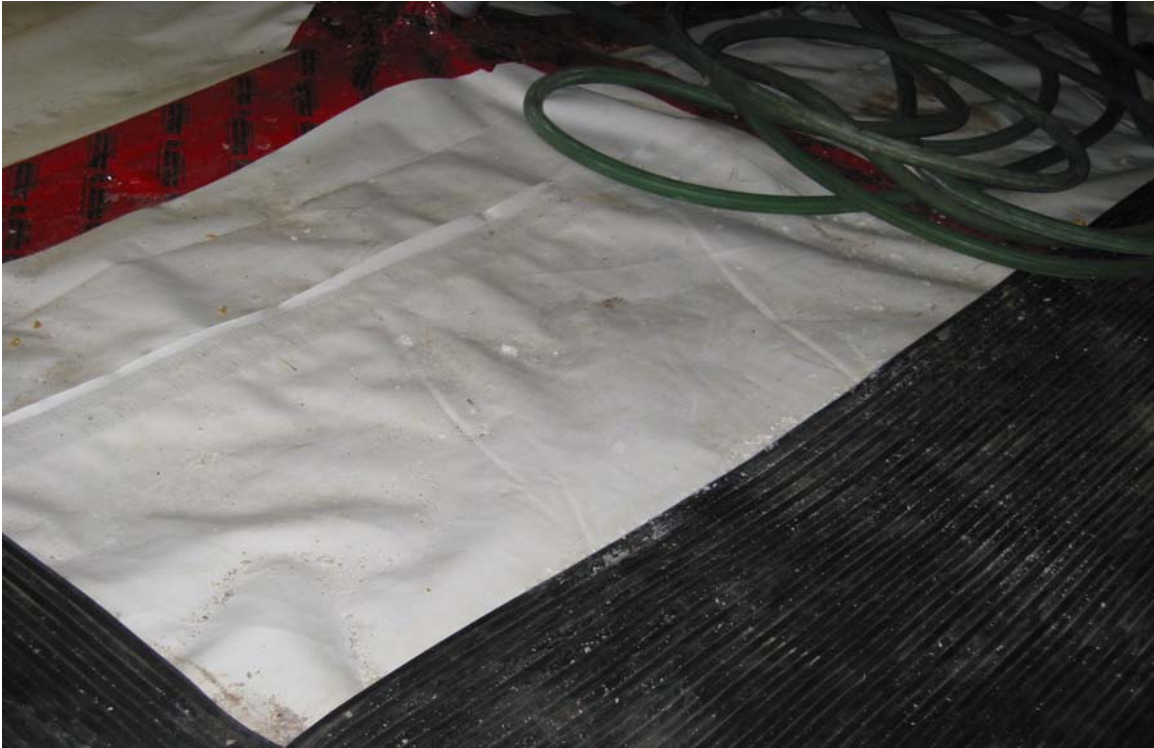
Photo 3: Crystallized bleach remains on the crawl space floor barrier from the bleaching method used for mold removal.

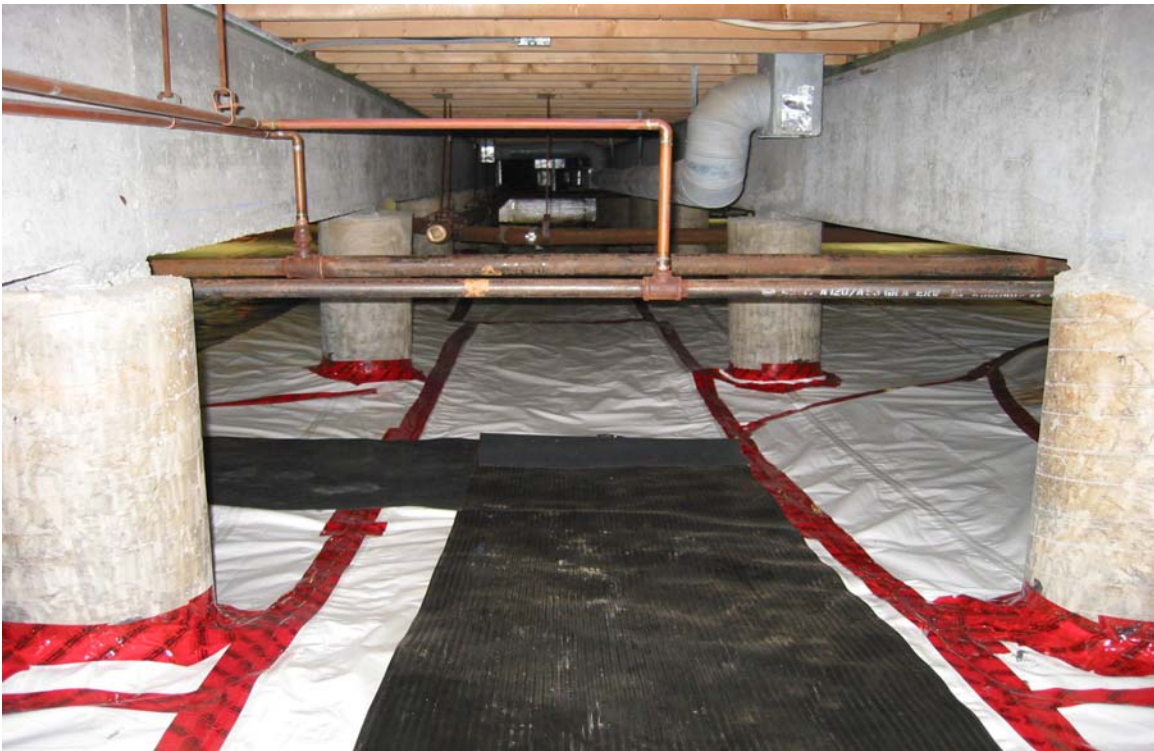
Photo 4: Crawl space floor barrier and tape is in good condition. The installed rubber floor mats, which can be moved for cleaning and maintenance, are useful in enhancing the durability of the floor barrier.

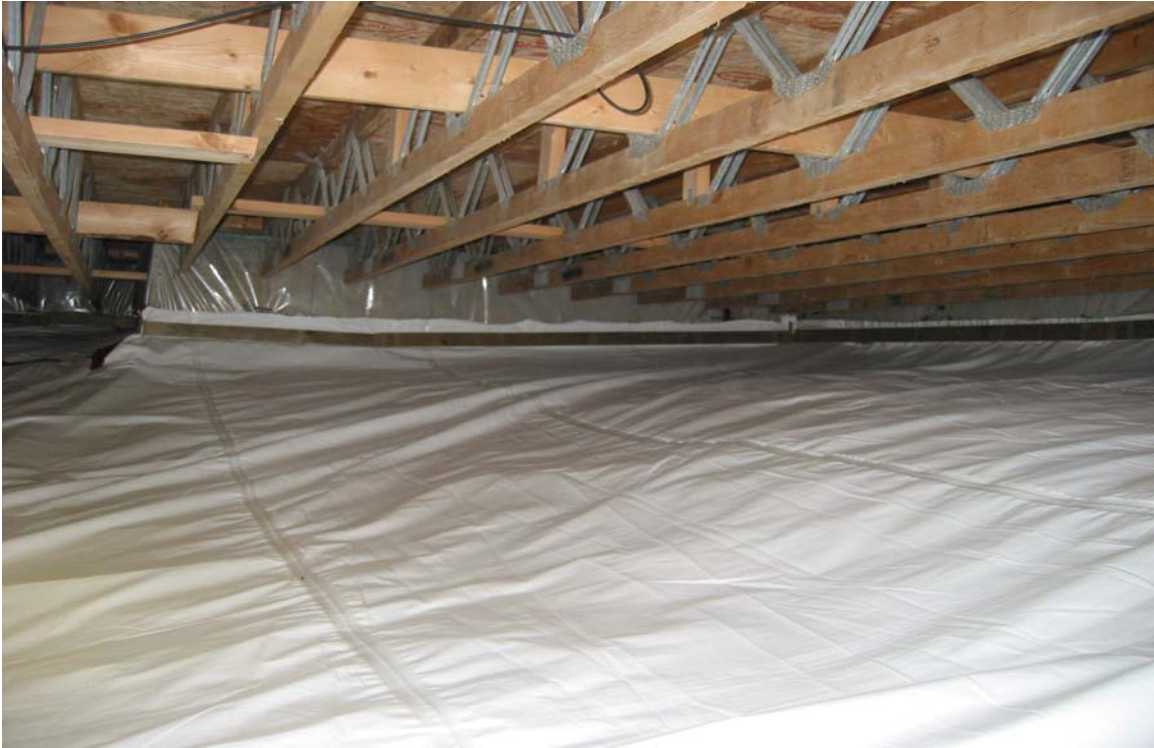
Photo 5: Floor barrier is clean and in excellent physical condition. The Permalon™ floor barrier extends part way up the exterior crawl space wall and merges with poly sheeting, which covers the remaining exterior walls. Wooden joists show no signs of mold re-growth or deterioration from extensive bleaching methods.

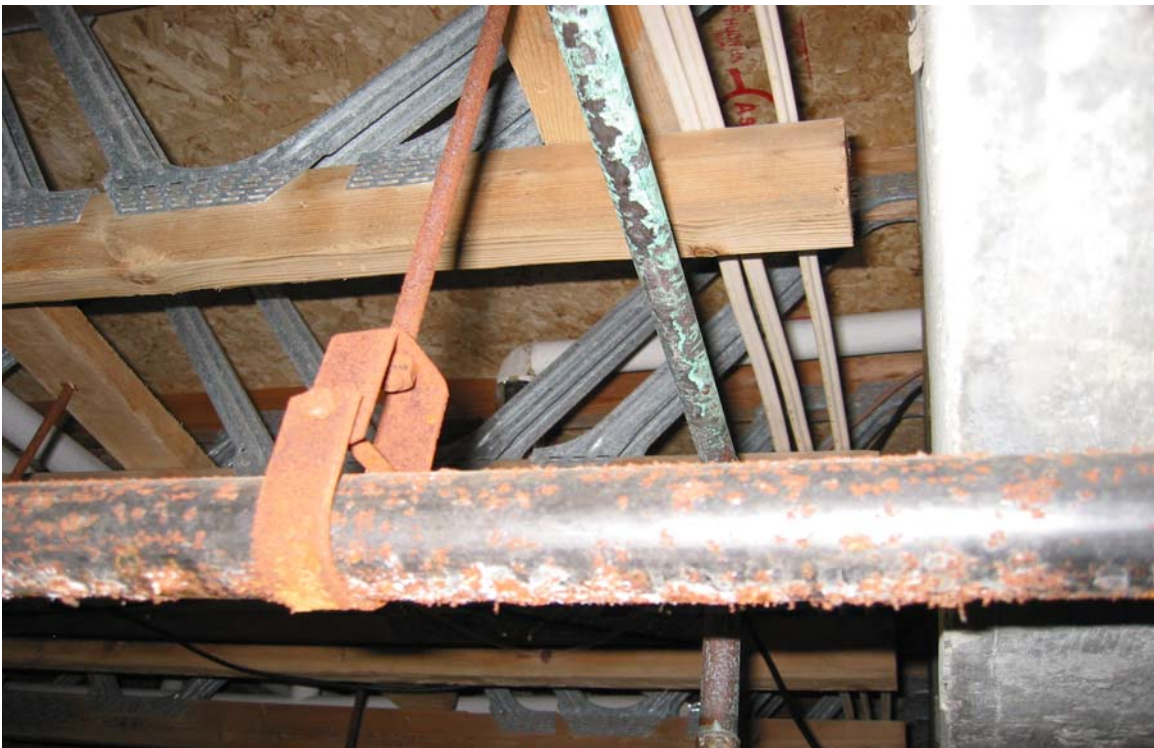
Photo 6: Rust is present on many of the crawl space piping components as a result of the use of bleach for mold removal.
