LONG TERM PERFORMANCE
OF SLAB-ON-GRADE HOUSE
FOUNDATIONS IN REGINA,
SASKATCHEWAN

Final Report

J. J. Hamilton P.Eng.

October 20, 2004

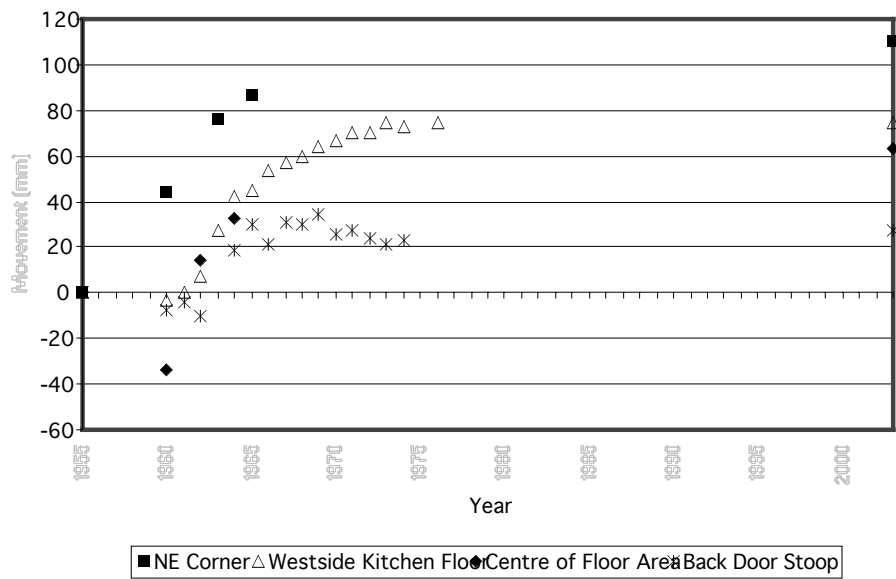
Figure 4a - Progressive Slab Heaving

chosen for detailed study because of technical interest of its owner occupant, and, because of its location in terrain that was relatively undisturbed from its previous agrarian use. The grass covered test plot of Figure 4c was located in the rear yard of this home. The progressive heaving of this slab-on-grade is plotted in figure 4a and its dish shaped distortion is shown in figure 5a.

The soil moisture profile #5 on Figure 5b adjacent to the E corner of the slab-on-grade on the same lot was almost identical on August 22, 2003, to that of the grassed area near the back of the lot (profile #4). However, the profile #6 near the N corner of the slab was wetter at all depths and especially so below 1.2 metres (4 feet). See also Floor slab contours for July 1960 in Figure 5a and, progressive slab heaving in Figure 4a.

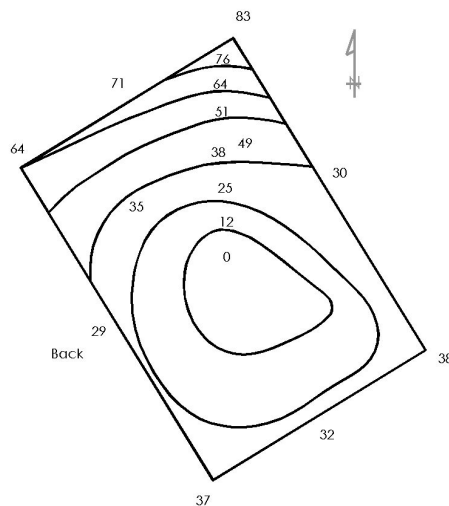
Figure 5a - Slab on Grade Dish shaped distortion July 1960

Floor level contours in Figure 5a for 1960 illustrate a nearly symmetrical dishing that many slabs-on-grade experienced during their first five years of life before trees, shrubs and other landscape influences became significant. By July 19, 1960 the differential between high and low floor elevations was 83 mm (3.3 inches). Heat flow from the perimeter and central heating ducts produced thermally activated soil moisture migration from the interior towards the perimeter areas of the floor. Soil shrinkage below central areas and swelling below perimeter areas caused differential movement of these ground-supported slabs.

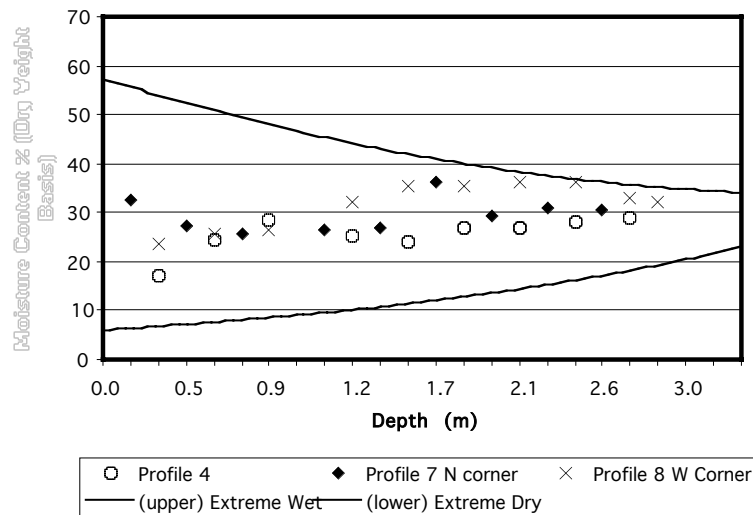
Figure 6c - Water Content Profiles on August 21, 2003 at NE and NW Corners

The 5 year (1955 to 1960) and 48 year (1955 to 2003) distortions of the slab-on-grade house located on the northwest side of the first house are shown in figures 6a and 6b respectively. Figure 6c shows the soil moisture profiles at the N (#7) and W (#8) corners of the second slab-on-grade compared with the profile (#4) from the backyard of the first house.

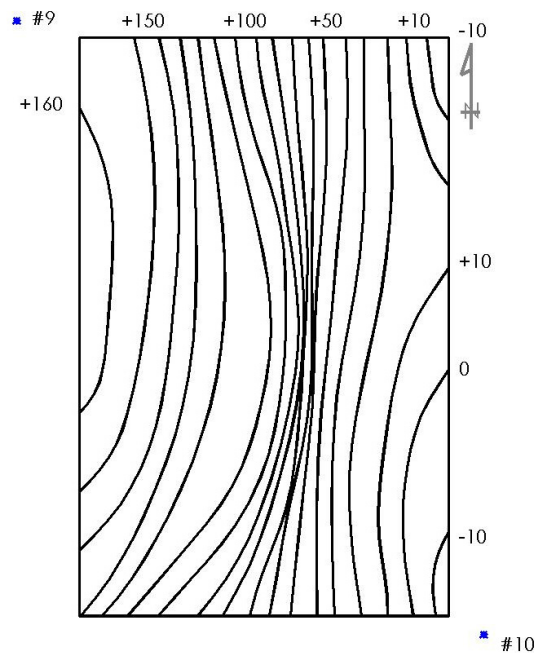
Figure 7a - Slab on Grade August 1, 2003

Figure 7a shows the back to front slope of a third slab-on-grade a few houses north on the same street as the previous two houses.

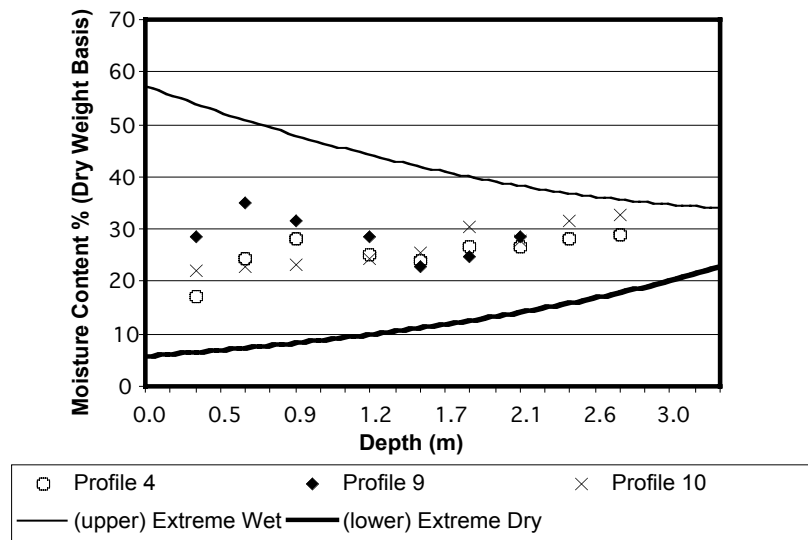
Figure 7b - Water Content Profiles on Sept 9, 2003 at NW and SE Corners

Figure 7b shows 2003 soil moisture profiles at the W (#9) and E (#10) corners of this third slab-on-grade compared again with the backyard profile (#4) from 1960. The higher moisture contents in the upper 1.5 m (4.95 feet) at the W corner are the result of lawn watering and the lower moisture contents at similar depths at the E corner are a result of a large tree growing too close to the house. See floor slab contours for this house on Aug.1, 2003 in Figure 7a.

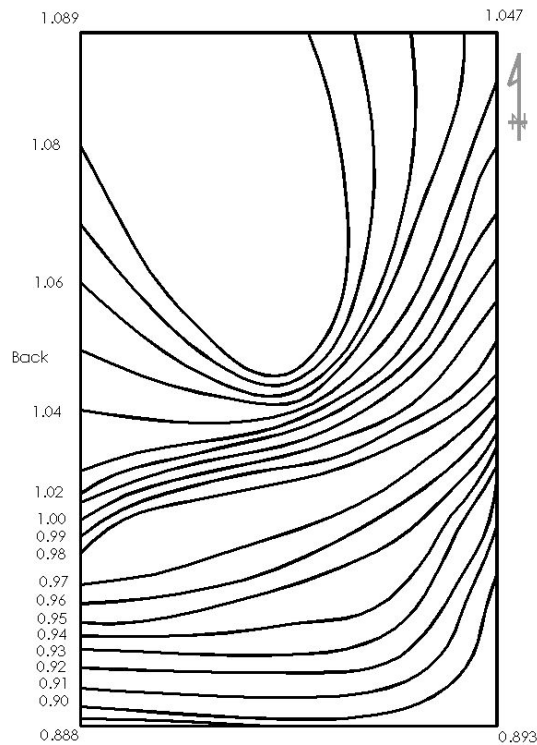
Figure 8a - Slab on Grade June 25, 2003

Figure 8a shows floor slab contours for a house where several large trees on the neighbour's lot stand close and parallel to the south property line. Their root systems control soil moisture below the south end of the slab. Negative surface drainage from

the back of the lot and from the neighbors to the north brings surface water periodically to the NW corner. Floor slab contours for this house measured on June 25, 2003 show a differential of 201 mm (7.9 inches) measured across the back of this slab.

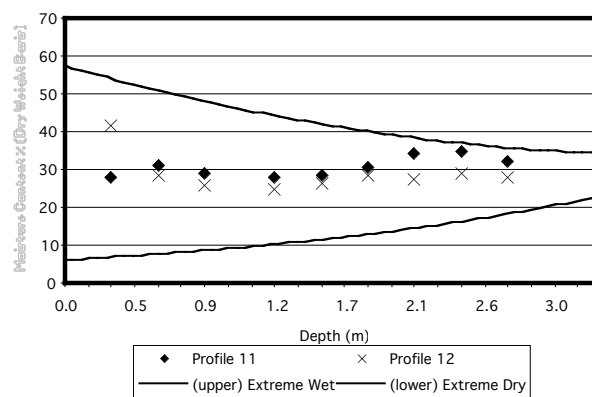
Figure 8b - Water Content Profiles on Sept 25, 2003 at NW and SW Corners

Figure 8b shows 2003 soil moisture profiles at the NW (#11) and SW (#12) corners of the slab shown in 8a. The 42% moisture content at 0.3 m (1 foot) on profile 11 was probably caused by rainfall preceding sampling on Sept 25, 2003

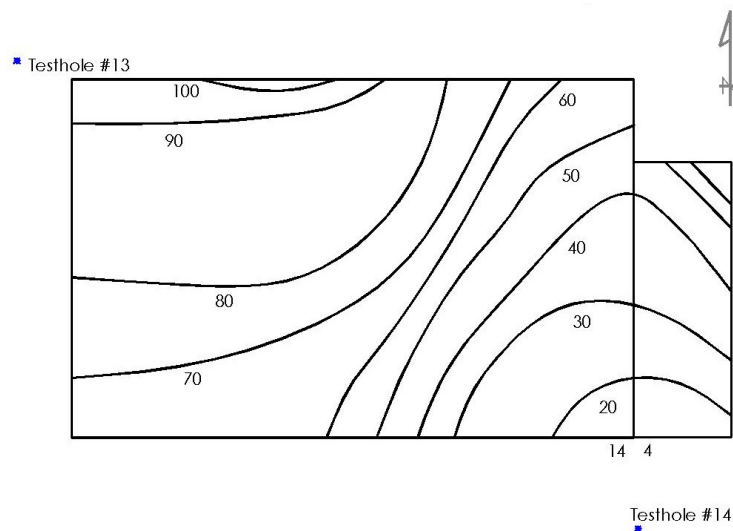
Figure 9a - Slab on Grade Influence of Several Large Trees

Figure 9a shows floor slab contours and Figure 9b shows 2003 soil moisture profiles at the NW (#13) and SE (#14) corners of a slab-on-grade which is also supported by piles and grade beams. Many deep-rooted trees were planted within 2.7 m (9 feet) of the slab perimeter and have now grown to maturity. Large trees close to locations of test holes #13 and #14 dominate subsoil conditions even though the homeowner has directed roof drainage from each side of the house to the ground surface at these corners. Although the average soil moisture contents are very similar to those at #11 and #12 in figure 8b, the differential in elevations across this slab of 86 mm (3.4 inches) is less than half. (See Figure 9a) Interior damage to the house has been minimal and the homeowner is satisfied that the pile and grade beam foundations have greatly reduced damage that might have occurred with trees so close.

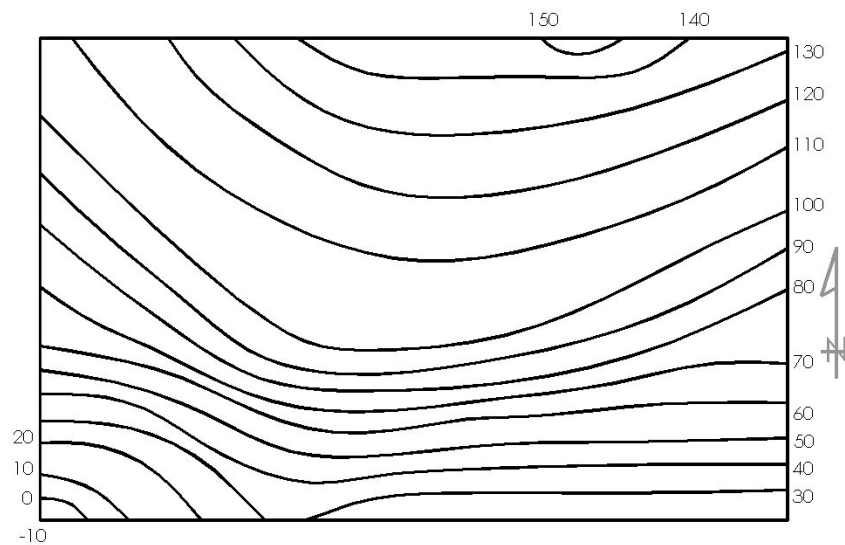
Figure 10 - Slab on Grade Front to Back Slope with Tree Influence

Figure 10 shows large differential heaving on the north side due to heavy lawn watering and settlement of the southwest corner due to a neighbor's nearby tree.

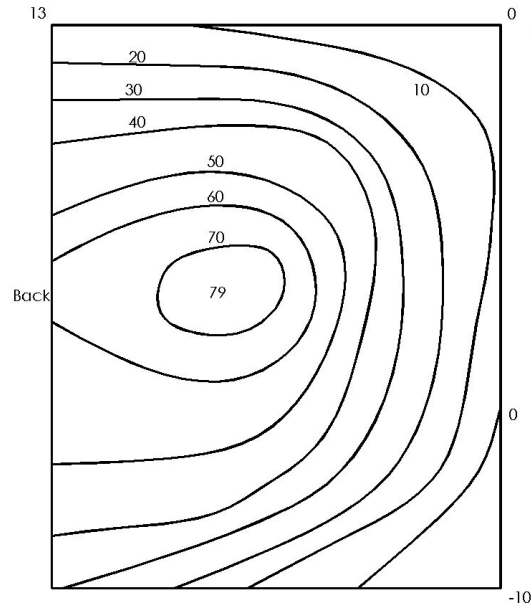
Figure 11 - Slab on Grade Back and Centre Heaving

Figure 11 shows back and centre heaving due to poor surface drainage from the back of the lot.
