## Monitored Performance of an Innovative Multi-Unit Residential Building: Final Report

***MONITORED PERFORMANCE  
OF AN INNOVATIVE MULTI-  
UNIT RESIDENTIAL BUILDING***

**FINAL REPORT**

**Enermodal Engineering Limited  
650 Riverbend Drive  
Kitchener, ON N2K 3S2  
Tel: 519-743-8777  
Fax: 519-743-8778**

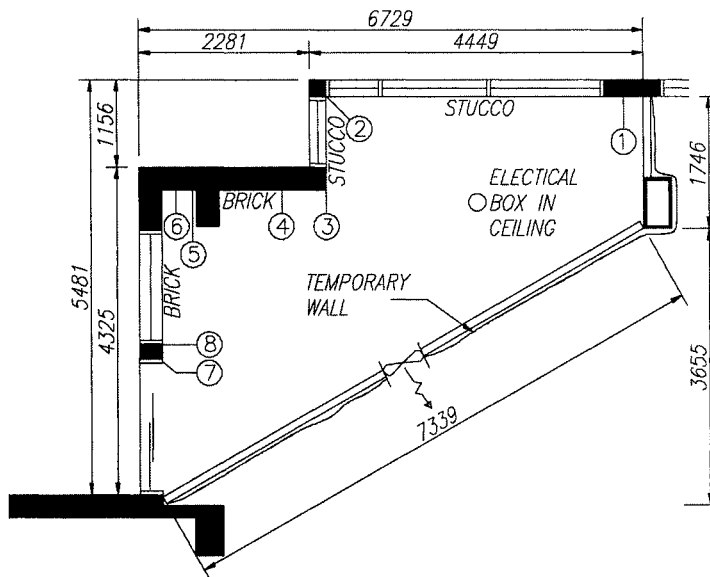
**Figure 2.6: Leakage Locations Identified in Representative Wall**

MAJOR LEAKAGE LOCATIONS:

- ① KING STUDS BESIDE WINDOW BETWEEN STUDS AND GYPSUM BOARD.
- ② CORNER POST LEAK BETWEEN FIBREBOARD.
- ③ AT TOP TRACK CHANNEL CORNER.
- ⑥ ⑤ ④ LOWER HOLE - FOR NON-EXIST.BRICK TIE.
- ⑦ WIRING PENETRATION @ 6'-0" HEIGHT.
- ⑧ JACK STUDS BESIDE WINDOW @ TIES FOR WINDOW SILL.

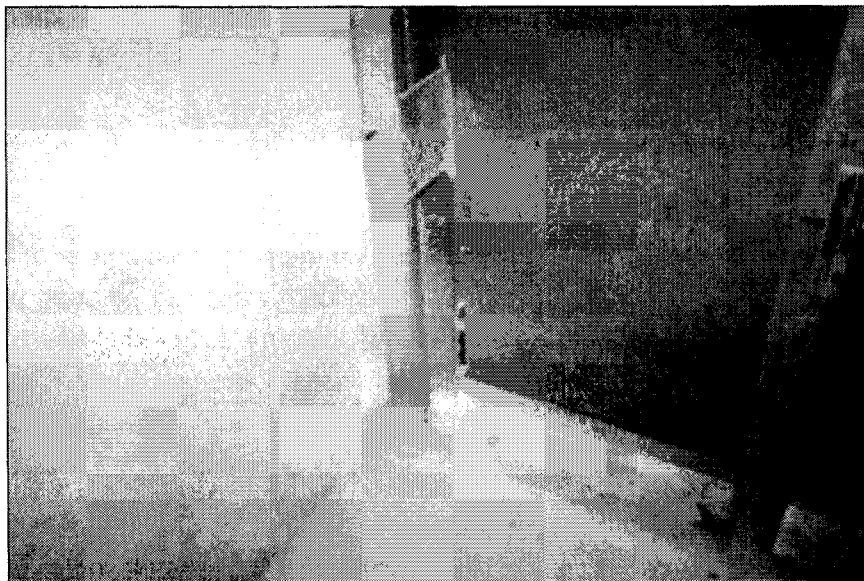
**Figure 2.9: Hole Left Unsealed When Brick Tie Relocated**

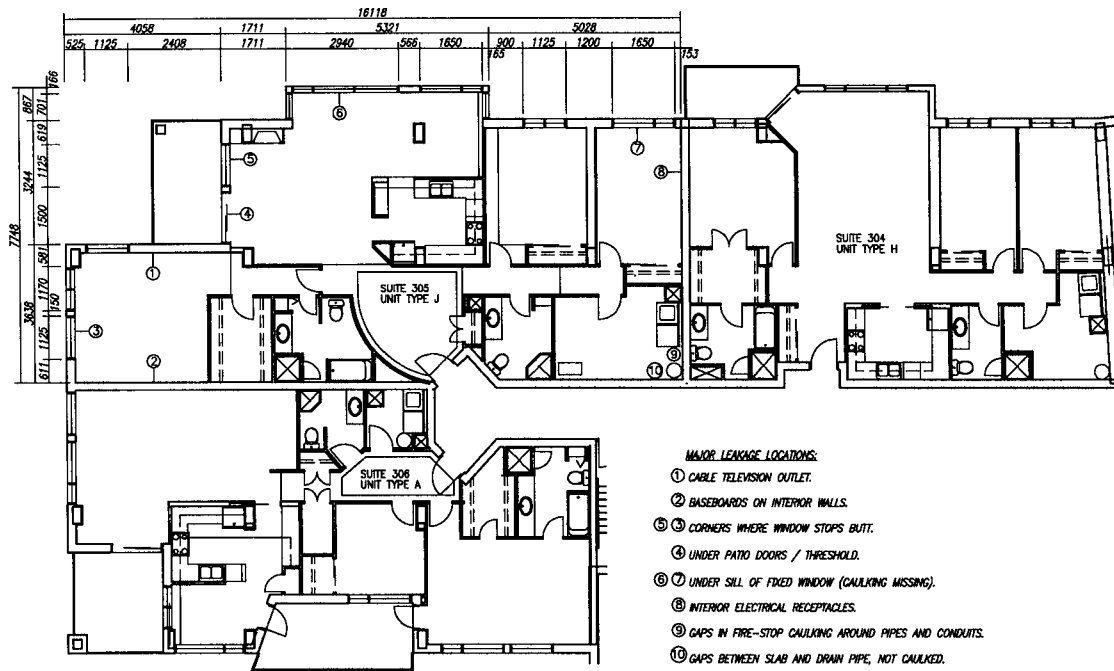
**Figure 2.10: Leakage Location Identified in Representative Suite**

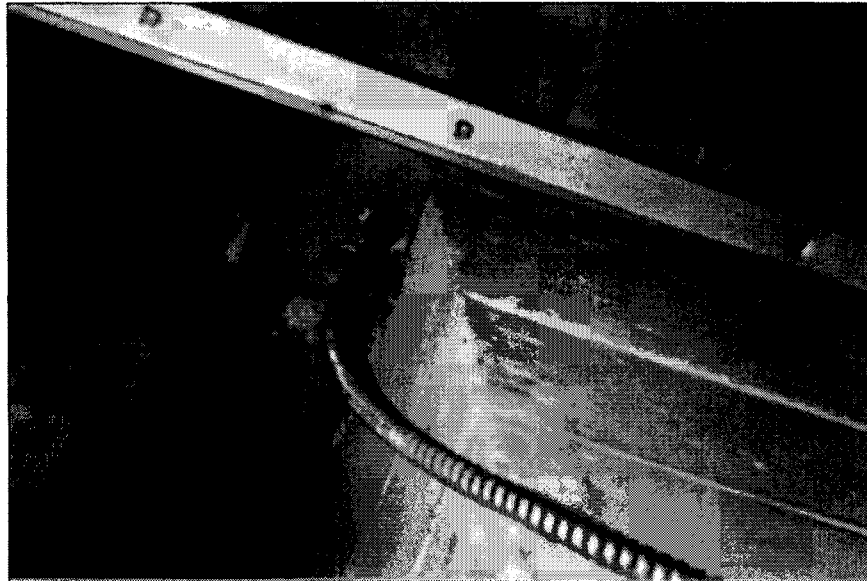
Interior partitions, on the other hand, were relatively leaky. Leakage locations include all boxes for electrical and other services such as cable and telephone, baseboards, and gaps in firestopping where the caulk did not go completely around conduits and piping. Figure 2.11 shows an electrical cable passing through a hole in a floor slab that had not been firestopped. Figure 2.12 shows an electrical box in a party wall that had been firestopped with drywall compound and a large section of the compound had fallen off, eliminating the airtight seal. During discussions with the building science specialist, it was suggested that imperfect firestopping is common in most construction projects. Thus firestopping reduces the movement of hot gasses and smoke but does not eliminate it. Odour and noise control would also be compromised when details such as firestopping are not completed to a reasonable level of quality.

**Figure 2.11: Wiring Passing Through Floor Slab Left Unsealed**
