Deterioration of Parking Structures Research Project

**DETERIORATION OF PARKING
STRUCTURES RESEARCH PROJECT**

ABSTRACT

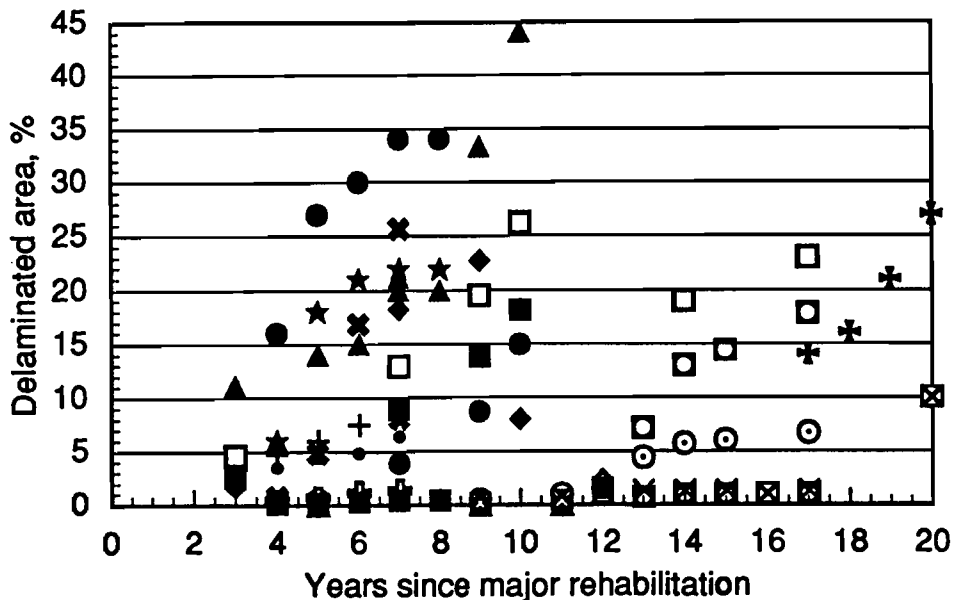
Fig. 1
Rate of delamination of garages after major
rehabilitation
(reinforced concrete decks)

It has to be emphasized that the inability of differentiating reliably between the soundings produced by delamination in the concrete and that by debonding of the waterproofing membrane from the concrete structure is also a major reason for the wide scatter of the results. Our efforts, partly funded by the Industrial Research Assistance Program, in the first year of the project to encourage Canadian instrument manufacturers to develop a reliable instrumental method for the accurate measurement of delaminations in concrete has not yielded useful results.

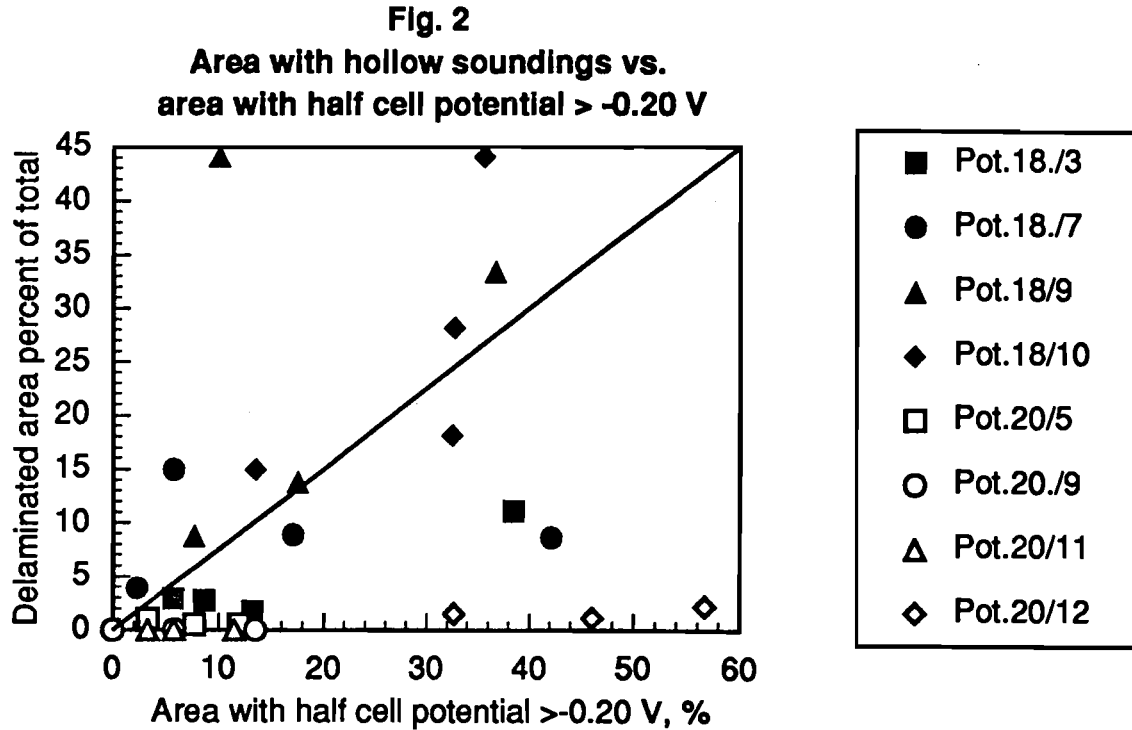
Garages No. 18 and 20 were in full agreement, the points would fall in the plot on the 45° line. No such tendency can be detected, in fact, there appears to be no relationship of any kind between the results of the two tests.

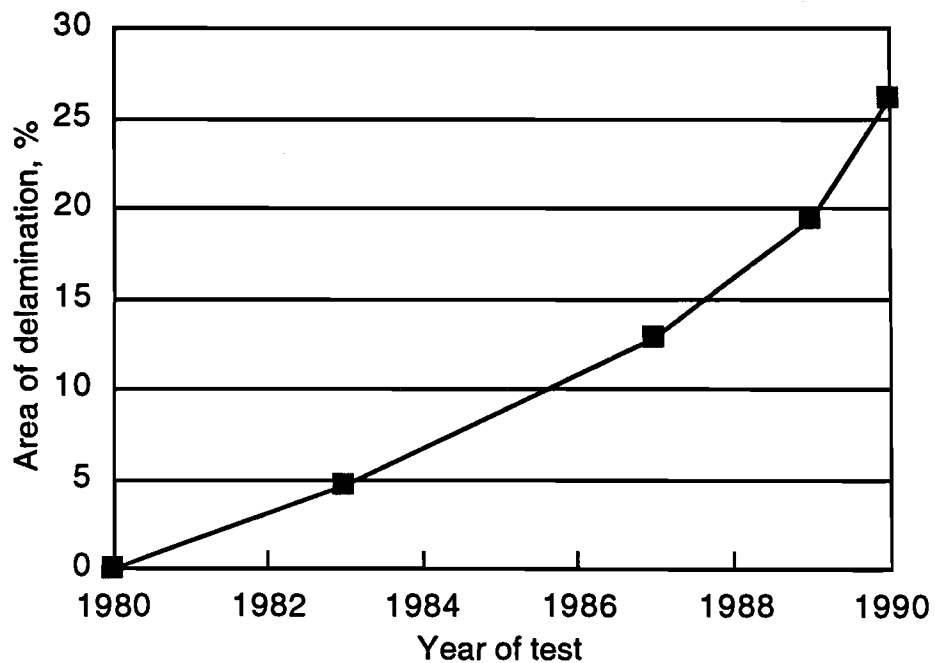
Fig.18. 1
Garage No.18.
Total extent of delaminations
in test areas vs. time

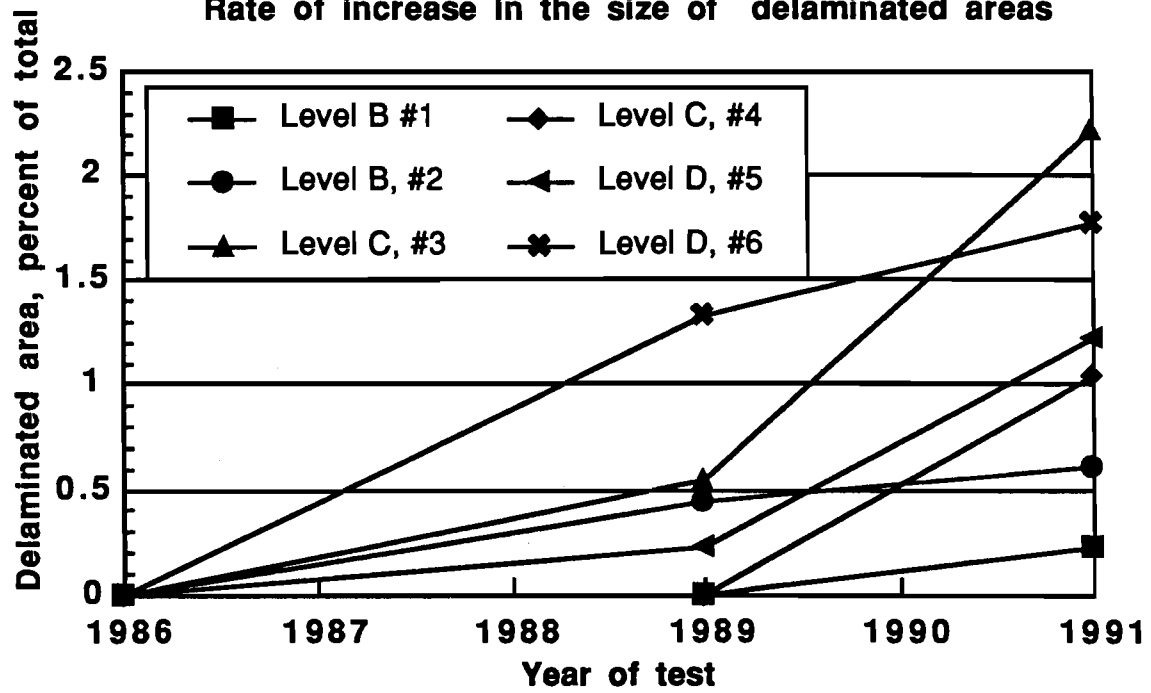
Fig. 29.1
Garage No.29.
Rate of increase in the size of delaminated areas

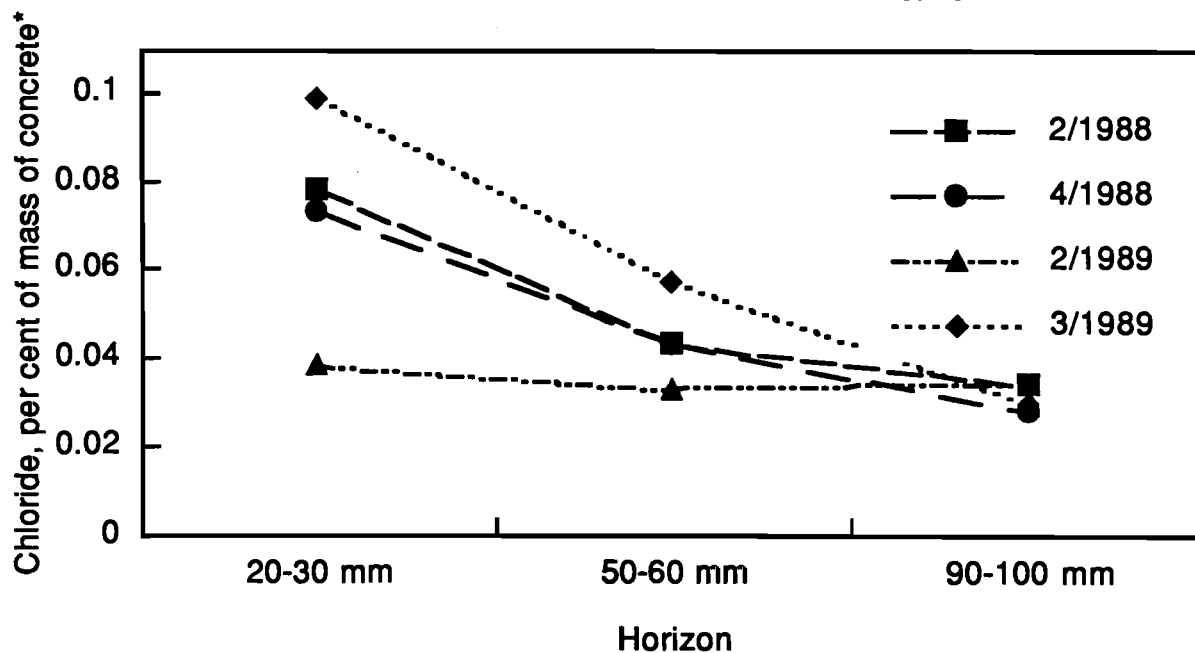
Fig. 51.1
Garage No. 51
Water soluble chlorid ion content

* Background chloride content is 0.030 %, an amount not available to act as a promoter of corrosion

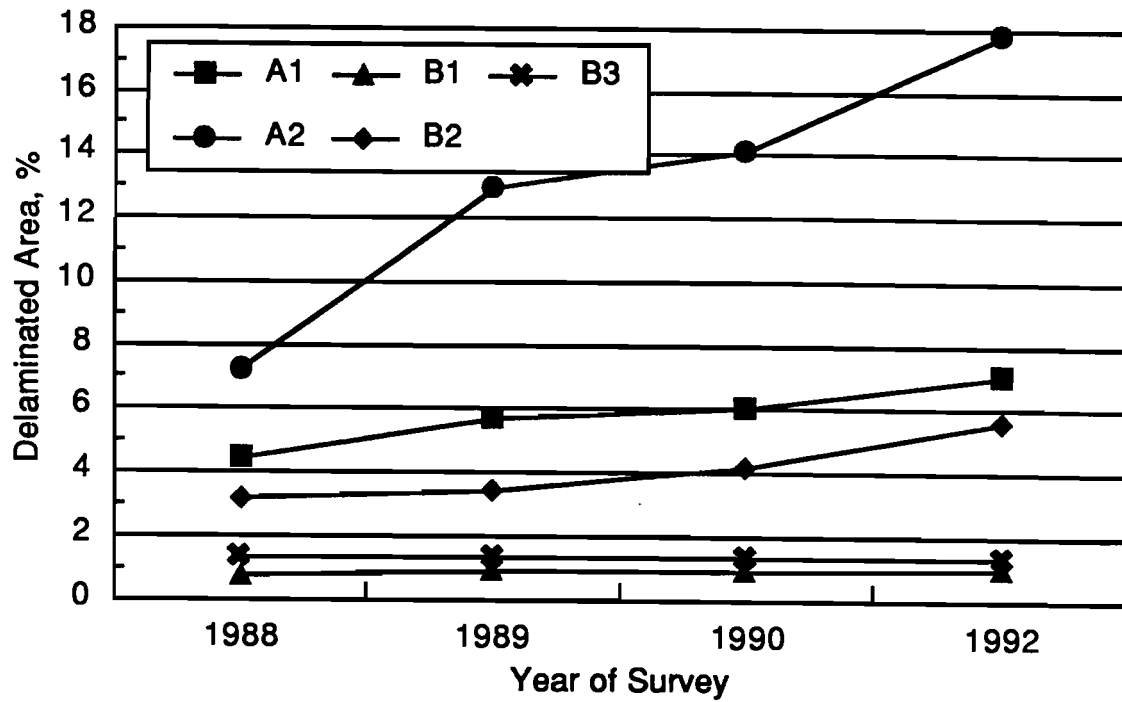
Fig. 53.1
Garage No. 53
Increase of Delaminated Areas of Surveyed Sections

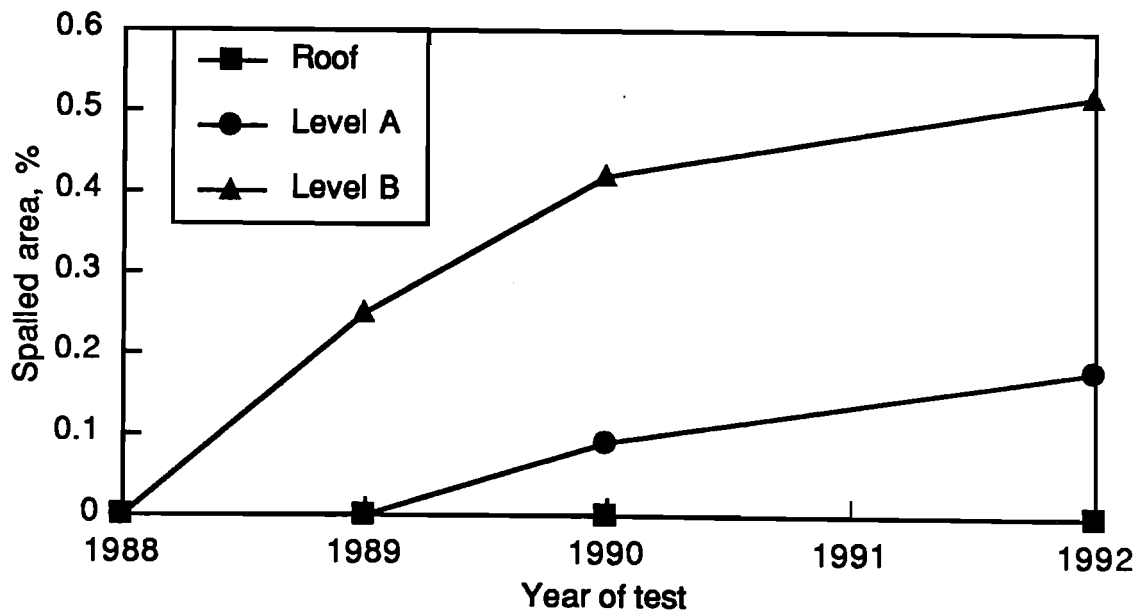
Fig. 53.2
Garage No. 53
Spalled areas of soffits of suspended slabs

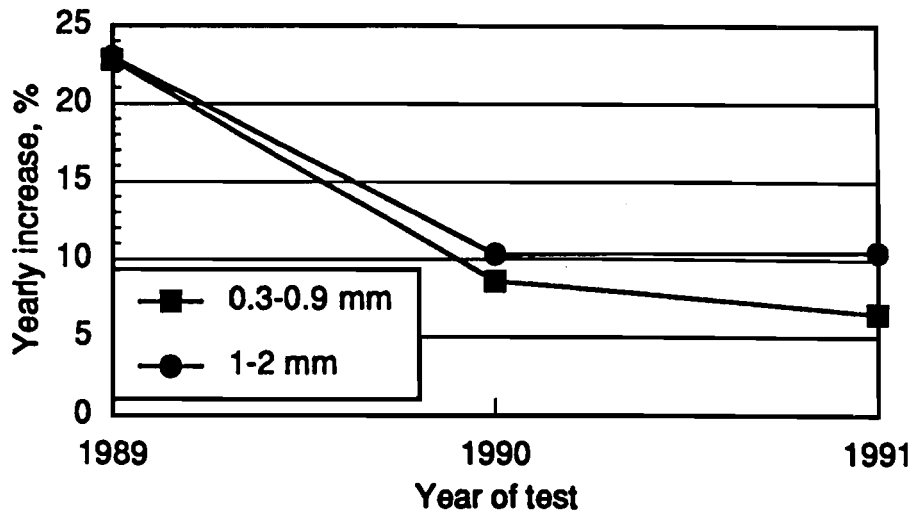
Fig. 55.1
Garage No. 55
Yearly increase of cracks,
of stated sizes, in soffit

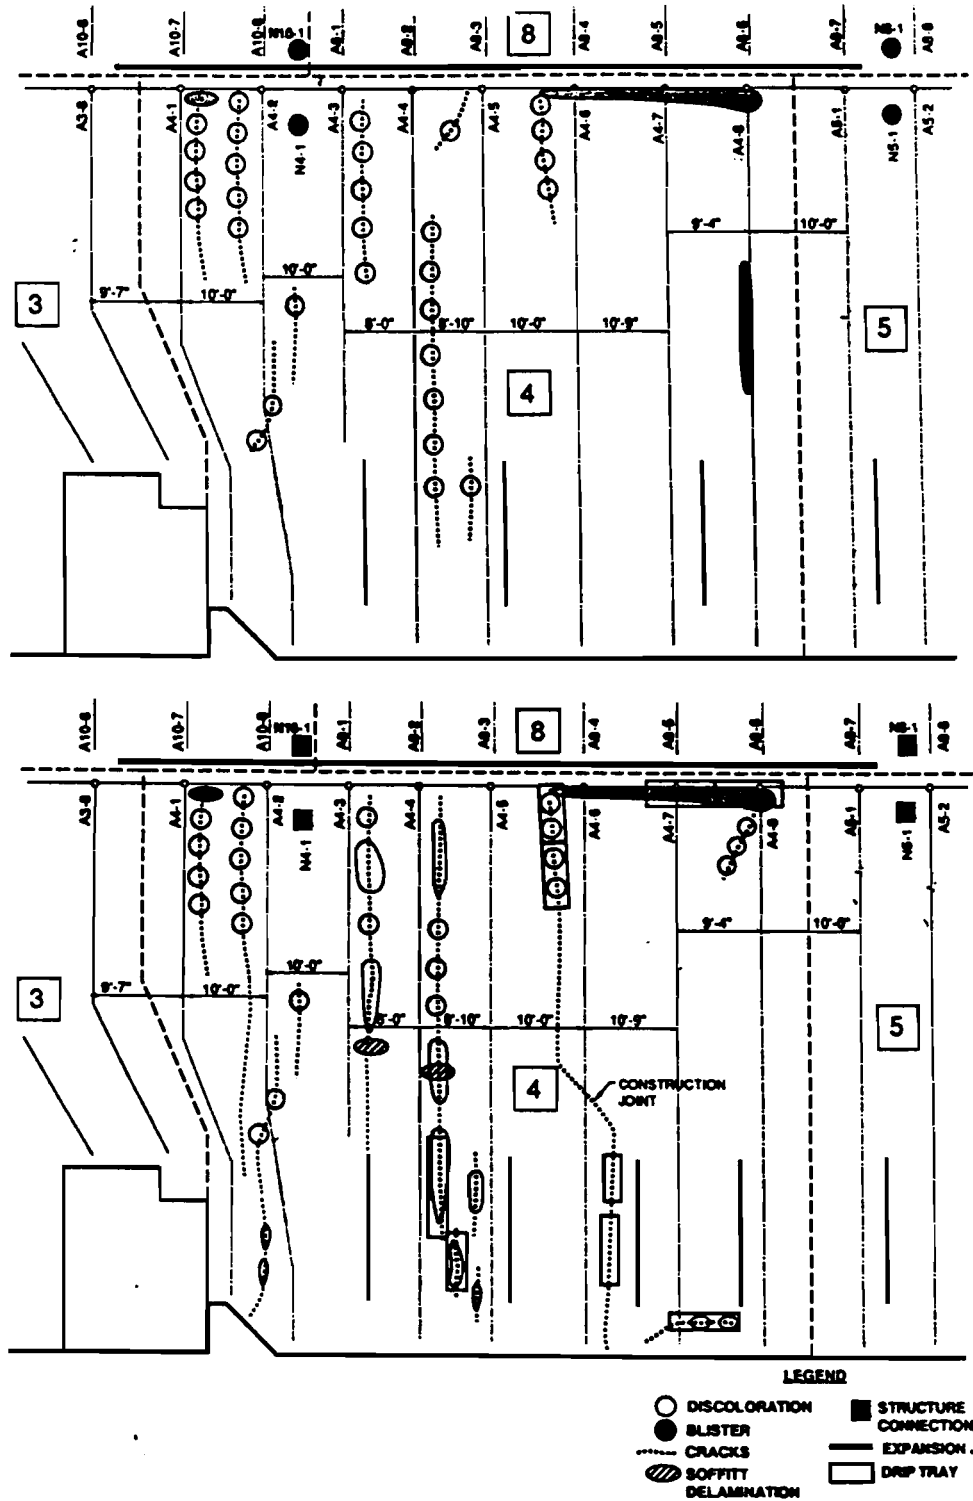
Fig. 57.2
Garage No. 57
Plan view of Section 4
in 1988 (top) and in 1991 (bottom)

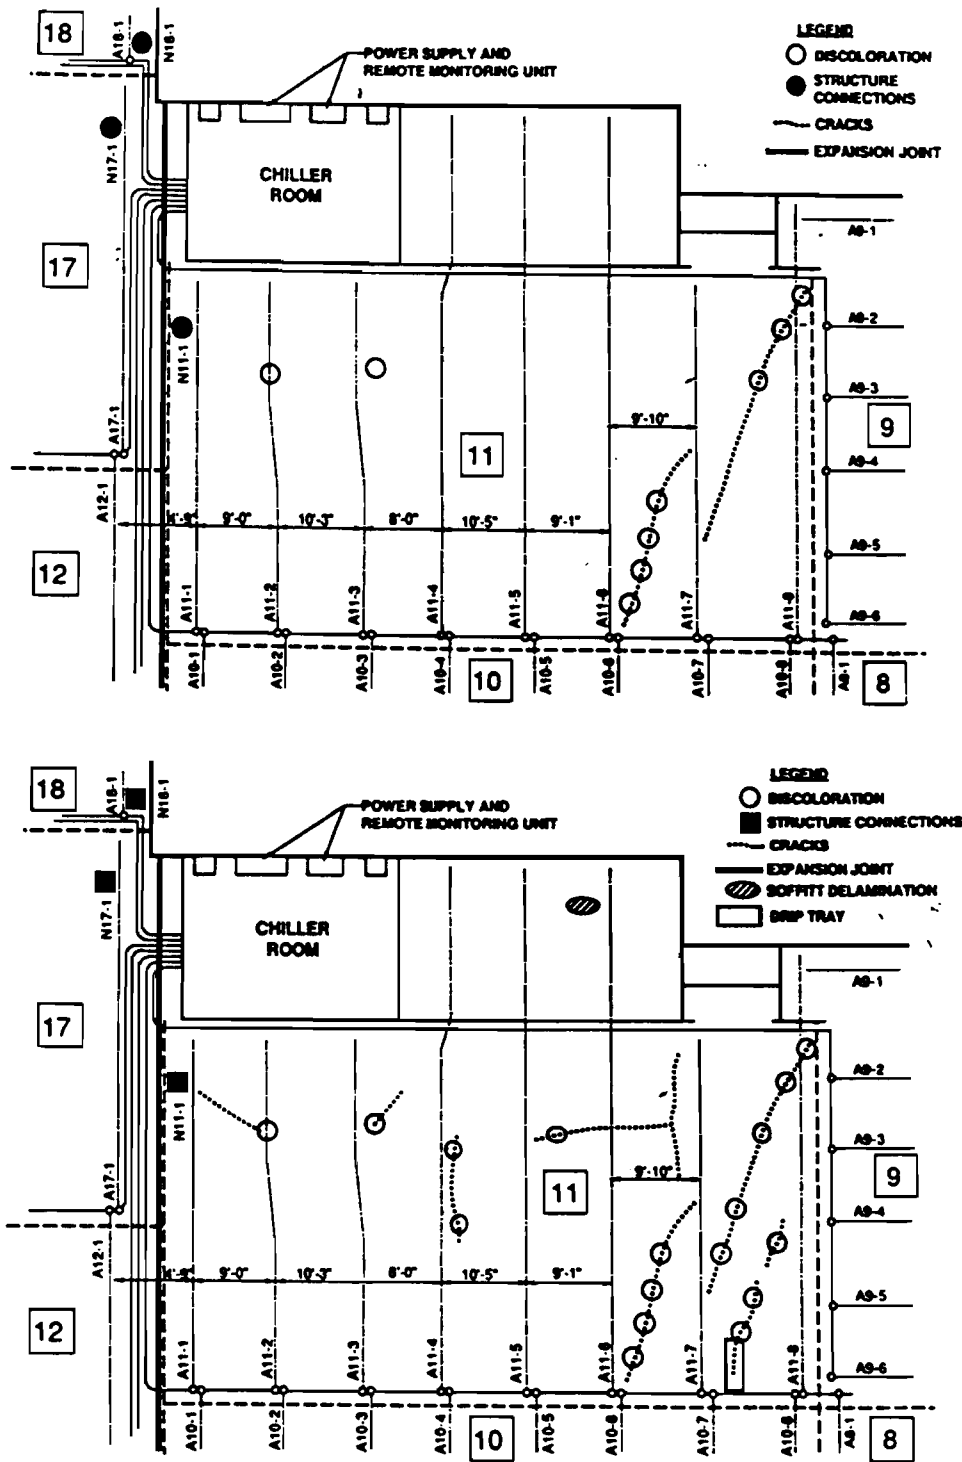
Fig. 57.3
Garage No. 57
Plan view of Section 11
In 1988 (top) and In 1991 (bottom)

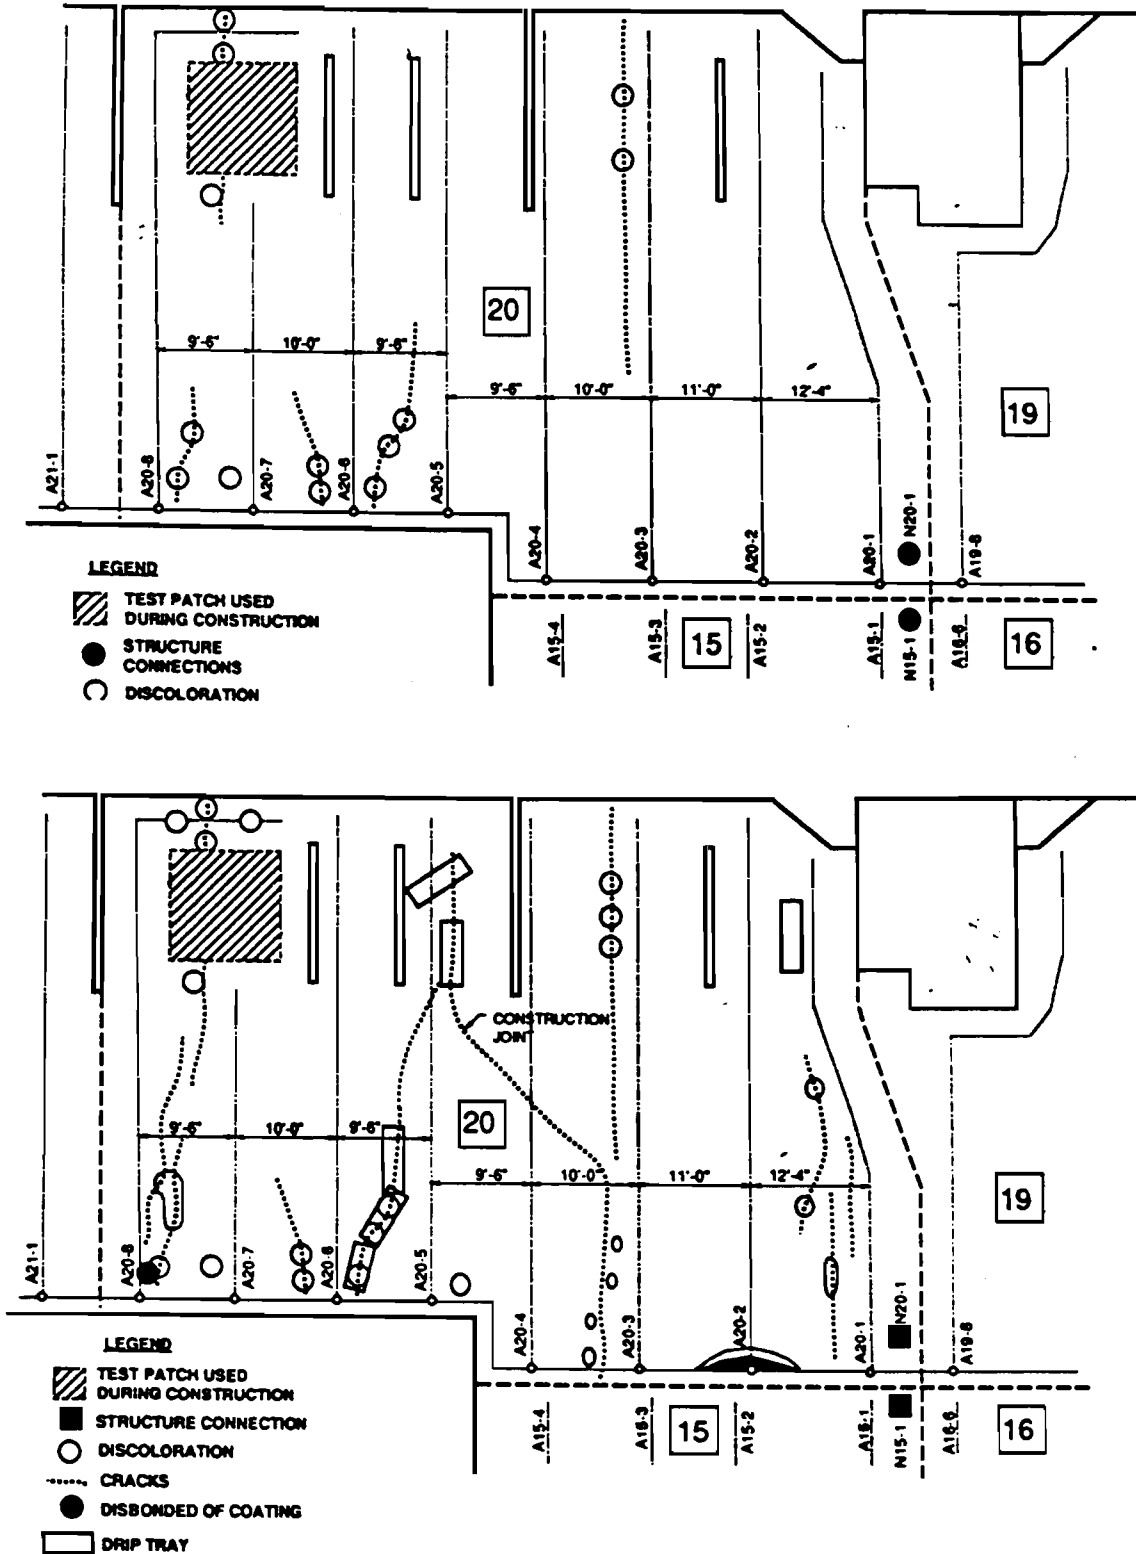
Fig. 57.4
Garage No. 57
Plan view of Section 20
In 1988 (top) and In 1991 (bottom)

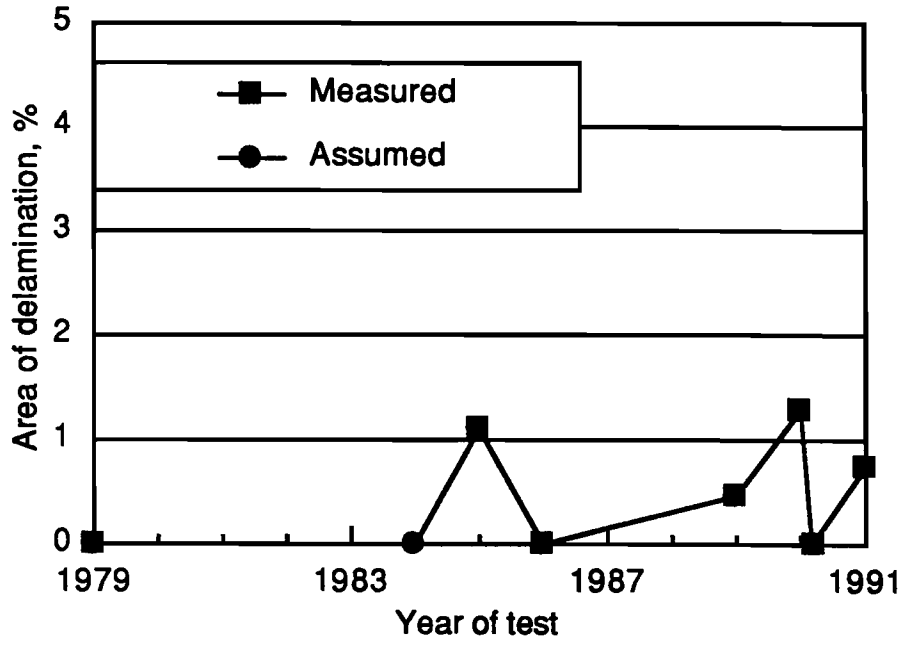
Fig. 58.1
Garage No. 58
Area of delamination

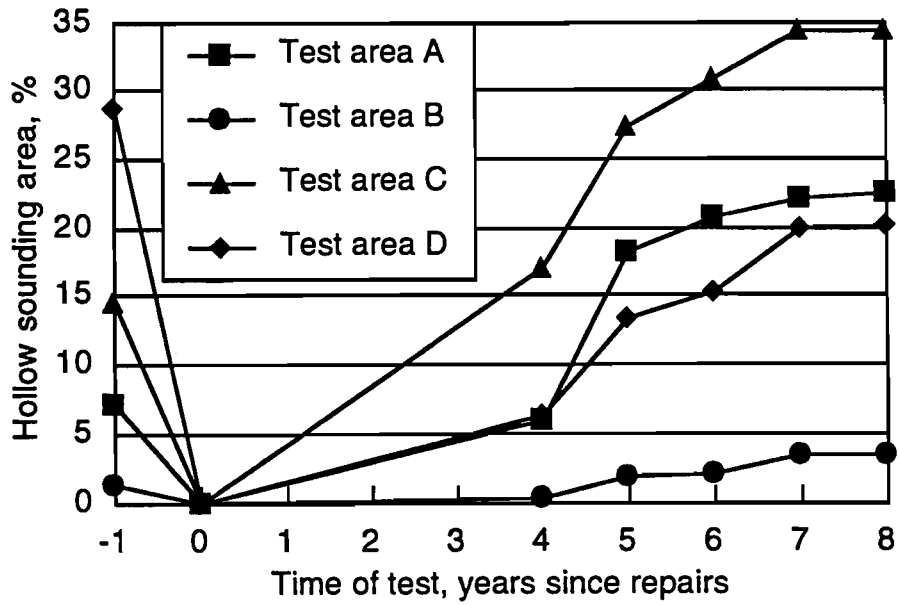
Fig. 64.1
Garage No. 64
Hollow sounding areas in test areas
detected by the chain drag test

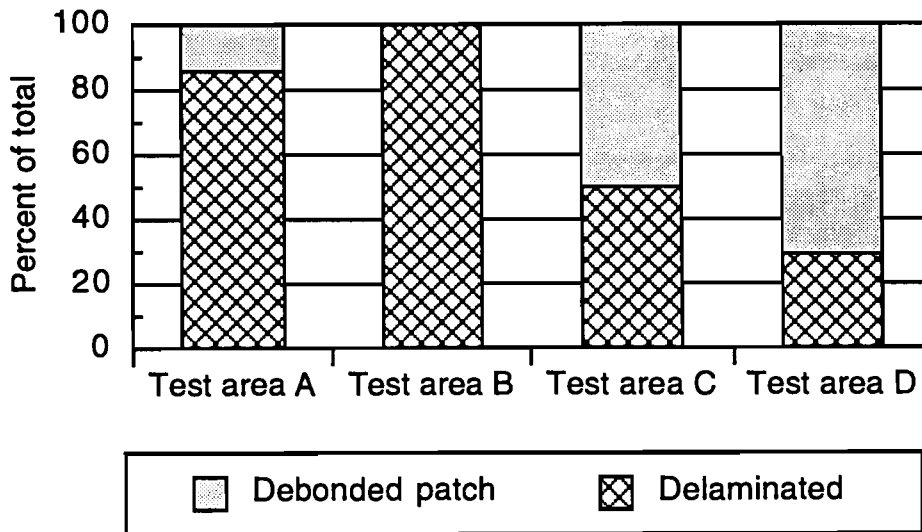
Fig. 64.2
Garage No. 64
Distribution of defects due to delamination and
debonding in cores extracted in the four test areas

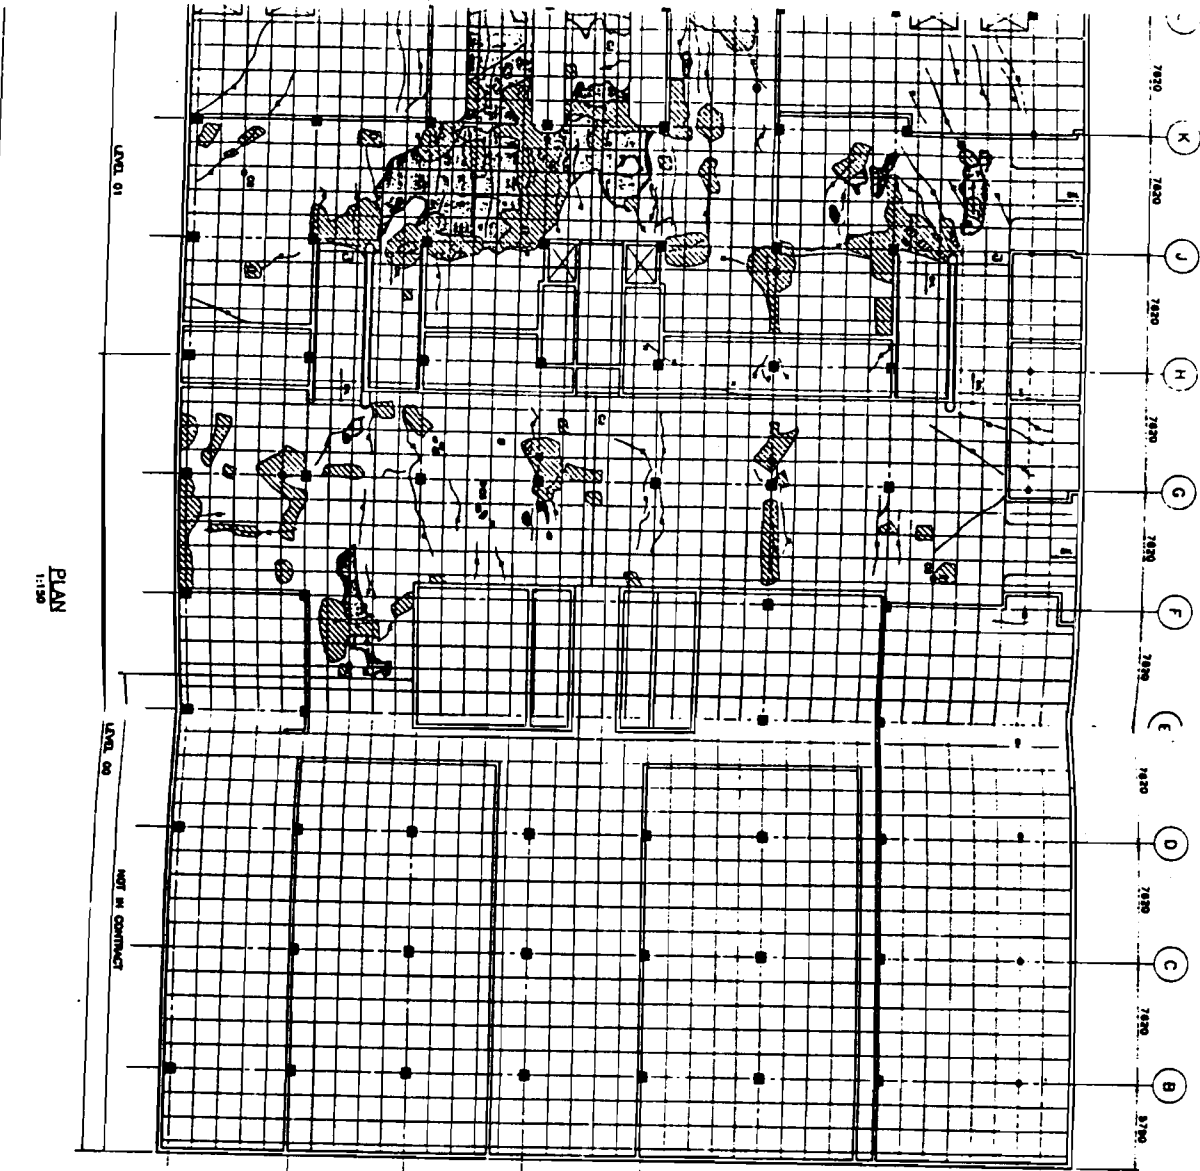
Fig. 74.1
Garage No. 74
Survey drawings, Level 01

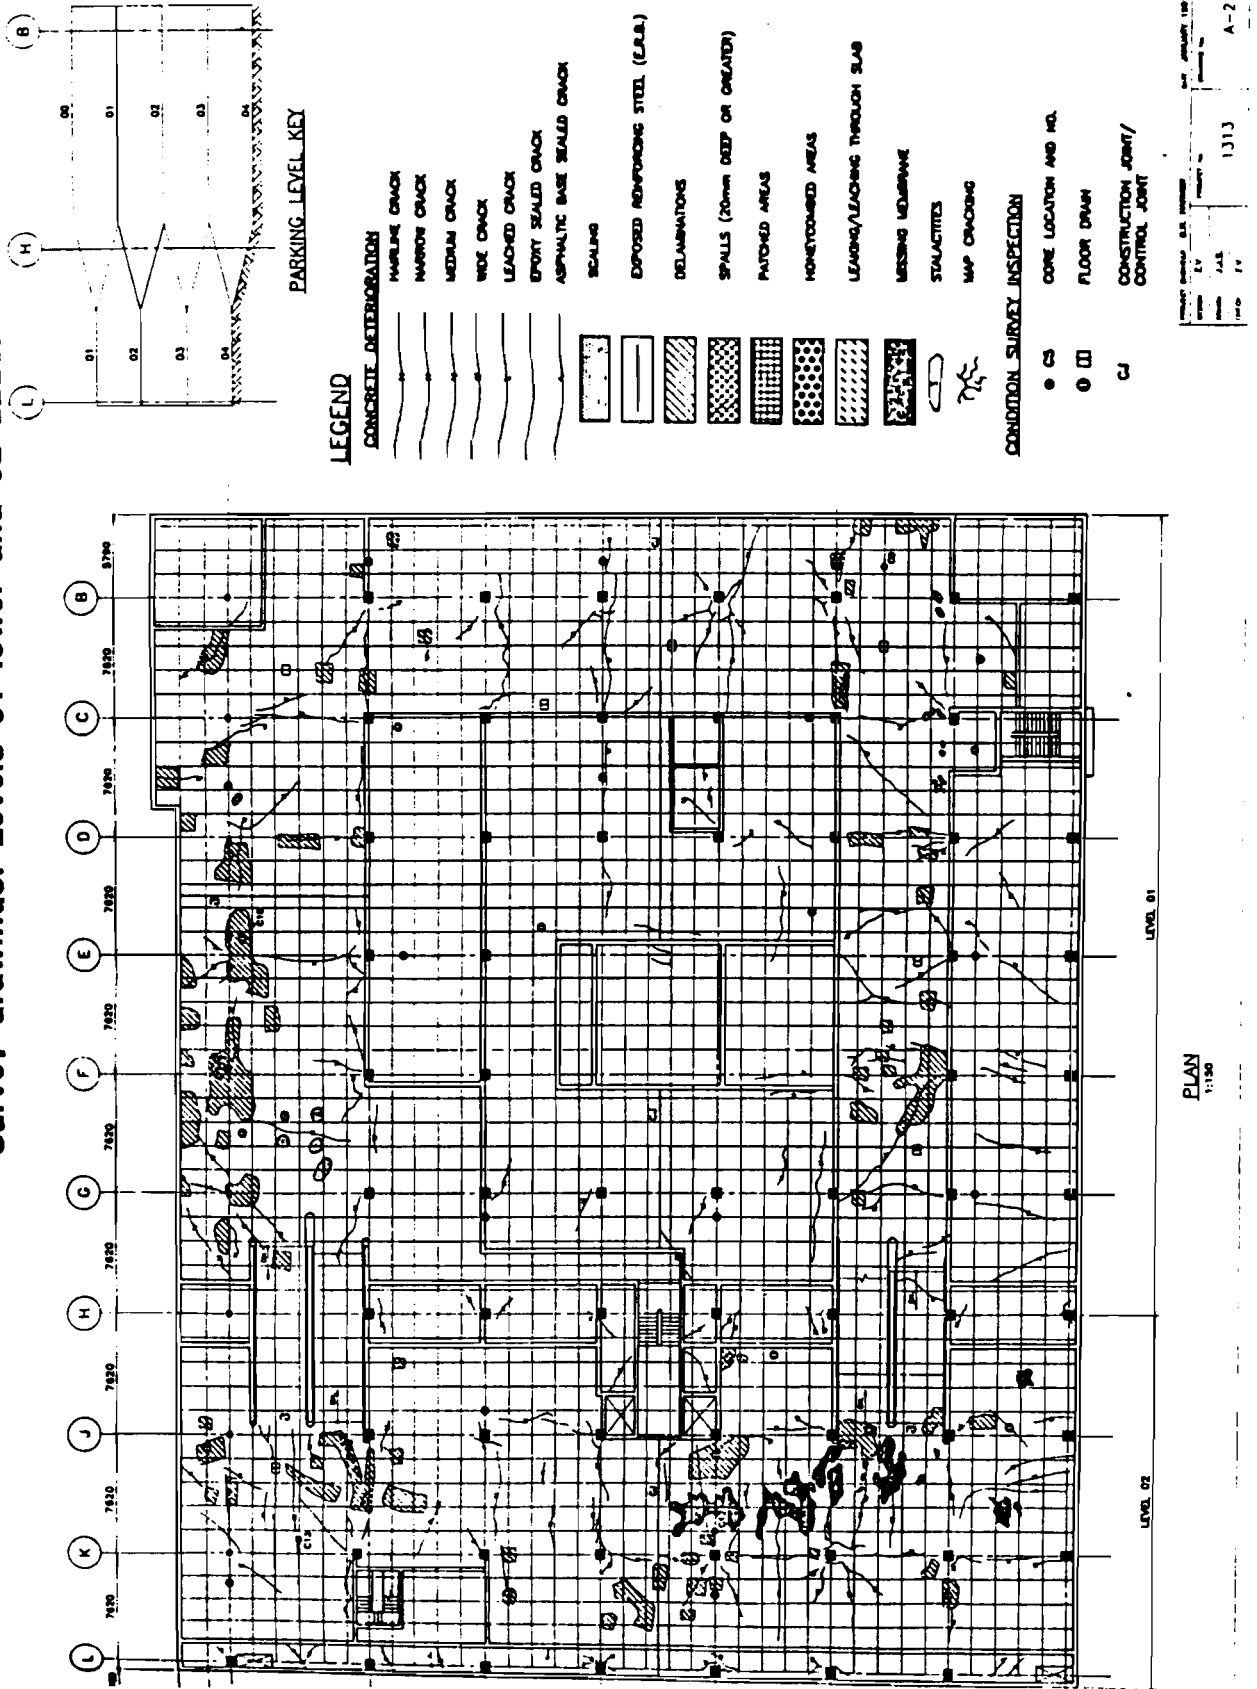
Fig. 74.2
Garage No. 74
Survey drawings. Levels 01 lower and 02 upper
