INVESTIGATING MOISTURE IN SEASONAL HOUSING

Abri Sustainable Design & Consulting

Final Report

15 November 2005

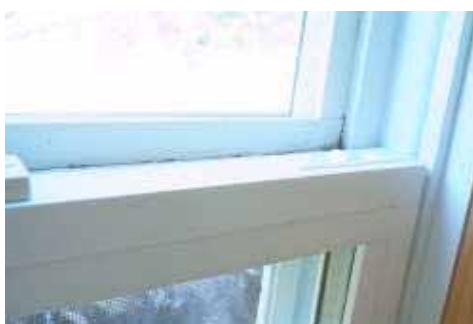
Interior: mold growth at rail of single hung window

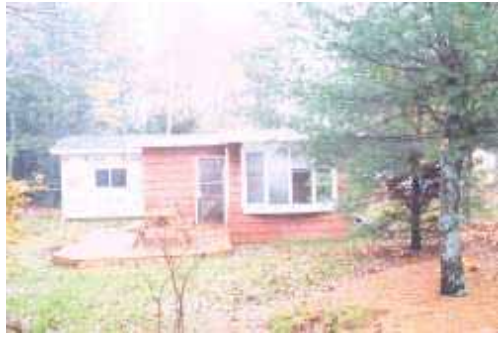
Ext: poor drainage @ flat roof, damage @ foundation Ext: poor detail @ grade Interior: condensation on all windows

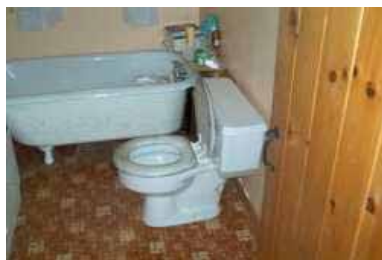
Interior: heavy mold growth in bathroom, on railing @ loft

The house had been uninhabitable for two years prior to the study because of high levels of mold. The pattern of mold growth was difficult to discern, initially, it seemed that there was no pattern at all. Closer inspection showed a definite 'tide line' on the sloped ceiling, almost directly in line with the railing of the loft.

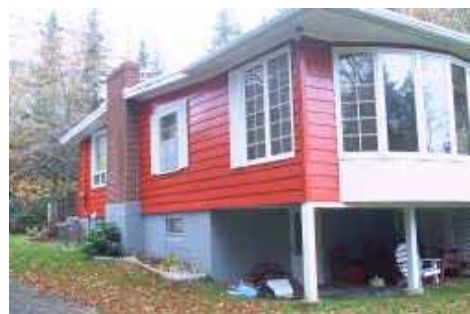
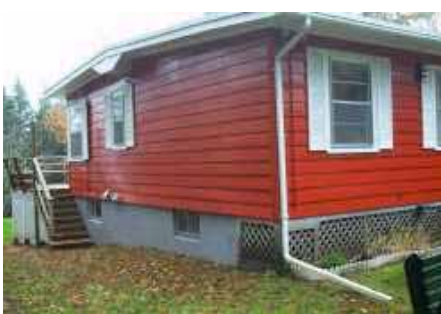
Exterior: right rear, shows walkout with poor drainage, left front shows rainwater leader in wrong position (should be at 90° from present position to drain away from house)

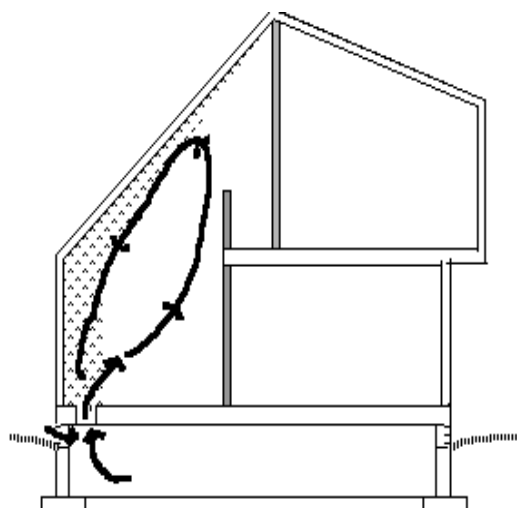
The cold exterior surfaces cool the interior air quickly, causing condensation on the interior sloped ceiling and wall surfaces

Cold air enters at the crawlspace vents.

The convection loop is strong, driven by the cold air from the crawlspace but is confined mainly to the 2 storey space that runs the length of the building

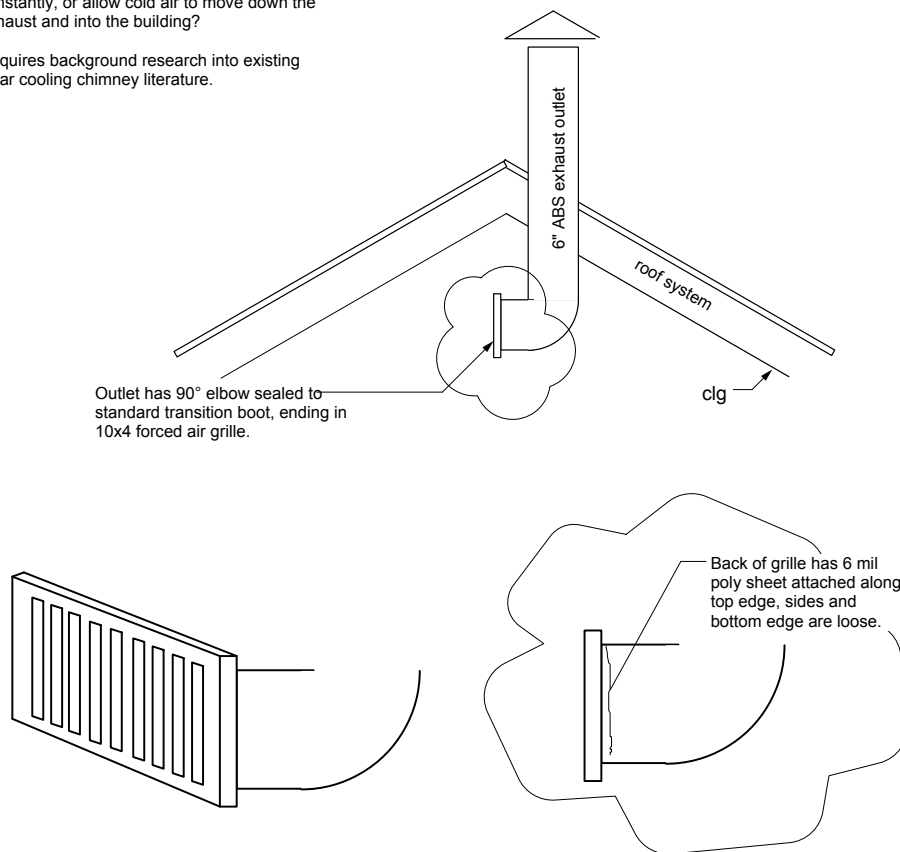
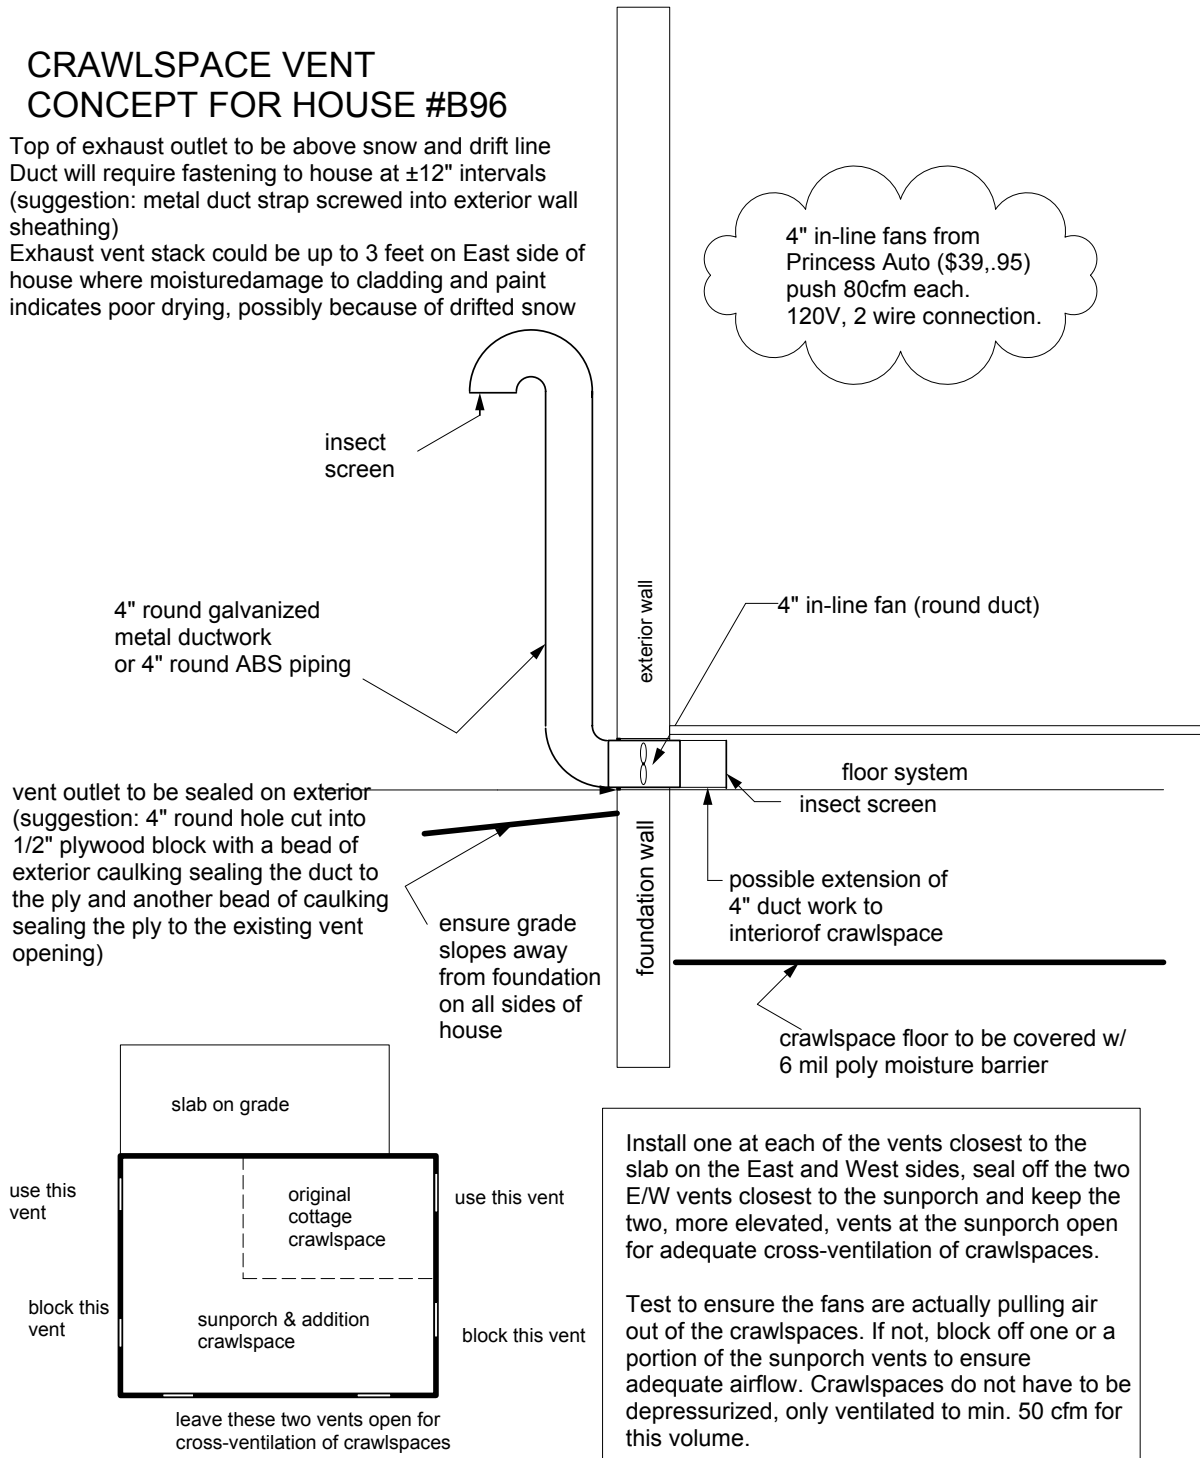
CRAWLSPACE VENT CONCEPT FOR HOUSE #B96

Top of exhaust outlet to be above snow and drift line
Duct will require fastening to house at $\pm 12"$ intervals
(suggestion: metal duct strap screwed into exterior wall sheathing)
Exhaust vent stack could be up to 3 feet on East side of house where moisture damage to cladding and paint indicates poor drying, possibly because of drifted snow

Exhaust outlet to be within 12" of highest interior point.
 Exhaust outlet to be 6" black ABS pipe, to take advantage of any extra solar gain available.
 Top of exhaust outlet to be 24" above peak to maximize 'chimney effect'.
 Exhaust outlet to have screen (1/4" wire mesh) and weather guard.
