RETROFIT ACOUSTIC TREATMENTS IN  
A HERITAGE APARTMENT BUILDING

**Hugh Williamson Associates Inc.**

**20 March 2004**

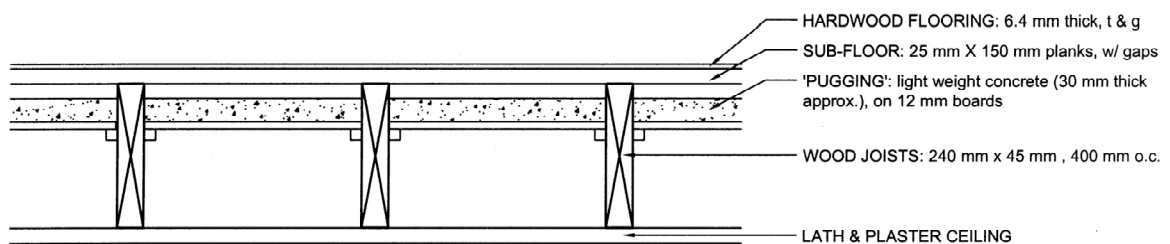
**Figure 3 Original Floor/Ceiling Construction**

- 6 mm ( $\frac{1}{4}$ " ) hardwood tongue and groove flooring.
- 25 mm by 150 mm (1" by 6") planking sub-floor, with approximately 3 mm ( $\frac{1}{8}$ " ) gaps between the planks.
- 240 mm by 45 mm (9.5" by 1.75") wood joists on 406 mm (16") centers.
- 'pugging': 12 mm ( $\frac{1}{2}$ " ) boards covered in approximately 30 mm (1.25") of light weight concrete set approximately 75 mm (3") below the top of the joists, see Figure 2. Note that the 'pugging' was not a solid continuous layer, i.e. holes and gaps were common.
- Lath and plaster ceiling.

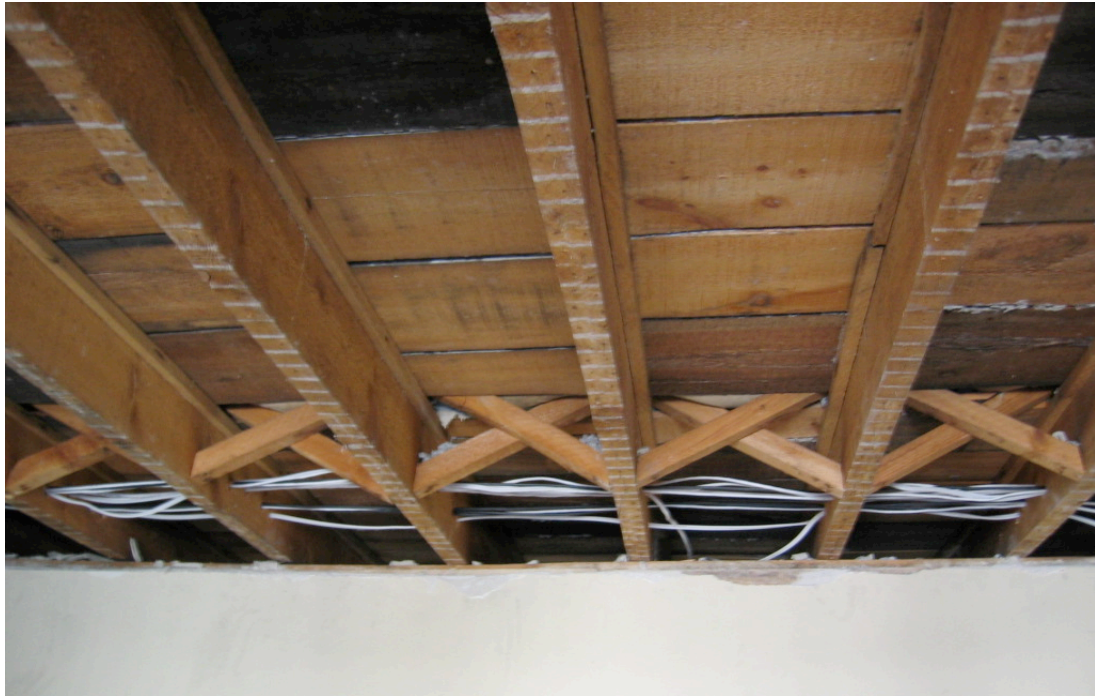
**Figure 4**      **Photo of Floor Joists in the Living/Dining Room  
with the Lath and Plaster Ceiling Removed**

Figure 4 is a photo of the floor joists and of the living/dining room viewed from below after removal of the lath and plaster ceiling.

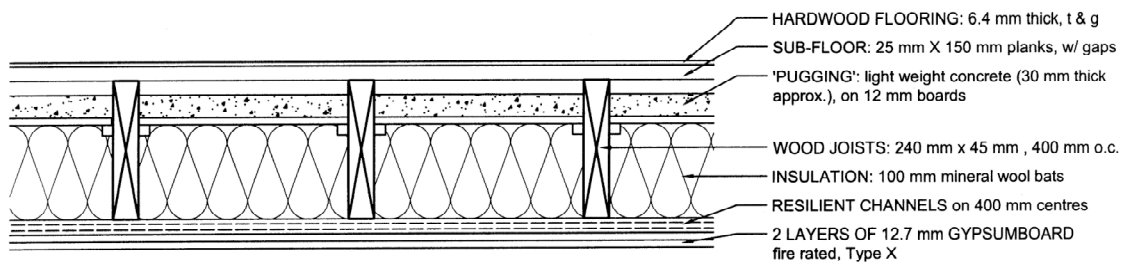
**Figure 5**      **Retrofit Floor/Ceiling Construction in the Living/Dining Room**

On the other hand the results in the living/dining room, FSTC 46 and FIIC 45 are considerably below the laboratory test result, and considerably below the results in bedroom 1 and 2. As the construction details of the retrofit were carefully executed, this suggests that there may be a major flanking path in the living/dining room which is preventing the achievement of higher acoustic insulation values.

It is well known<sup>2</sup> that leaving an existing ceiling in place, then adding one or two layers of gypsum board on resilient channels, leads to relatively poor acoustical results in terms of STC (Sound Transmission Class) or IIC (Impact Insulation Class). The small air space between the old ceiling and the new gypsum board leads to a close acoustical coupling and poor sound isolation, especially at low frequencies. It was considered that the optimal treatment would be the complete removal of the lath and plaster ceiling prior to installing batt insulation, then installing the resilient channels and two layers of gypsum board. This was the retrofit which was applied to the living/dining room ceiling as shown in Figure 5.
