Radon Mitigation Planning Inspection
and Mitigation System Installation

On behalf of
Health Canada - Radiological Impact Section
And
Canada Mortgage and Housing Corporation

ARTHUR SCOTT AND ASSOCIATES

Fixing Houses with High Radon— A Canadian Demonstration

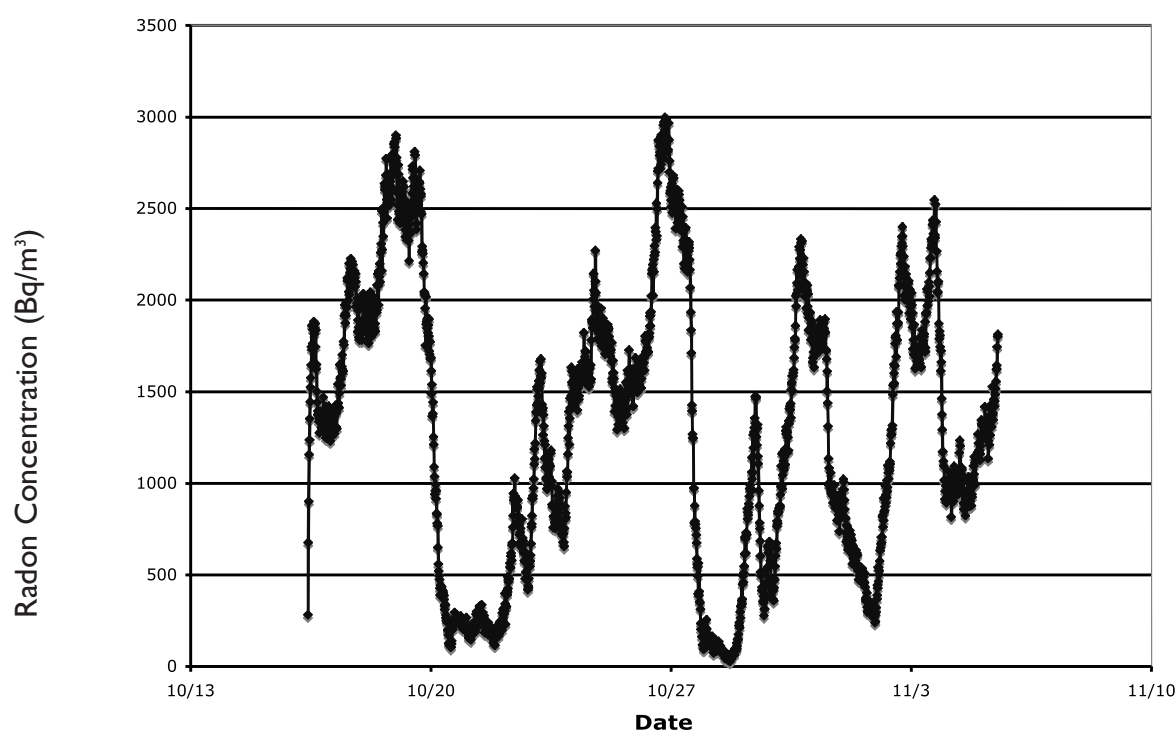
Figure 1 Continuous radon monitor trace, October–November, 2007

A homeowner in the community of Kanata in western Ottawa contacted CMHC and Health Canada for advice on high radon concentrations he had measured in his new house. Figure 1 shows almost a month of radon readings from his basement. Note that the concentration fluctuates due to house operation, climate factors, and so on. A short reading of two days duration could give a reading as low as 150 Bq/m³ (for example, Oct. 28) or as high as 2,700 Bq/m³ (Oct. 19). For that reason, *Radon: A Guide for Canadian Homeowners* recommends that houses be tested for at least one month.

Averaged over the test period, the homeowner's results were in the order of 1,400 Bq/m³, considerably in excess of either the new or old guideline. The basement had a poured concrete floor and walls, and was not remarkably different from neighbouring houses. It had a slab poured on polyethylene sheeting, which should reduce the radon entry rate.

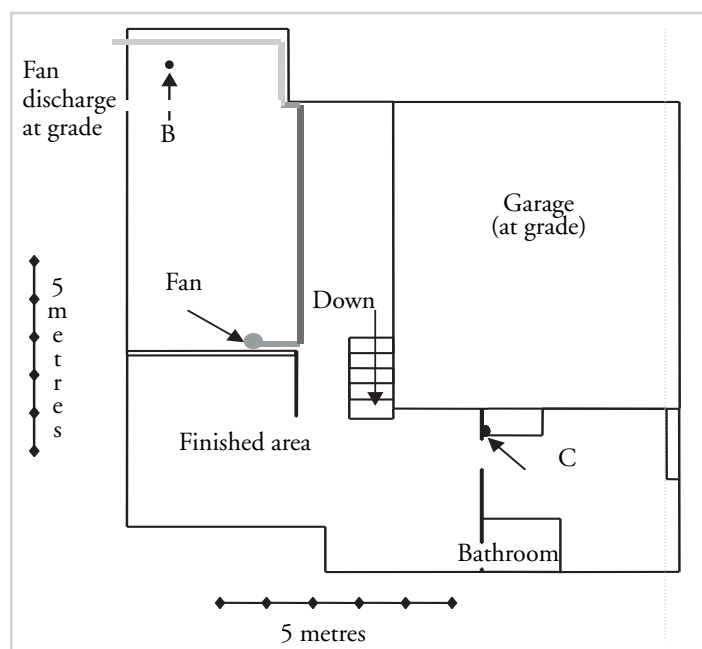
Figure 2 Installed fan and piping layout

The exhaust fan discharged the sub-slab air at grade and not at roof level, as recommended by the United States Environmental Protection Agency (EPA). This was due to concerns regarding the possible condensation and ice build-up problems within vertical vents on the outside of houses in cold Canadian climates. The project team felt that, if re-ingestion of the exhausted radon through windows, doors or other envelop leakage points in the vicinity of the exhaust fan discharge point was a large factor, the post-mitigation test would show high levels of radon inside the house. The radon concentrations were measured for a month in the winter following installation of the system. Figure 2 shows the basement, the location of the measurement holes (B, C), and the fan and ducting system.

During the commissioning of the system, the fan flow was not quite high enough to make a consistent depressurization at the test holes B and C shown in Figure 2. This was cause for some concern, but it was decided to run the fan for a month and monitor its effectiveness before looking for a way to increase fan flow.

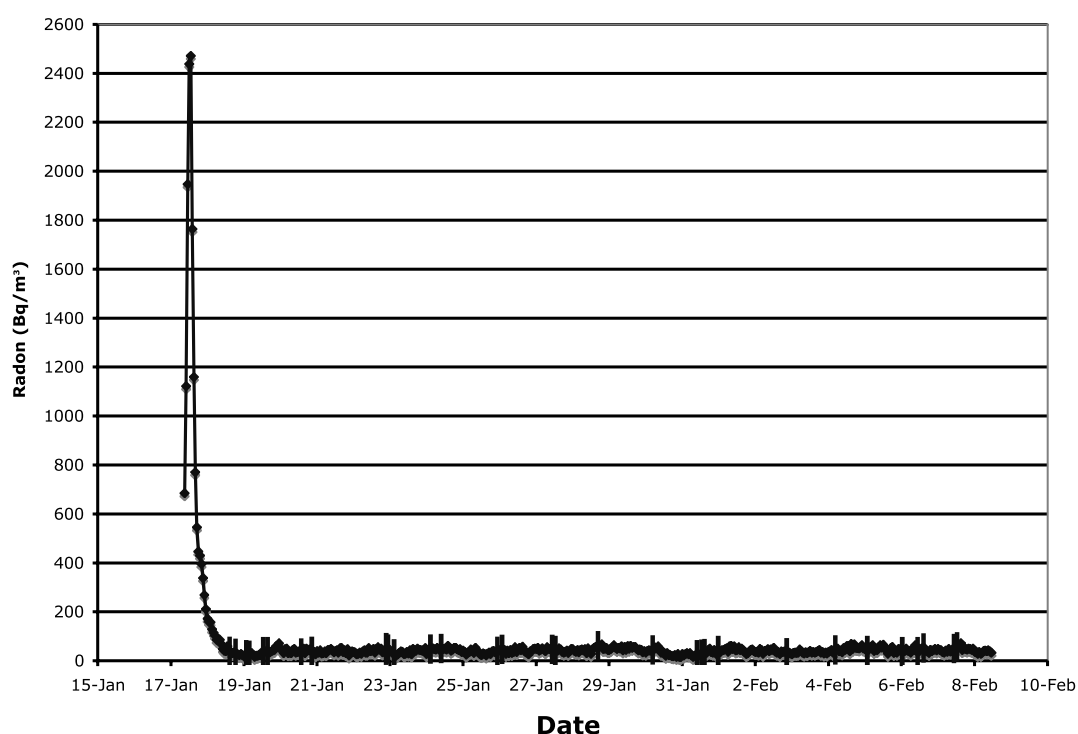
Figure 3 Continuous monitor trace during and after mitigation

The system was remarkably effective (see Figure 3). Radon concentrations dropped from an average of 1,400 Bq/m³ to about 40 Bq/m³ for the month following, significantly below the HC 200 Bq/m³ guideline. The homeowner was happy with the installation of the system and with the results. Re-ingestion of the exhausted radon was not a significant factor in this location during this period.

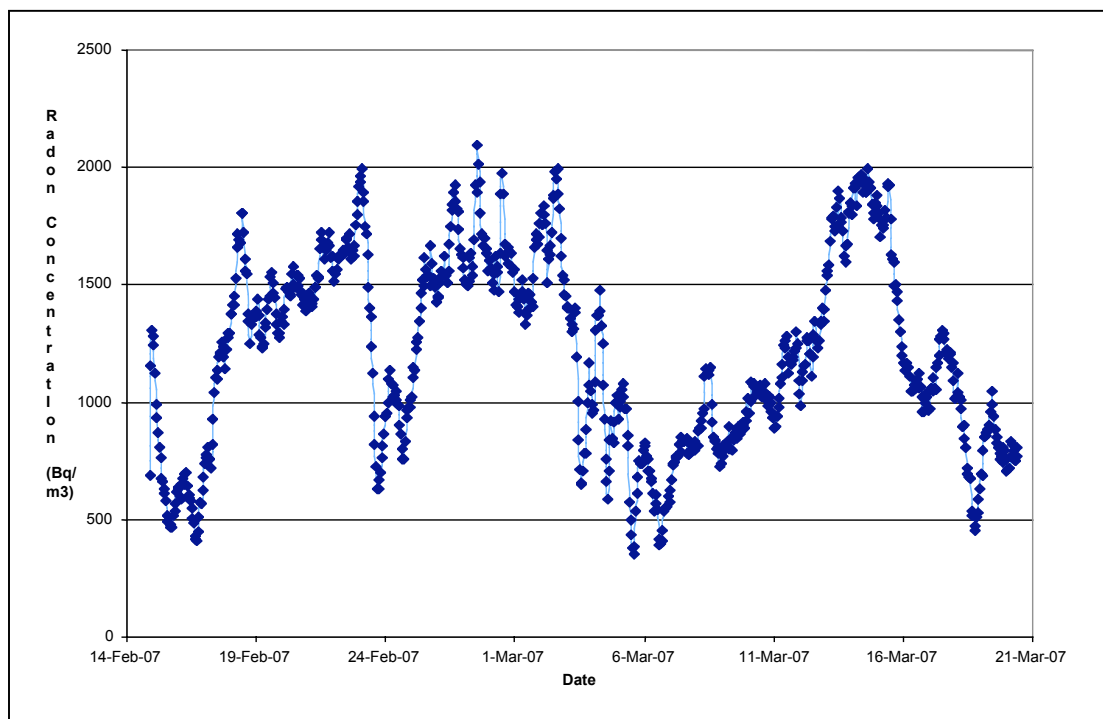
Figure 1 Continuous Radon Monitor trace February – March 2007

The owner of this house purchased an electronic radon meter, and found elevated radon levels. He contacted Health Canada, who made further measurements with a continuous radon monitor, (Pylon AB4), and radon concentrations were found to vary between 500 to 2000 Bq/m³ in February-March 2007, and from 50 to 3000 Bq/m³ in October-November 2007. The average value was about 1400 Bq/m³. The monitor traces are shown in the Appendix as Figure 1 and Figure 2.

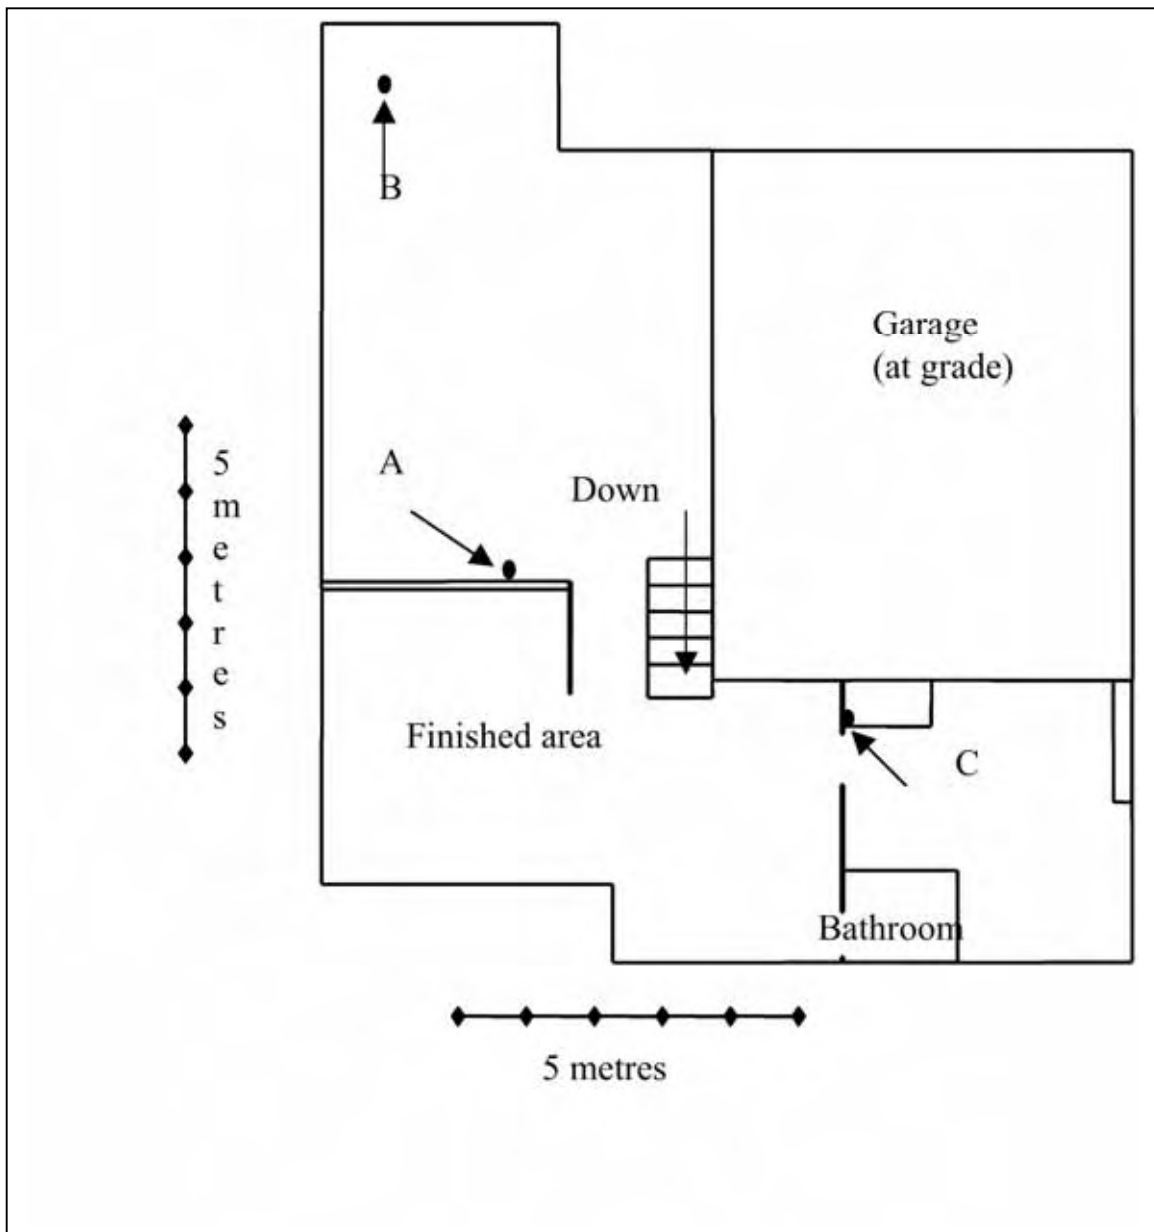
Figure 3 Basement Layout

A review of the basement layout suggested that a sub-slab exhaust fan in the unfinished utility room adjacent to the frame wall between the utility room and finished area might be able to effectively depressurise the entire basement slab. A possible fan location was about 50 cm from the frame wall and 100 cm from twin teleposts on the centreline corner. This would avoid the telepost footing. The location is shown as A on Figure 3.

The carpet was peeled back in a corner of a closet in the finished area, and a 9.5 mm diameter test hole drilled there. This is shown as location C on Figure 3 Basement Layout. A probe down the hole found the slab was ~10 cm thick, poured on a plastic sheet, with ~10 cm of coarse aggregate beneath.

The long and wide floor crack suggests that there has been major slab shrinkage, and the (concealed) wall/floor joint may be several mm wide, and provide little resistance to airflow.
