## Performance Monitoring of a Brick Veneer/Steel Stud Wall System

SUBMITTED BY: KELLER ENGINEERING ASSOCIATES INC.  
1390 PRINCE OF WALES DRIVE, SUITE 107  
OTTAWA, ONTARIO  
K2C 3N6

REPORT DATE: JUNE 4, 1993

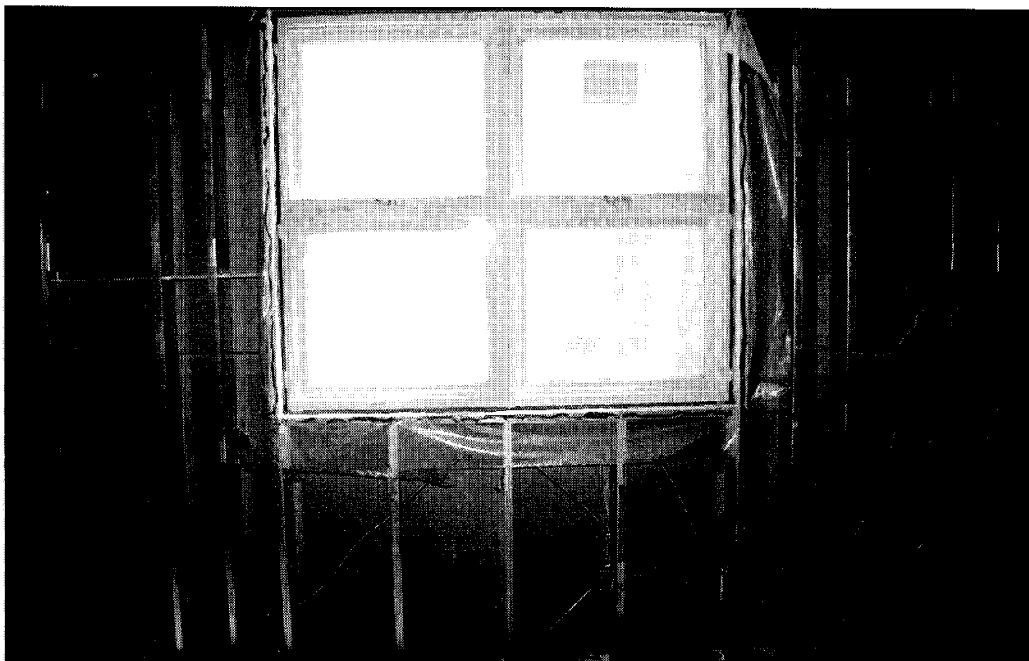
2 Interior view of typical steel stud arrangement at window opening. Note that the designer opted to use single studs at the window but that the spacing of the studs was gradually reduced.

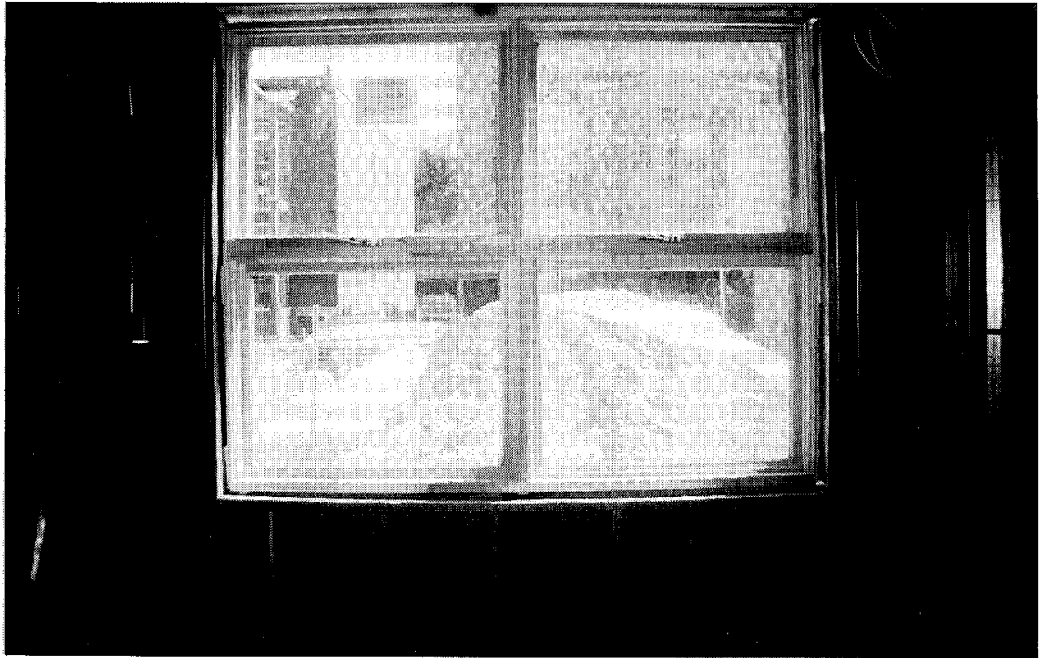
- 3 In this location, double studs were used at the window opening

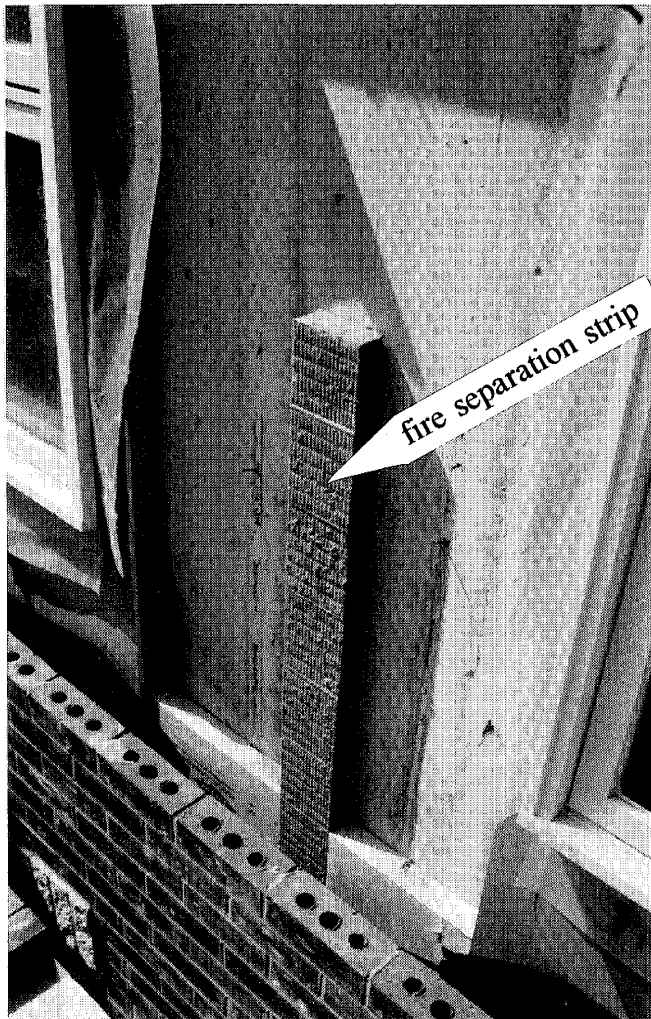
- 8 Showing use of rigid insulation at column locations. Note vertical fire separation strip.

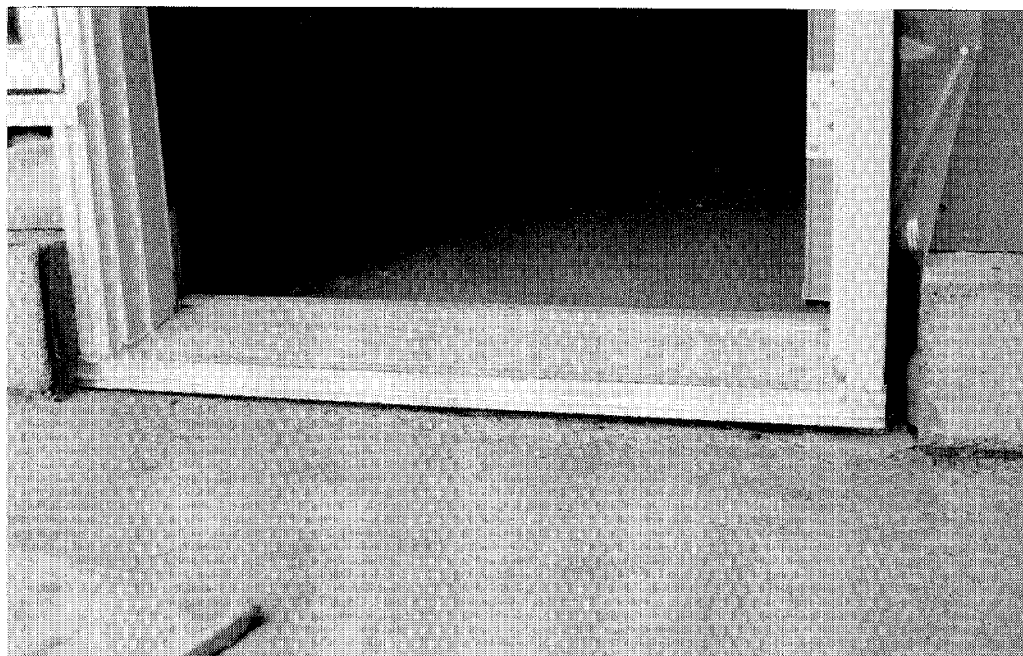
- 9 Showing example of poor balcony door detail. Note absence of curb. The gap below the door threshold is merely sealed with a bead of caulking which is prone to deterioration and ongoing maintenance.

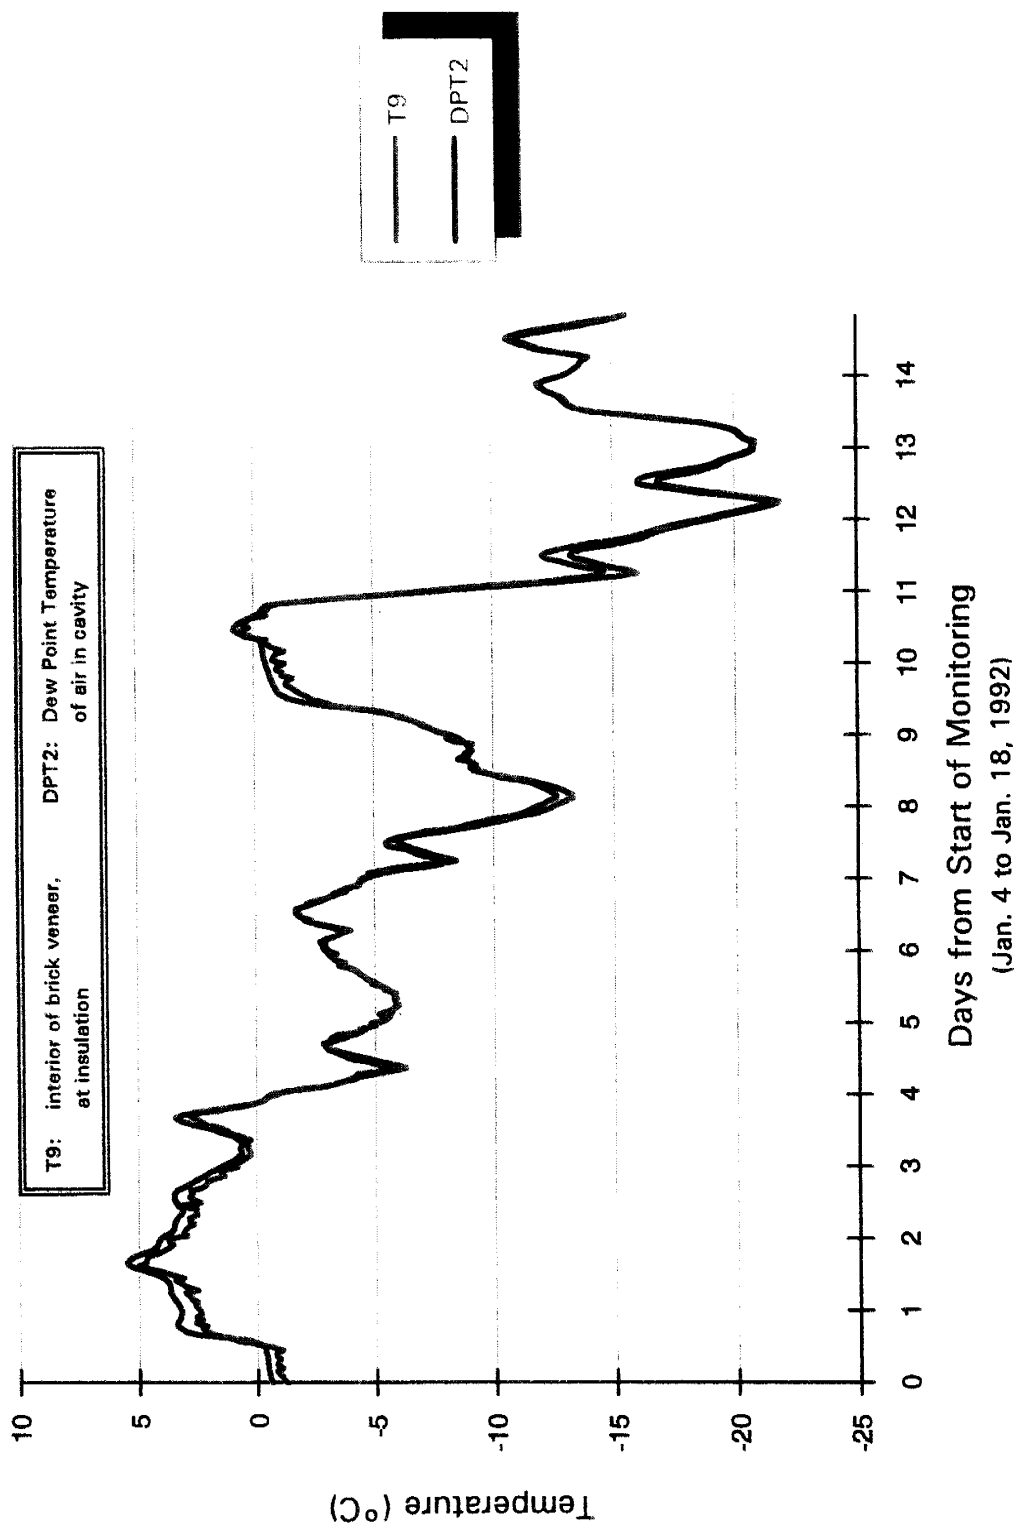
Fig. 9 Comparison of Surface Temperature on Interior Face of Brick Veneer to Dew Point Temperature of Cavity Air

Tables 2 to 7 show that the hourly average relative humidity in the cavity ranged from about 70% to nearly 100% for all monitoring periods except for the summer period. However, at similar air temperatures, the relative humidity of the exterior air was often much lower than that of the air in the cavity. This indicates that moist air is not easily vented from the 25 mm air space. Experience indicates that a wider air space would have provided better venting of the cavity, since wider air spaces are less likely to be clogged with mortar protrusions and droppings that impede air movement in the cavity. In reviewing the data files, it was observed that the dew point temperature of the air in the cavity is often much higher than the dew point temperature of the exterior ambient air (since humidity levels are high, regardless of the air temperature in the cavity). In addition, the temperature on the interior surface of the brick is often lower than the dew point temperature of the air in the cavity, particularly at exterior temperatures near or below 0°C (Fig. 9). Therefore, the monitoring work indicates that condensation regularly occurs on the interior surface of the brick masonry veneer. In addition, condensation regularly occurs on the brick ties and occasionally on the exterior surface of the exterior gypsum board sheathing.

Experience has shown that this condition could be detrimental when the interior surface of the brick falls below freezing temperatures. The resultant freeze/thaw action could cause significant deterioration of the interior surface of the masonry, a condition which is of particular concern since much deterioration may occur before it is evident on the exterior face of the masonry wall. The main concern with back spalling is that the brick masonry will deteriorate to the point that it is no longer adequately supported by the brick ties although the exterior face of the brick veneer may show little or no distress. If this condition goes undetected, sudden failure of the masonry wall could occur. While the above situation represents an extreme case, back spalling can lead to major brick replacement work as the masonry distress may not become evident on the exterior until much deterioration has already occurred. Condensation within the cavity is of concern since this condition can also lead to corrosion and eventual failure of brick ties.

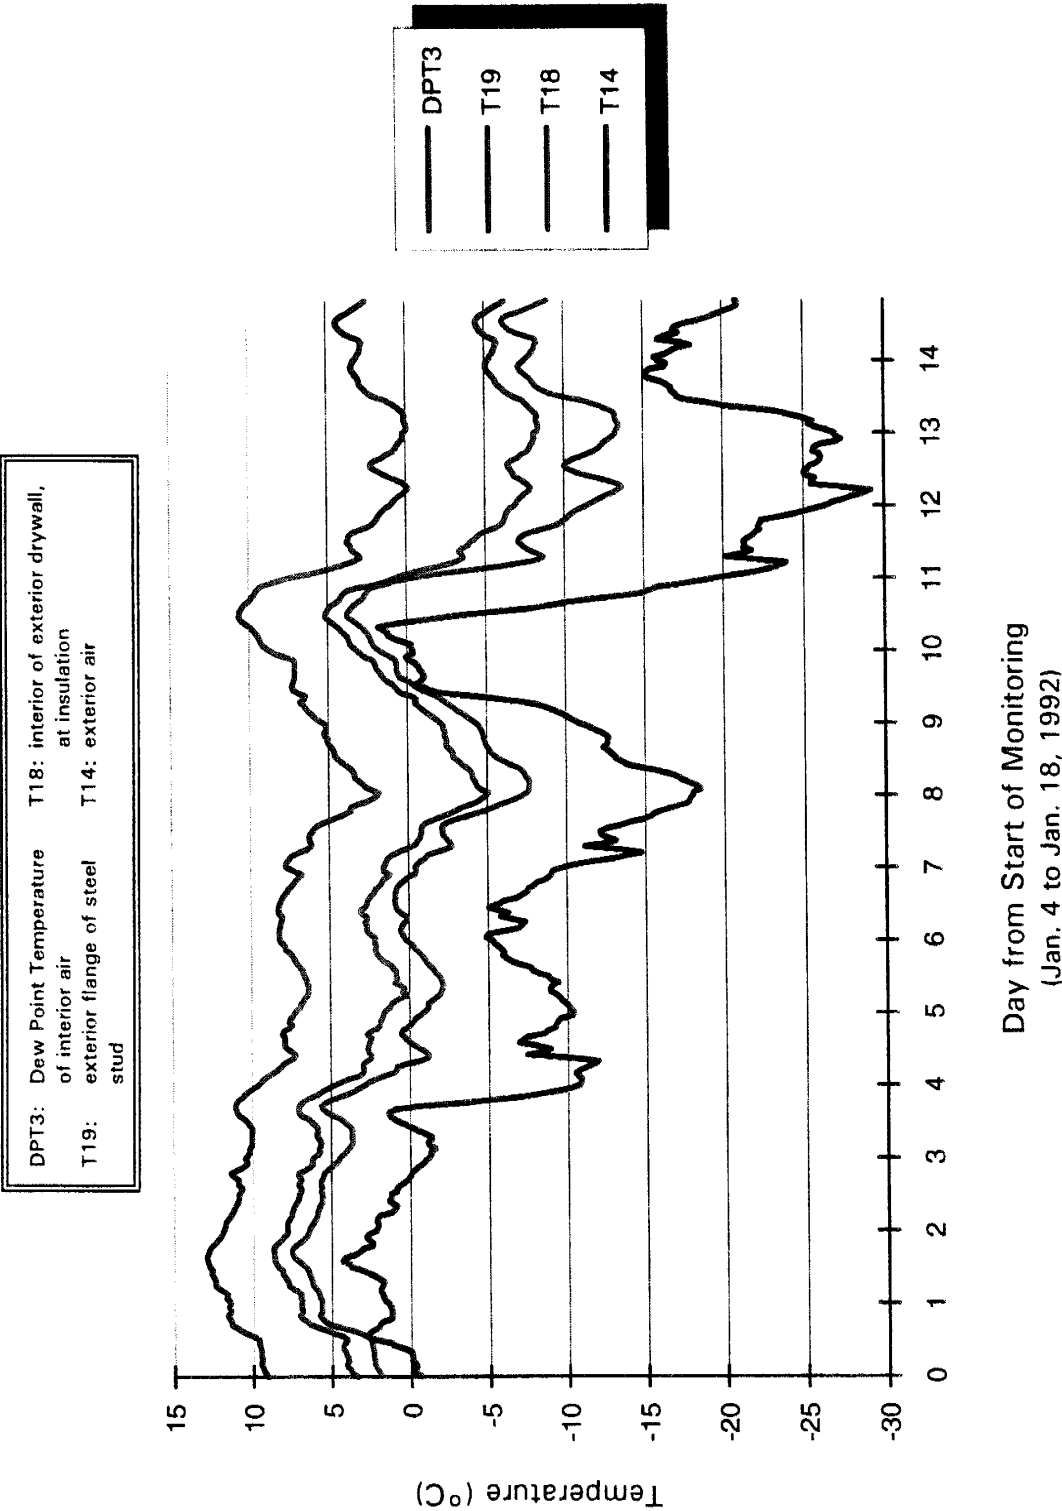
Fig. 10 Comparison of Surface Temperatures at the Exterior Drywall to the Dew Point temperature of the Air in the Stud Space

In comparing the dew point temperature of the air in the stud space to the surface temperature on the interior of the exterior gypsum board, it was observed that minor condensation generally occurs on the interior surface of the exterior gypsum board at exterior temperatures of about 0°C or less (Fig. 10). The 2.5 Volt (or nearly so) readings on the condensation sensor during monitoring periods with colder weather confirm that condensation regularly occurs on the interior surface of the exterior drywall. In comparing the dew point temperature of the interior air to the surface temperatures within the stud space, it is obvious that any moist interior air which escapes into the wall space will condensate within the wall (Fig. 11). The above findings demonstrate that minor amounts of condensation will likely occur within most steel stud walls that lack exterior insulation. Therefore, the walls should be designed such that condensation which forms in the stud space and travels down to the bottom track can be drained from the stud wall rather than being trapped in the bottom track where it can cause significant corrosion over the long term. The test wall was not specifically designed to allow moisture accumulations to drain from the stud wall and, therefore, there is a potential for corrosion of the bottom tracks over the long term. In addition, the above findings provide further evidence that exterior insulation should be used to keep temperatures within the stud space as high as is reasonably and economically achievable.

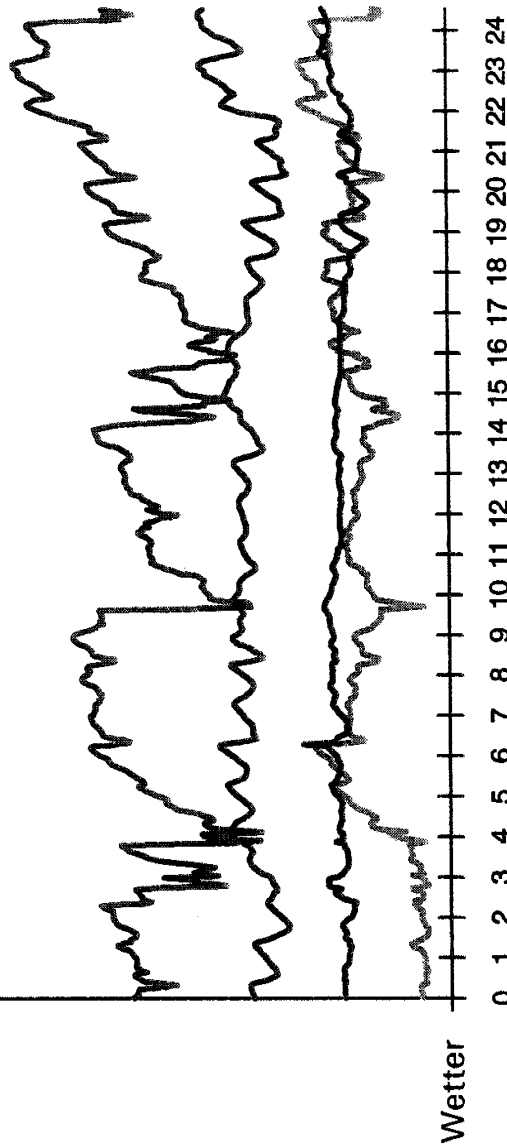
Fig. 12 Comparison of Wetness Levels at Different Monitoring Points on the Brick Veneer

The wetness of the brick surface at monitoring points M1, M2, M3 and M4 is shown in Figs. 12 and 13 for the April 1991 and January 1992 monitoring periods, respectively. Note that the electrical resistance moisture sensors in the test wall were not calibrated to determine the specific moisture content in the brick. Therefore, the readings indicate relative wetness. Higher resistance readings are obtained when the brick is drier and, conversely, lower readings are yielded when the brick becomes wetter. Figs. 12 and 13 indicate the degree of wetness for the monitoring points. Note that during freezing temperatures, freezing of water in the brick will result in higher readings, giving a false indication of the brick being drier and, therefore, this point must be kept in mind when analyzing the data.

The weather during April 6 to 30, 1992 was relatively dry, with only occasional rain or snow. Exterior air temperatures were generally above 0°C and, therefore, the data collected during this period is considered reliable. In Fig. 12, the graphs of M2 and M4 indicate that the degree of wetness on the interior face of the brick is fairly consistent when the wall is not subjected to significant exterior sources of moisture. The data also indicates that wetness levels are consistently higher near the roof level than at the fourth floor slab. The data also indicates that, at the floor slab level, the interior face of the brick veneer is generally wetter than the exterior face of the brick, even during most of the rainy weather. One reason for the higher moisture levels on the interior brick face may be from condensation which forms on the interior of the brick veneer, since the surface temperature of the brick consistently was nearly identical to the dew point temperature of the cavity air in April 1991.

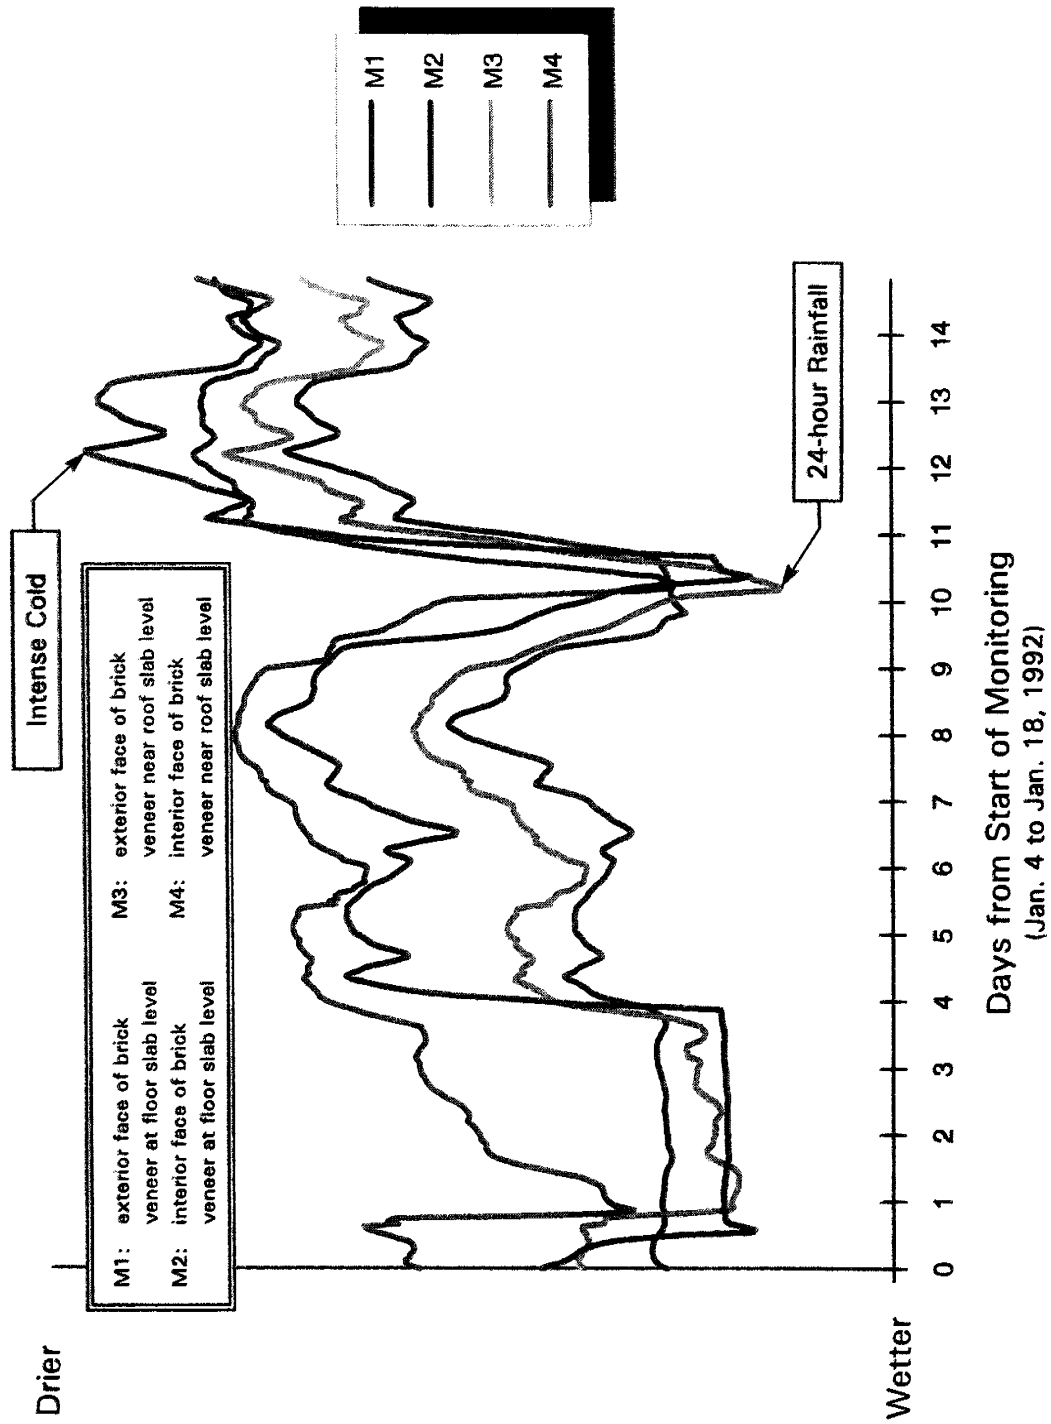
Fig. 13 Comparison of Wetness Levels at Different Monitoring Points on the Brick Veneer

Immediately following the major rain storm, a cold front moved in, dropping temperatures to  $-30^{\circ}\text{C}$  within 40 hours of the rain storm ending and within 30 hours of the snowfall ending. Therefore, the moisture in the brick veneer froze. The high electrical resistance values shown in Fig. 13 illustrate how the moisture sensors provide inaccurate results in freezing conditions, as discussed above, since the data indicates that the brick has dried out considerably whereas it is very likely that the moisture is frozen in the brick.

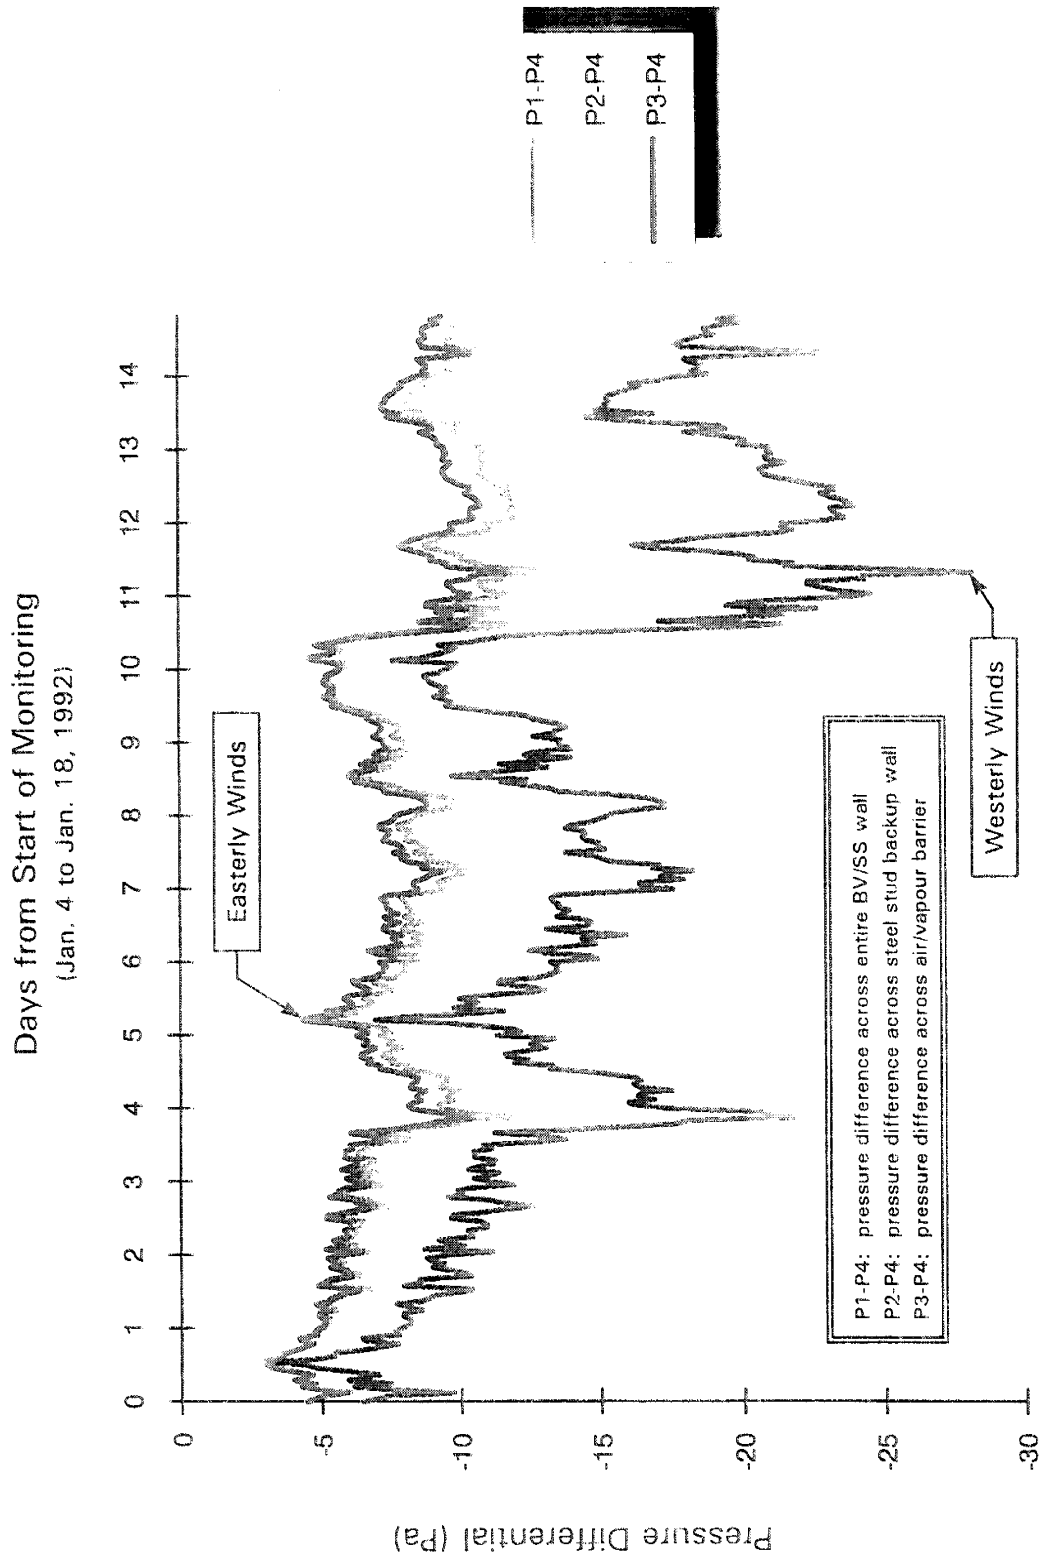
Fig. 14 Hourly Average Pressure Differentials Across Test Wall

Fig. 14 illustrates that the pressure differential between the cavity air and the exterior air (P1-P2) varies significantly depending on wind conditions. During easterly winds, the magnitude of all pressure differential values are reduced as positive wind pressures partially counteract the negative pressure differentials caused by building pressurization. The simultaneous increase in pressure on the exterior and within the cavity illustrates that pressure equalization does occur to some degree and that both the brick veneer and the backup wall are affected by wind pressures, and thus resist, wind loads.

The magnitude of P1-P2 not only indicates that pressure equalization is not fully effective. This data also indicates that air leakage occurs through the air barrier since air leakage partially "releases" pressure on the air barrier. In order to examine air leakage on its own, pressure differences across the test wall are plotted against the ratio of the temperature difference across the insulation to the temperature difference across the entire wall (i.e.  $\Delta P$  is plotted against the ratio of  $T_{\text{cavity}}$  minus  $T_{\text{exterior}}$  to  $T_{\text{interior}}$  minus  $T_{\text{exterior}}$ ). If no air leakage occurred, then the above temperature ratio would be relatively constant regardless of the pressure difference across the test wall. However, the temperature ratio for the test wall decreases slightly as the pressure difference increases, indicating that air leakage does occur through the air/vapour barrier system. While it appears that only minor air leakage occurs, air exfiltration does contribute to the high water vapour levels in the cavity which lead to condensation on the brick veneer and exterior sheathing.
