Monitoring the Performance
of an EIFS Retrofit on a 15 Storey
Apartment Building, Toronto, Ontario

FINAL REPORT

**Monitoring the Performance
of an EIFS Retrofit on a
15 Storey Apartment Building**

Toronto, Ontario

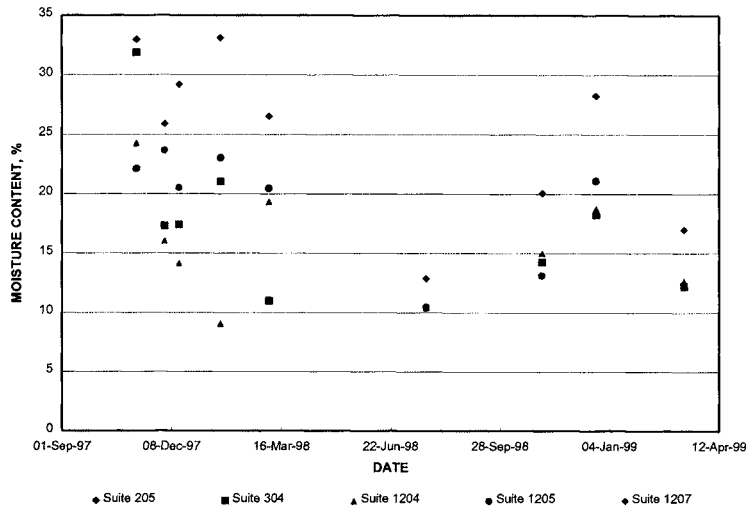
As seen in Figure C1, the moisture content measured under the exterior finish at each suite is generally higher than 15%, although it is noted that the only summer reading

is lower than 15%. These results are consistent with an assembly that is experiencing high local moisture levels, and it is postulated that some exterior moisture penetrates the exterior finish. None of the rain gauge events correlated to a change in the moisture content from the duff gauges, although this may be in part due to the time interval between the rain pulse and the duff gauge reading. It is speculated that the penetrating moisture is vapour since Duff gauges fail after exposure to liquid water.

Figure C1. Moisture content measured by Duff gauges to the interior of the lamina for all suites.

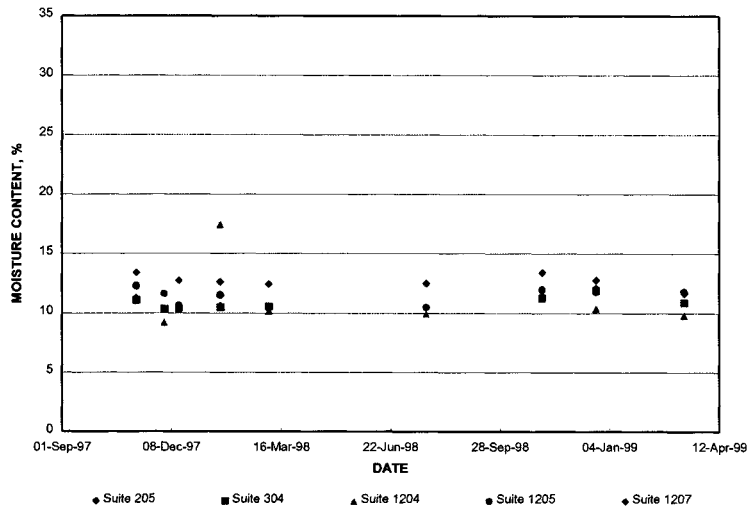
In contrast to the measurements under the exterior finish (Figure C1), the moisture content measured under the drainage plane is always less than 15% (Figure C2). It is concluded that external water is not penetrating past the drainage plane at the monitored locations and, by extension, at other similar locations.

Figure C2. Moisture content measured by Duff gauges to the interior of the drainage plane for all suites.

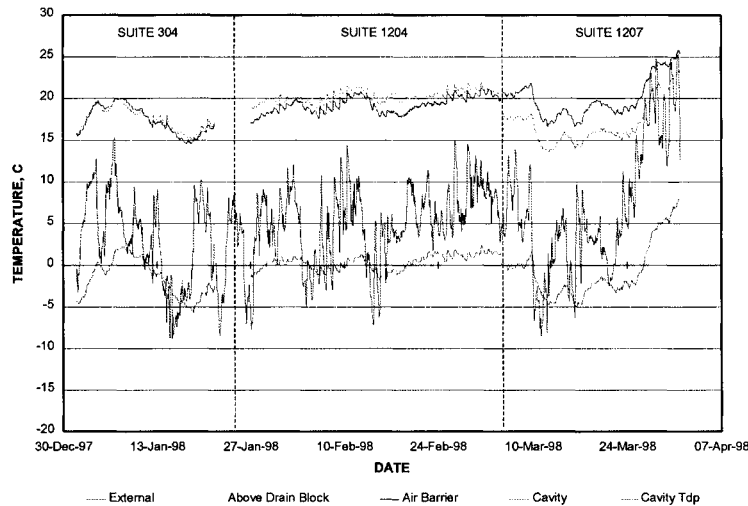
It is not possible to judge whether the temperature index is affected by air leakage since insufficient data with large pressure difference were recorded. However, note that the ‘Above Drain Block’ temperature is occasionally depressed by a high wind condition, e.g., Figure D2, Suite 1207, without a corresponding depression in the ‘Air Barrier’ or ‘Cavity’ temperatures. From this, it appears that there is no air leakage through the cavity since the depression manifests itself as a local effect at the drain block that does not extend through the drainage cavity.

Note that the lamina experiences roughly half the pressure difference across the wall during high winds (e.g., see Figure D2, Suite 1204). During gust conditions the lamina pressure difference is higher than that at the interior layers because damping reduces the amplitude and time of response at the interior layers. The dynamic response must be considered when generating statistical results from monitored data.

Figure D2. Measured surface temperatures and calculated cavity dew point temperature at Suites 304, 1204 and 1207. Note the large wind-induced dip in 'Above Drain Block' temperature at Suite 1204 in mid-February.

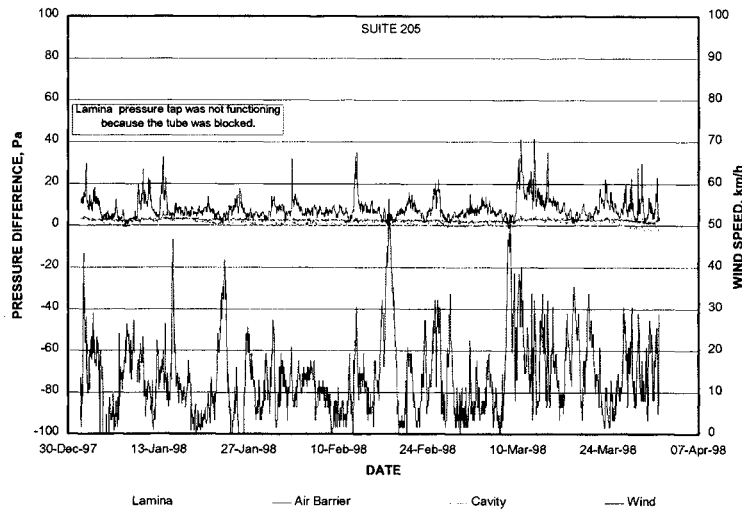
Figure F1. Pressure difference measured at Suite 205 (positive pressure difference is an infiltration condition). Note that the 'lamina' pressure tap was not functioning.

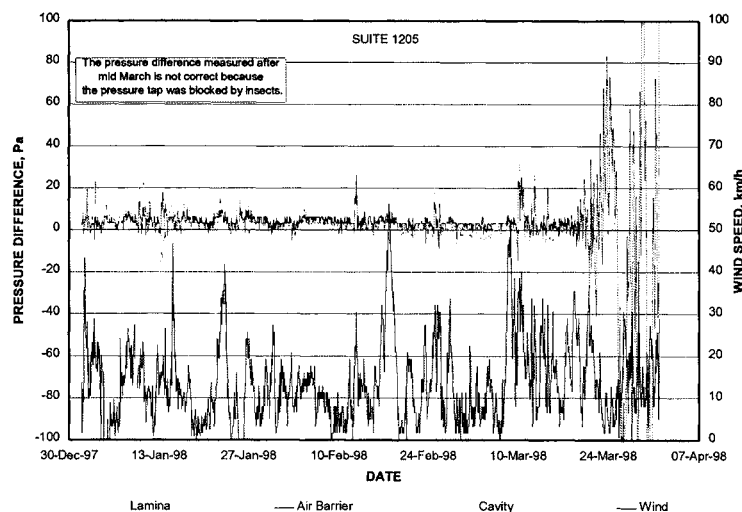
Figure F3. Pressure difference measured at Suite 1205 (positive pressure difference is an infiltration condition). Note that all pressure taps ceased to function accurately around the middle of March.
