Investigation Of Crawl Space Ventilation
and Moisture Control Strategies for B.C.
Houses: Appendices

INVESTIGATION OF CRAWL SPACE VENTILATION
AND
MOISTURE CONTROL STRATEGIES
FOR B.C. HOUSES

Sheltair Scientific Ltd.
#2 - 3661 W. 4th Ave.
Vancouver, B.C. V6R 1P2

June, 1991

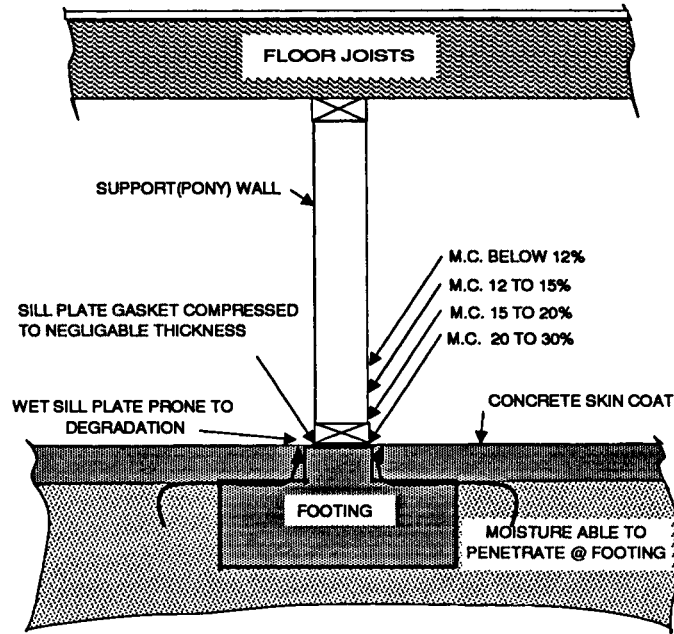
- Bottom plates of structural support walls sitting on the slab absorb water (as in House #2 where wood moisture content (MC) was 25 to 30%²) and eventually decay leading to expensive repairs;
- Moisture from humid crawl space air condenses behind insulation on cold perimeter wall surfaces and on header joists;
- Moisture-laden air migrates into living spaces through interface air leakage points or via forced air duct work. The higher humidity levels increase window condensation potential in the living areas especially during the fall & winter ;

The absence of concrete curb walls for interior support walls may cause structural damage in many houses built in this manner. Three (3) of the houses visited had support walls built at floor level and in House #2 and House #10, measured wood MC's were greater than 20 % at the sill plates. These pony walls rest on a concrete footing that is flush with the floor slab. Moisture moving horizontally through the floor slab saturates the sill plates. Figure 4 shows the typical moisture gradient of sill plates resting on the slab.

Figure A2-1: Typical support wall moisture gradient.

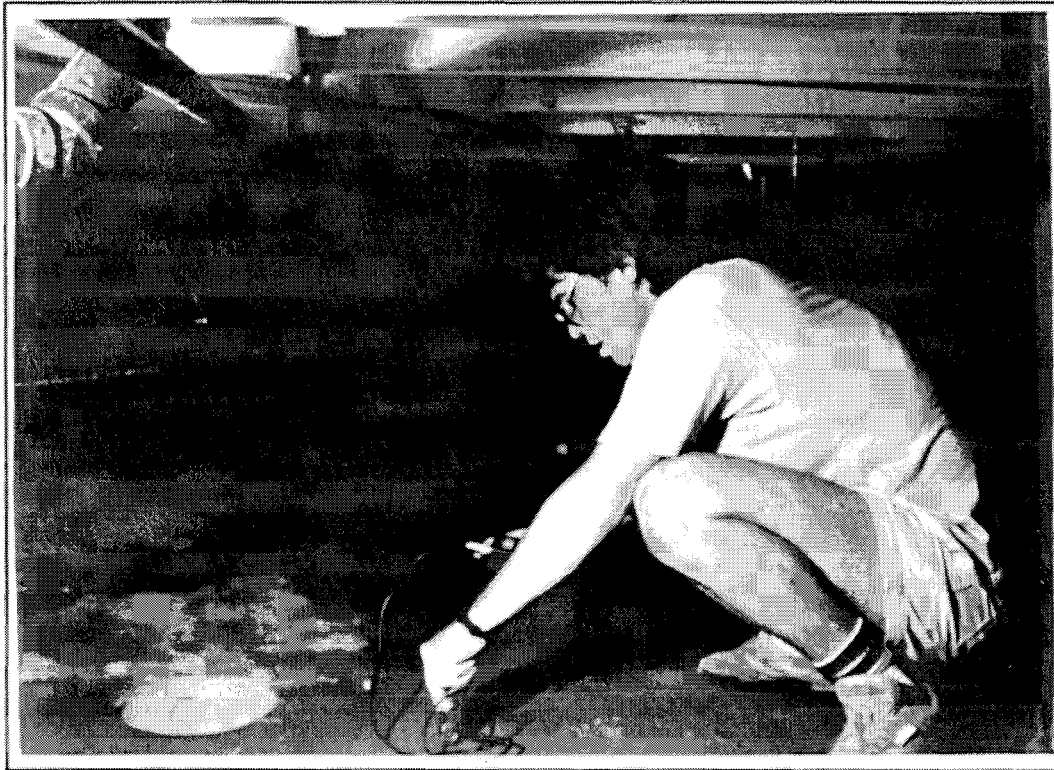
Figure 2: Moisture measurement in wet area

Problem History & Remedial Measures Taken: Large wet areas were found on the C.S. floor. Concrete was found to be cracked in some sections. Occupants experienced high humidity in all areas of the house, condensation on windows in winter and odours in the living room in fall & spring. Two weeks after our visit NHWP proceeded to take measures to reduce moisture. Six (6) passive vents were cut through headers and the entire floor above the C.S. was insulated with RSI 2.9 batt insulation. Heating ducts were also wrapped with batt insulated. A 0.5 m X 3 m test strip of polyethylene was placed on a wet area of the floor by NHWP to test its effectiveness.

Test Results & Observations: High summer temperatures, humidity and winds prevailed on the day of testing. MC content of the crawl space floor was > 85% in areas though the wood MC was low. In winter conditions, the wood MC is expected to be much higher and a return visit is planned to verify this. Air leakage testing was difficult because of high winds and also because of the location of the crawl space hatch. The ELA of the crawl space was 1340 cm². This figure includes the below floor leakage (Qa) and the interface leakage (Qb). The house ELA was 928 cm² (Qc).

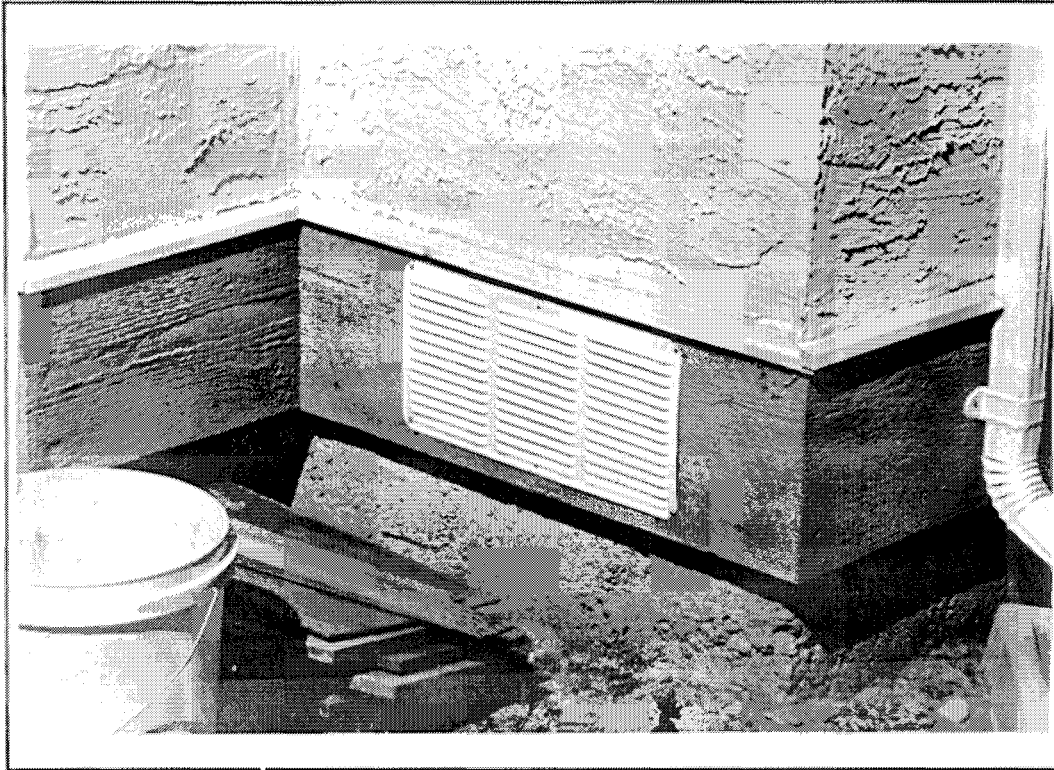
Figure 4: Crawl Space Vent

Crawl Space Description: The crawl space of House #2 was initially a heated and non-vented but groundwater problems led to remedial measures by NHWP. Before our visit, six 300 cm² inoperable louvred crawl space vents were installed by NHWP. Insulation was initially applied to C.S. perimeter walls but again had been removed by NHWP to reduce condensation on the concrete. Joist headers were insulated with RSI 1.75 batt insulation. As in House #1 heating is provided to the crawl space from 2 supply outlets cut directly in the main plenum, fitted with 50 mm X 300 mm grilles. There is also a return grill and a 5" return duct in a far corner of the space fitted with a damper. The duct is presently sealed.

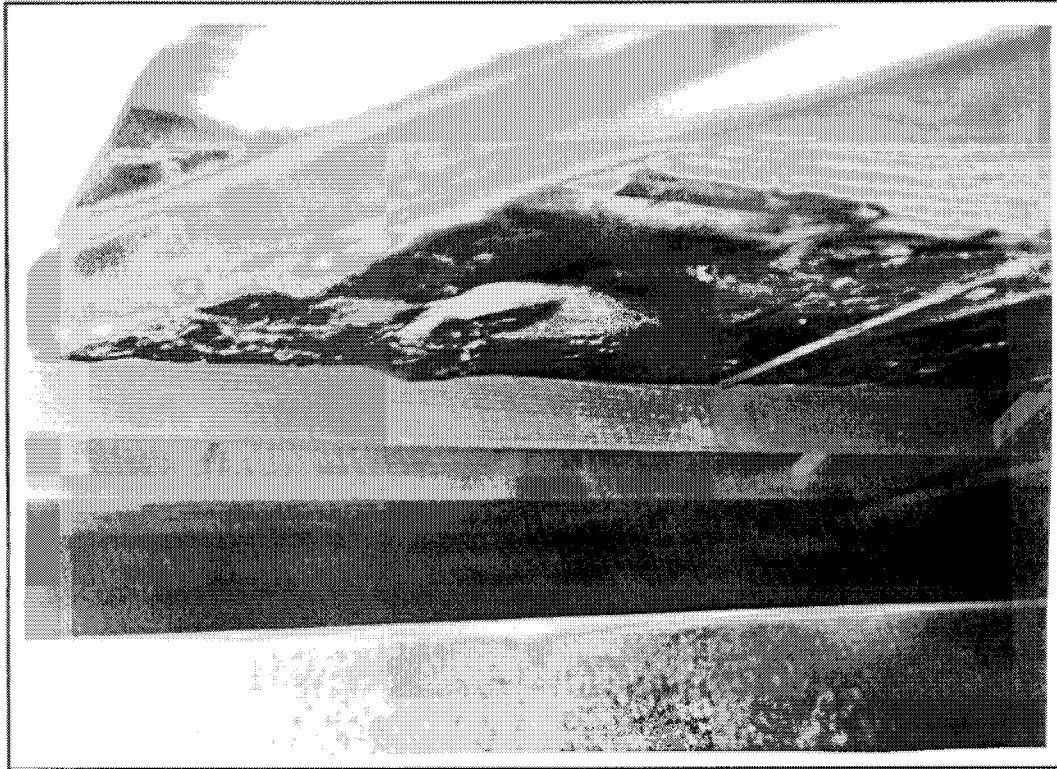
Problem History & Remedial Measures Taken: The occupants had problems with high humidity in the living area and window condensation. A musty odour was also present last winter that originated from the crawl space. Wet areas were noticed on the C.S. floor in one section and the homeowner placed a carpet over the area which he uses for storage. It was suspected that the poly moisture barrier had been omitted. The residents experienced very high winter heating costs which we suspect are related to crawl space over-ventilation. Vents in the crawl space were mistakenly left closed during most of the summer and two weeks before our investigation these were opened.

Figure 7: Poorly Constructed Return-air Plenum

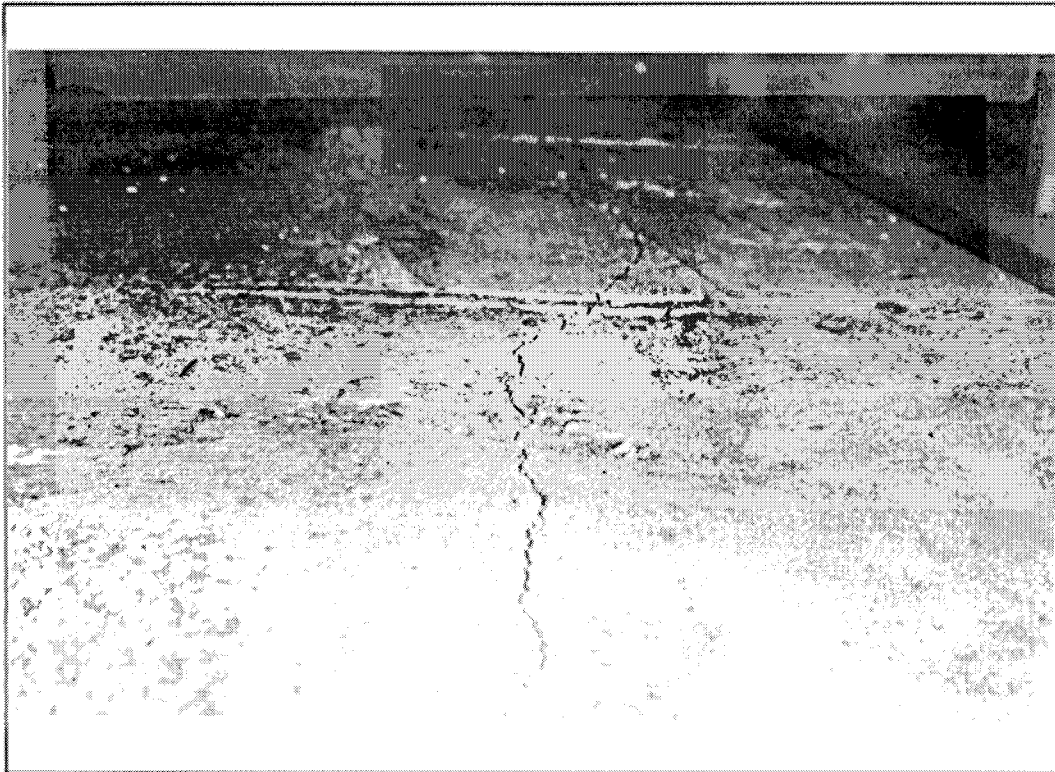
Test Results & Observations: Tests were performed in mid October in mild dry weather. Air leakage tests were performed and the interface ELA was measured to be 285 cm² and the crawl space 332 cm². MC levels in both wood and concrete were normal except in one small area where concrete at the base of the perimeter wall was wet. Measured MC of the concrete wall at that point was 55% and the floor 85%. Concrete was notably cracked in several areas as can be seen in the photograph below. This implies fast curing with no expansion joints provided to accommodate for the shrinkage.

Figure 9: Cracks in concrete skin coat.

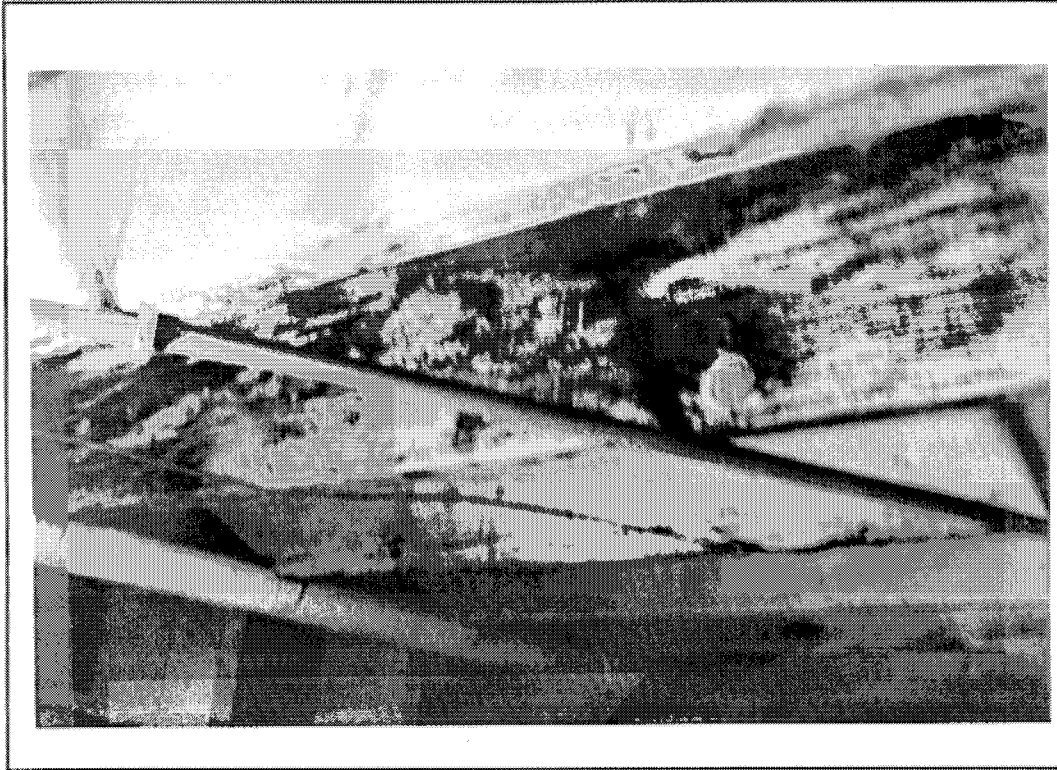
Problem History: Large wet areas were found on the C.S. floor. A test hole revealing the absence of polyethylene vapour barrier. Concrete was found to be cracked in some sections. Occupants experienced high humidity in all areas of the house, condensation on windows in winter and a persistent musty odour in the living room. Carpets in that room had been stained at fringes by air movement beneath partition walls. The homeowner believed that this was due to mould migrating through from below but it is not confirmed. NHWP had cleaned the carpets once recently and there were only traces to be seen during our investigation.

Figure 12: Mould Growth on Joists in Crawl Space

Test Results & Observations: House #6 was visited in mid October after one week of more than average rainfall. MC in wood and concrete were very high. The MC of the header joist behind insulation was 26 % and subfloor plywood was 20 % in some areas. In one corner, adjacent to the drainage collection box, perimeter walls were visibly wet. Although it is possible that this is due to seepage but condensation of crawl space moisture on the surface is suspect.

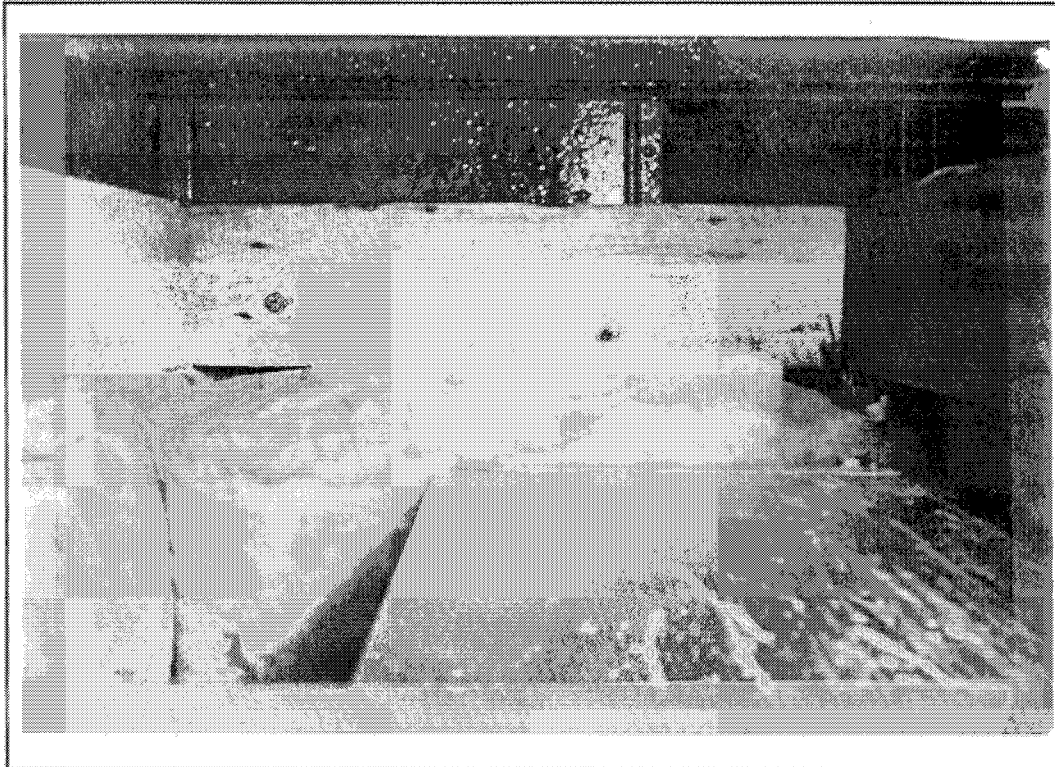
- In House #6, an especially confusing problem misled the contractor into unnecessary expense. Incidence of water, pooling under a chimney cavity in the crawl space, led to an assumption that the drain tile was blocked or damaged. The entire front elevation of the house was re-excavated and drain tile replaced. To ensure quick migration of groundwater drain rock was installed to a full 1 metre in depth above the footing. It was later determined by Sheltair that the water pooling had been caused by the migration of moist crawl space and house air into the back of the fireplace opening. Moisture was condensing on the cold masonry and metal surfaces in the chimney cavity then running down the inside foundation wall into the crawl space. This type of confusion reflects a need for builder education or technical support services in the area of moisture, humidity, and foundation construction.

Figure 13: Condensation in Chimney Cavity

Sheltair monitored conditions and installed a poly vapour barrier on the existing concrete. After 3 days of monitoring, an additional 50 mm concrete skin coat was applied to the existing slab, sandwiching the new poly. The reduction in moisture levels was monitored for 40 days until conditions were quite stable. An option was left to seal the vapour barrier to the perimeter walls and sealed to the top of the insulation. Poly sheets were cut oversized so that enough material extended to join to the board insulation terminating 25 cm from the floor.

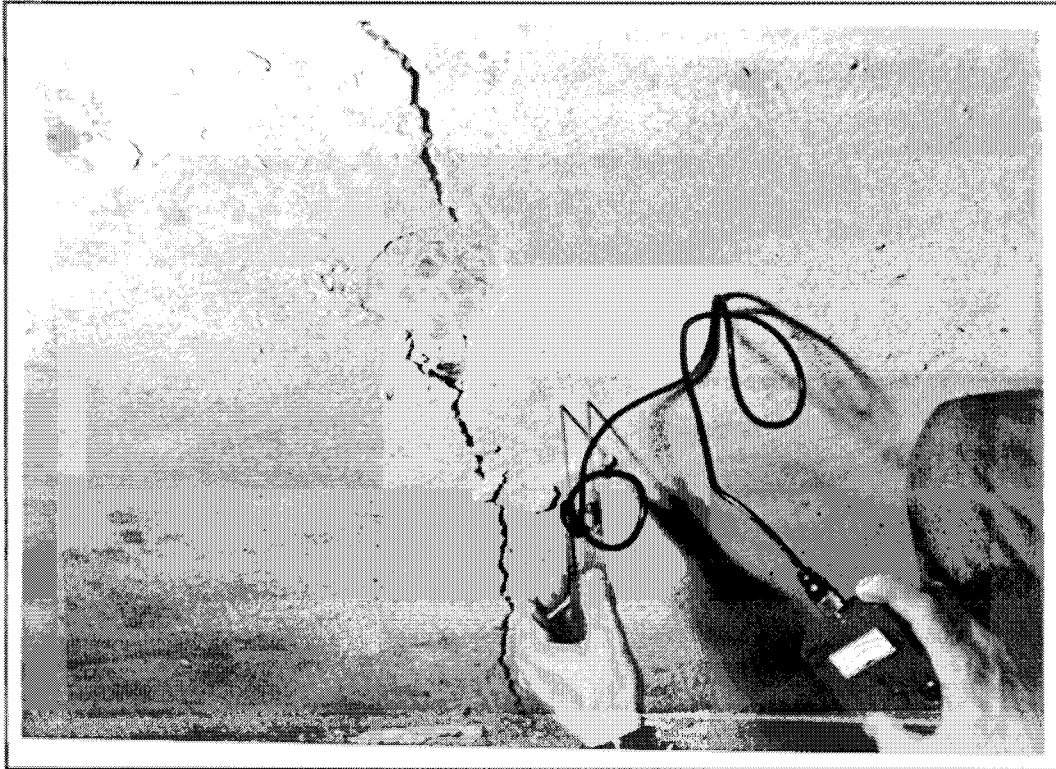
Figure 17: Crack in Thin Concrete Revealing Poly

Crawl Space Description: Crawl Space floors covered with a skin coat of concrete, otop of a 6 mil. polyethylene barrier. The poly is lapped up and visible around the perimeters in most locations, and also through cracks in the skin code in various locations. The inside of the crawl space foundation wall is insulated with one inch expanded polystyrene board insulation from sill plate to below grade. In accordance with typical construction practice, each board of insulation is attached with two nails to the concrete, causing the boards to bow away from the wall and destroying the effectiveness of the insulation. Pieces of RSI 2.9 batts are stuffed in the joist ends. Supporting pony walls in the crawl space are sitting on a foam gasket and concrete curb.

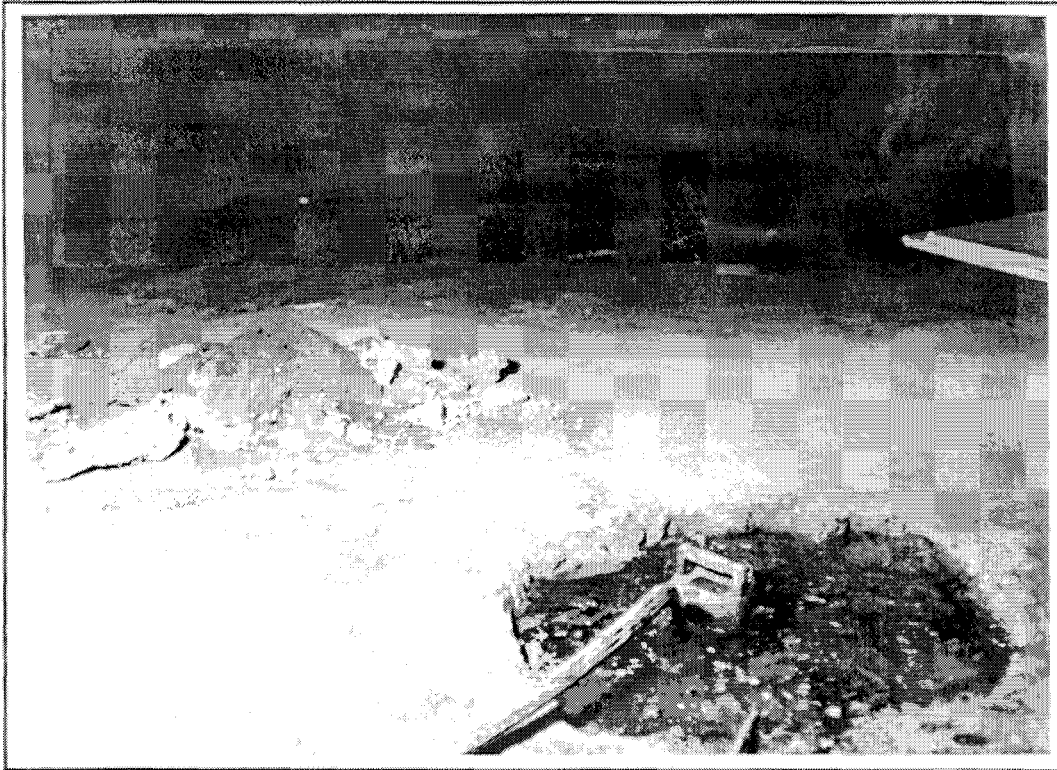
Figure 19: Temporary Sump in Crawl Space Floor for Flood Relief

Crawl Space Description: The crawl space floor consists of a two inch thick concrete skin coat. No polyethylene moisture barrier had been installed below the concrete. The more exposed sections of the crawl space wall had been insulated with fibreglass batts, held in place by two by four framing with a polyethylene moisture barrier against the concrete. Batt's had been stuffed in all the box ends. One inch expanded polystyrene boards had been nailed to the interior of the concrete foundation wall on the west and north sides. Crawl space vents had not been installed initially, but had been retrofitted in place the day prior to inspection, as part of remedial measures for moisture problems. At the time of inspection, four vents were identified, all with louvres and open dampers. In one case the new crawl space vent had been located directly in front of the household plumbing lines.

Findings and observations: The visit by researchers on January 4, 1991 revealed very high moisture levels in the crawl space and house. It would still be too early for the remedial measures to have any impact. Due to the cold weather at the time, windows throughout the house were covered in thick condensation and ice. Inspection of the crawl space revealed an extremely wet situation, with pooling and running water throughout, and heavy condensation build-up behind batts and behind the wall moisture barrier.

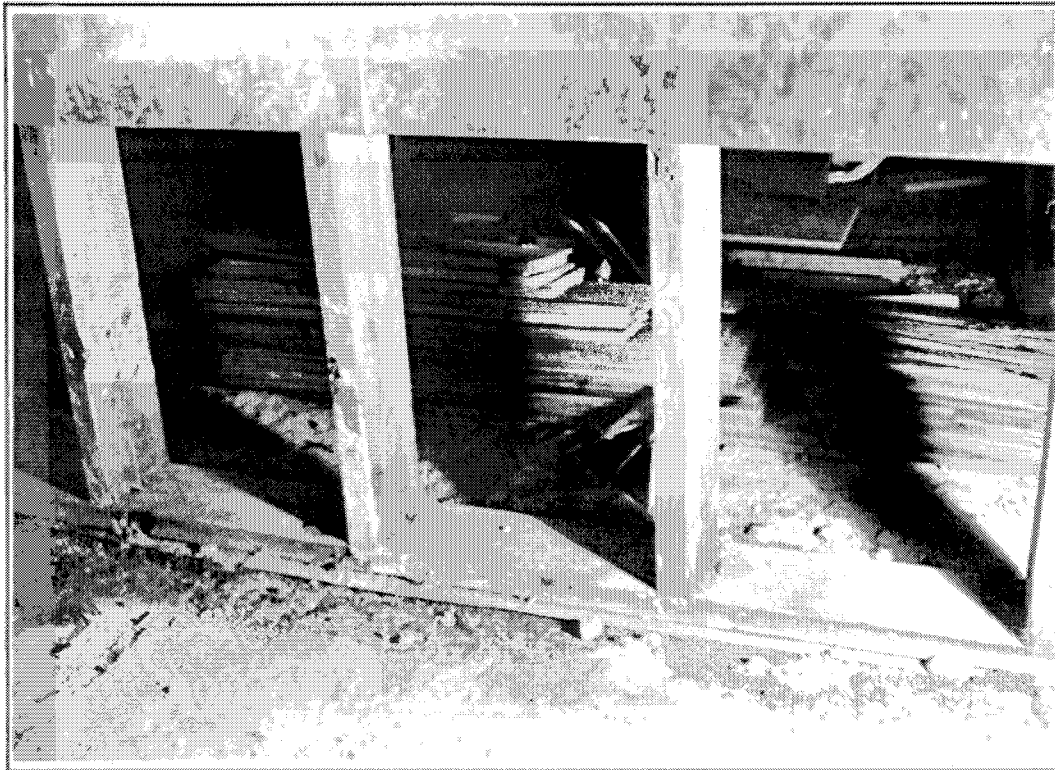
Figure 21: Support Wall Resting on Slab
