Issue 01/2008

Feedback

Canadian Aviation Service Difficulty Reports

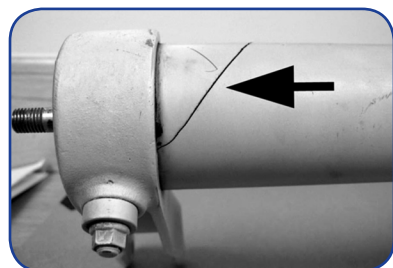
Elevator Torque Tube Severely Cracked

The tail cone was removed to carry out *service bulletin (SB) 2145*, elevator torque tube fitting inspection, which is due every 100 hours. The technician then noticed that the elevator torque tube itself, although not part of SB 2145, was severely cracked. The last detailed inspection of the torque tube was some 245 hours ago.

The crack originated from the horn attachment taper pin and spiralled approximately 270 degrees around the circumference of the actual torque tube.

This general area is inspected every 100 hours, thus it appears that this crack developed rapidly within this timeframe.

Fortunately, the crack was discovered thus preventing a potentially serious accident and loss of elevator control authority. The type certificate holder has been notified.

The SDR database contains several previous reports related to torque tube cracks originating at the taper pinhole, but none as severe as this event. ✖

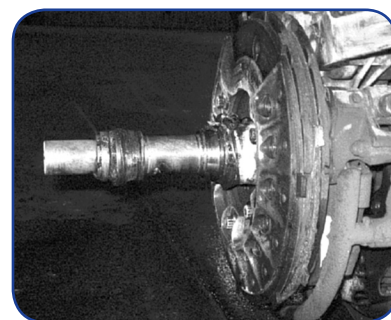
SDR# 20070212010

As a precautionary measure, the remaining three (3) main wheel assemblies were removed and inspected for condition and security. Two of these remaining wheel assemblies were found to have been grease-coated on the outside of the bearings, but were not "grease-packed" inside (as per manufacturer's instructions). Subsequently, the wheel bearings were cleaned, inspected and properly repacked with the specified lubricant.

The missing main wheel assembly was located in the area near the active runway.

Transport Canada Civil Aviation (TCCA) does have previous service history on this wheel-bearing problem. Subsequently, TCCA issued Service Difficulty Alert (AL 2006-02) to inform operators and maintenance personnel that the present wheel-bearing lubrication schedule may be inadequate. ✖

Main Wheel Assembly Missing

After landing and all of the passengers were unloaded for refuelling of the aircraft, the pilot walked around the aircraft to speak with the fuel truck driver. It was then noticed that the right main gear was missing the complete tire and wheel assembly. Maintenance was immediately contacted and the aircraft was grounded.

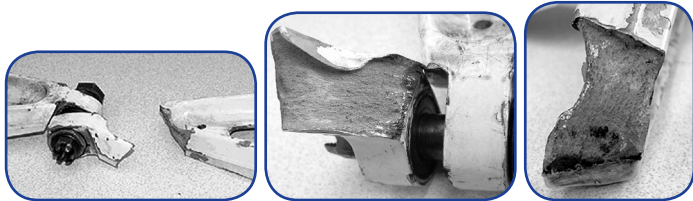
Landing Gear Torque Link Failed

After touchdown and decelerating through 60 knots indicated airspeed (KIAS), the aircraft began to violently shake, shudder and appear to skip while veering toward the left side of the runway. Control of the aircraft was maintained as it was brought to a slow taxi at which time the conditions ceased.

Upon examination of the aircraft, it was discovered that the left main gear lower torque link, part number (P/N) 50810323, had failed. The torque knee was replaced and the aircraft was returned to service.

The operator initiated a fleet-wide aircraft non-destructive testing (NDT) inspection that revealed three additional cracked torque links. The latest revision of Raytheon Beech safety letter (SL) 0516-200 incorporates torque

link hardware and bushing replacement, however there is no further requirement to conduct a NDT inspection as recommended in the original SL 0516-200.

The torque link has been sent to the Transport Safety Board (TSB) lab for analysis and the type certificate holder has been advised of this failure. ✖

Transport Canada recommends operators to inspect the main landing gear torque link assemblies for defects. NDT may need to be reconsidered.

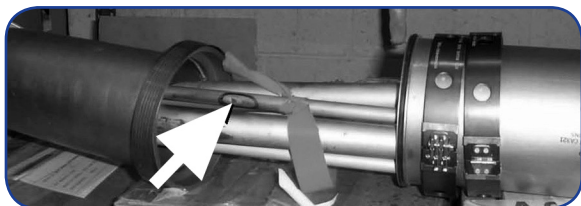
Fuel Line Chafed

During a heavy maintenance check the fuel shroud assembly, fuel lines at frame 559 were removed to facilitate a sheet metal repair.

It was discovered that both shroud and fuel lines had chafing damage beyond acceptable limits. This same repair was carried out on other aircraft in the fleet and similar damage was found in the same location.

The fuel lines and shroud assembly have been ordered.

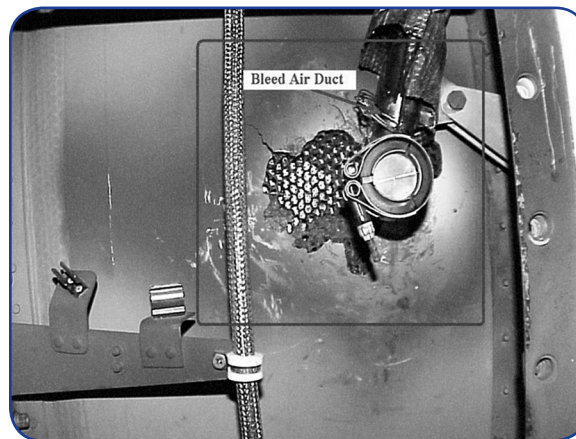
Engine Inlet Cowl Bleed Air Damaged

After the engine fan cowl was removed during a scheduled maintenance check, structural damage was observed on the inlet cowl. It was apparent that the capped 14th stage bleed air duct had leaked hot bleed air and caused heat damage to the immediate area.

It was later confirmed that an incorrect clamp had been used.

Unfortunately, human factor errors still occur and directly led to this event. Always take the time to verify that the correct manufacturer's illustrated parts catalogue (IPC) part number is installed. ✖

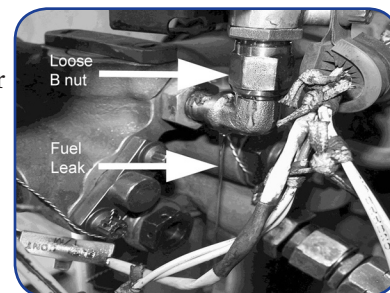
SDR # 20070404011

The technician was troubleshooting the APU, GTCP36-150RJ, following an "auto-shutdown" event due to high oil temperature indications. Ground inspection revealed that the electrical connector for the oil temperature sensor was found partially installed. The connector was secured and the APU enclosure inspected with no evidence of fuel or oil leakage.

Shortly after APU functional start and with both air condition packs operating normally, a strong smell of fuel was noted in the galley and cockpit area. Fuel was also seen coming from the APU drains and the APU was immediately shut down.

A technician climbed into the aft equipment bay and began to open the APU oil-servicing panel, when a fire flared up. The cockpit crew employed the onboard extinguishing agent and the ground crew also utilized a dry chemical agent into the APU enclosure.

The APU was removed and sent to the original equipment manufacturer (OEM) for further examination. There was no evidence of fire damage other than some fire suppressant contaminants.

When the APU was hooked up to the test cell, a stream of fuel was seen coming from the elbow fitting between the fuel control and the fuel shut-off valve. Closer examination found that the fuel leak originated at the

B-nut fitting. The B-nut was tightened approximately $\frac{3}{4}$ of a turn and the fuel leakage stopped. Other operational checks were carried out with no defects found.

Transport Canada recommends always double-checking fluid carrying lines following assembly. ✖

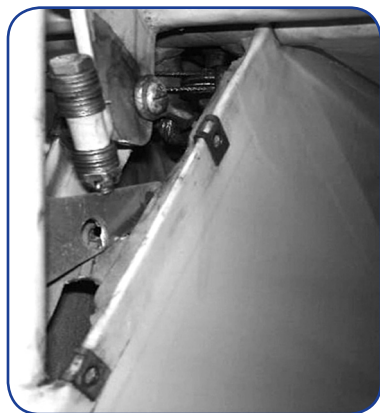
Elevator Travel Impeded due to Failed Gusset

After recovering from an aerobatic manoeuvre, the pilot noted that the “full down” elevator travel could not be obtained. An uneventful landing was carried out.

Maintenance personnel removed the elevator bell crank cover and found that the left gusset from the aft stringer support had fallen into the belly of the aircraft. Over a period of time, the gusset worked its way back and became lodged in the narrow clearances around the elevator bell crank.

Examination of the gusset, support and rivets indicated that the airframe fabric vibrations occurring during flight had loosened the soft aluminium pop rivets and allowed the gusset to become free.

Fortunately, the dislodged gusset was found before a complete elevator jam occurred. It is unknown how long the gusset was in this area. ✖

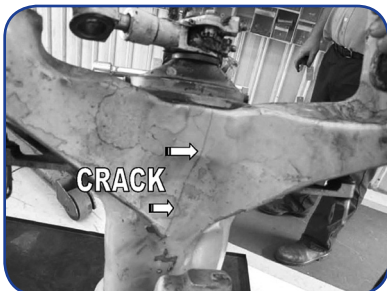
Nose Landing Gear Shock Strut Housing Cracked

During a scheduled maintenance check, task card 3220/01 & 02, visual inspection & lubrication of nose landing gear (NLG) assembly, a crack was discovered in the NLG outer cylinder, part number 8814-7. The nose landing gear assembly was immediately replaced.

The assembly was forwarded to Messier-Dowty for investigation, which revealed evidence of earlier rework. The crack origin showed evidence of re-work resulting in a non-conforming surface finish and a visible absence of shot peening.

Bombardier/ de Havilland has made reference to two earlier investigations on outer cylinder separations. Bombardier/ de Havilland subsequently initiated an information campaign informing fleet operators on the non-recommended practice of single engine taxiing, which produces stress on the NLG assembly.

Although the origin of this crack was due to non-conforming practices, the single engine taxiing appears to have been a contributing factor. ✖

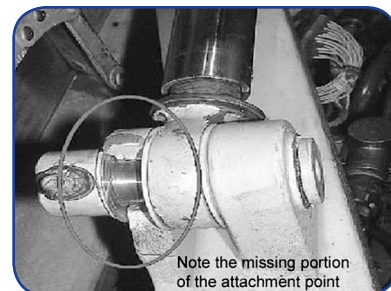
Main Landing Gear Yoke Fitting Cracked

During a scheduled A-check the right main landing gear yoke was found to have a cracked fitting at the auxiliary actuator attachment point.

The landing gear manufacturer Messier Dowty, and the aircraft type certificate holder, Bombardier, are conducting an investigation into this yoke fitting fracture.

Transport Canada wishes to disseminate this information to the operators of this aircraft type even though an investigation is on-going. An alert technician discovered this discrepancy before an incident or accident occurred. ✖

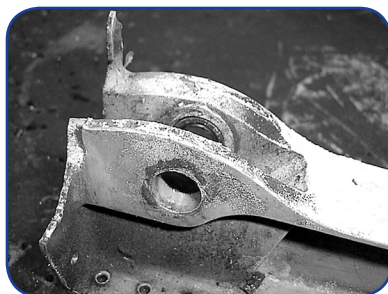
Nose Landing Gear Uplock Actuator Assembly Fitting Cracked

The aircraft was ferried with the landing gear secured in the down position to a maintenance base for further inspection. Maintenance personnel then discovered that the NLG uplock actuator fitting assembly was cracked at the actuator attachment point. The discoloration in the crack area indicated that the crack propagation occurred over a period of time.

Additionally, the NLG trunnion sidewall web and top web were also found cracked. The “Z” member, P/N 85311420, on the right side of the wall was also found cracked. Repairs were accomplished in accordance with the manufacturer’s instructions.

The SDR submitter recommended that a more focused specific visual or NDT inspection to be carried out on this fitting.

The submitter comments that as aircraft accumulate lengthy time in service, the need for extra attention during routine inspections is recommended. ✖

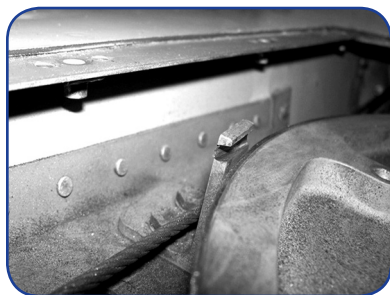
SDR# 20070427008

Aileron Cable Misrouted

The pilot reported that roll control inputs were “stiff”, especially left to right applications. Ground functional tests could not duplicate this snag and nothing seemed adverse with the roll disconnect.

Maintenance inspection found that the left outboard aileron cable was routed around the wrong side of the cable guard. The aileron cable was inspected, routed correctly and re-rigged, and an Independent Check carried out.

The cable guard had to be replaced due to “wear” and the aircraft was returned to service.

Fortunately, it was the cable guard that was worn and not the actual aileron cable. An Independent Check is a mandatory safety measure that is required if engine or flight control rigging is disturbed. ✖

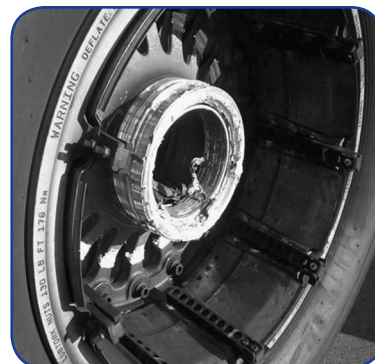
Further inspection found the above wheel bearing seized on the gear axle, with the No. 4 tire and the brake damaged. Discoloration of the axle was noted due to excessive heat build up.

The investigation continues to identify the root cause of the problem and component strip shop reports are requested.

Transport Canada (TC) will update this issue when the root cause is determined. ✖

The right landing gear assembly, brake and tire were replaced as per the *Aircraft Maintenance Manual* (AMM).

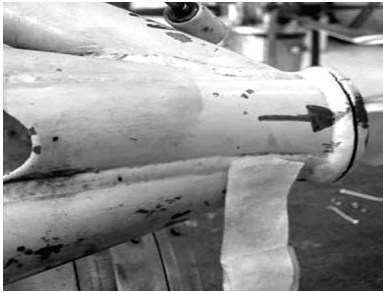
HONEYWELL (GARRETT) TPE331-12UHR SDR # 20070507008
(FAIRCHILD SWEARINGEN SA227)

Engine Truss Mount Cracked

During a Phase 6 inspection, a crack was found on the right engine truss mount support assembly. The crack was located at the upper inboard weld joint that attaches to the engine firewall.

The last detailed inspection of the engine truss was previously done 300 hours ago during the Phase 4 inspection.

If one or more of the engine truss (or mounts) is significantly damaged, a catastrophic event could occur, including complete engine separation from the wing. ✖

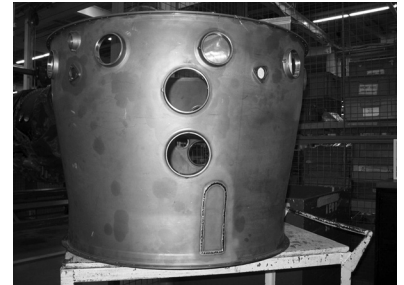
Bypass Duct – Unapproved Repair

The engine was received from a foreign operator for inspection. During disassembly, the engine front bypass duct was found to have a non-standard patch repair that was not in accordance with the original equipment manufacturer's (OEM) limitations. The patch repair was on the outside wall and measured 8 inches long by 2.5 inches wide.

The bypass duct was subsequently removed from service.

Always follow the maintenance and repair instructions published by the OEM. ✖

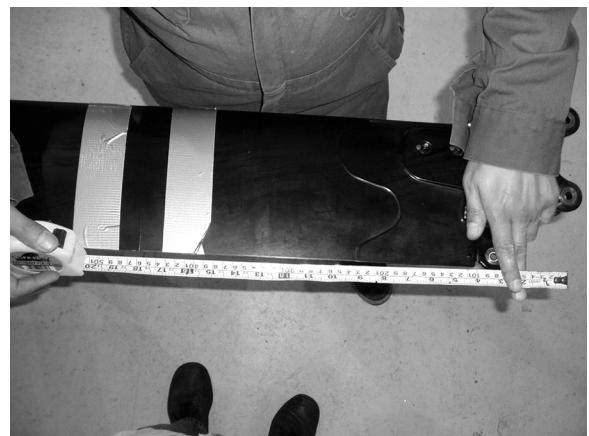
Main Rotor Blade Cracked

The pilot felt a vibration during flight and thus investigated further after landing. An 18" crack was found at Blade Station 36.

This crack was running perpendicular to the blade trailing edge. It appears that the blade became debonded because the crack followed straight from the rib towards the "C" channel before it trailed off to the side.

The SDR submitter opined that this incident might be caused by too much tension on the blades during and after blade tie-down. This may lead to "oil-canning" between the blade ribs and thus put undue pressure on the bonds.

This blade has accumulated approximately 2600 hours, which is about 2/3 of the 3500-hour life limit on this blade. FAA AD 2005-21-02 "Torque Event Inspection" applies to this particular blade. ✖

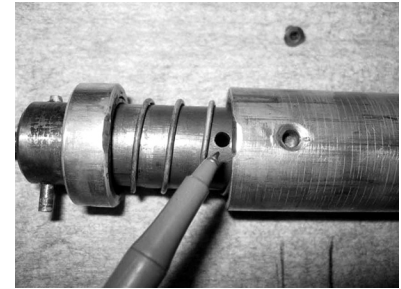
Ground Terrain Incident - Parking Brake Failed

As the pilot was looking downward and completing final shutdown checks, the aircraft began to move forward until the left propeller made contact with the ground power unit. The force of the impact severely bent and twisted the propeller blades and caused the left engine to quit running. Fortunately, ground support personnel were able to get out of the way in time and evade any of the debris that was flying around.

Maintenance troubleshooting found that three (3) rivets that secure the inner shaft to the outer sleeve of the parking brake lever assembly had failed. This failure

The operator has stated that there is no maintenance visit specified for inspection to check the condition of the rivets that secure the park brake shaft and sleeve mechanism.

Due to the propeller strike, the engine was removed and sent out for further investigation.

The above scenario is a good reminder to all ground personnel of the potential hazards of working in close proximity to an aircraft with the engine running. This is especially important around propeller-driven aircraft. ✖
