Issue 2/2011

Canadian Aviation Service Difficulty Reports

TP 6980E
(6/2011)

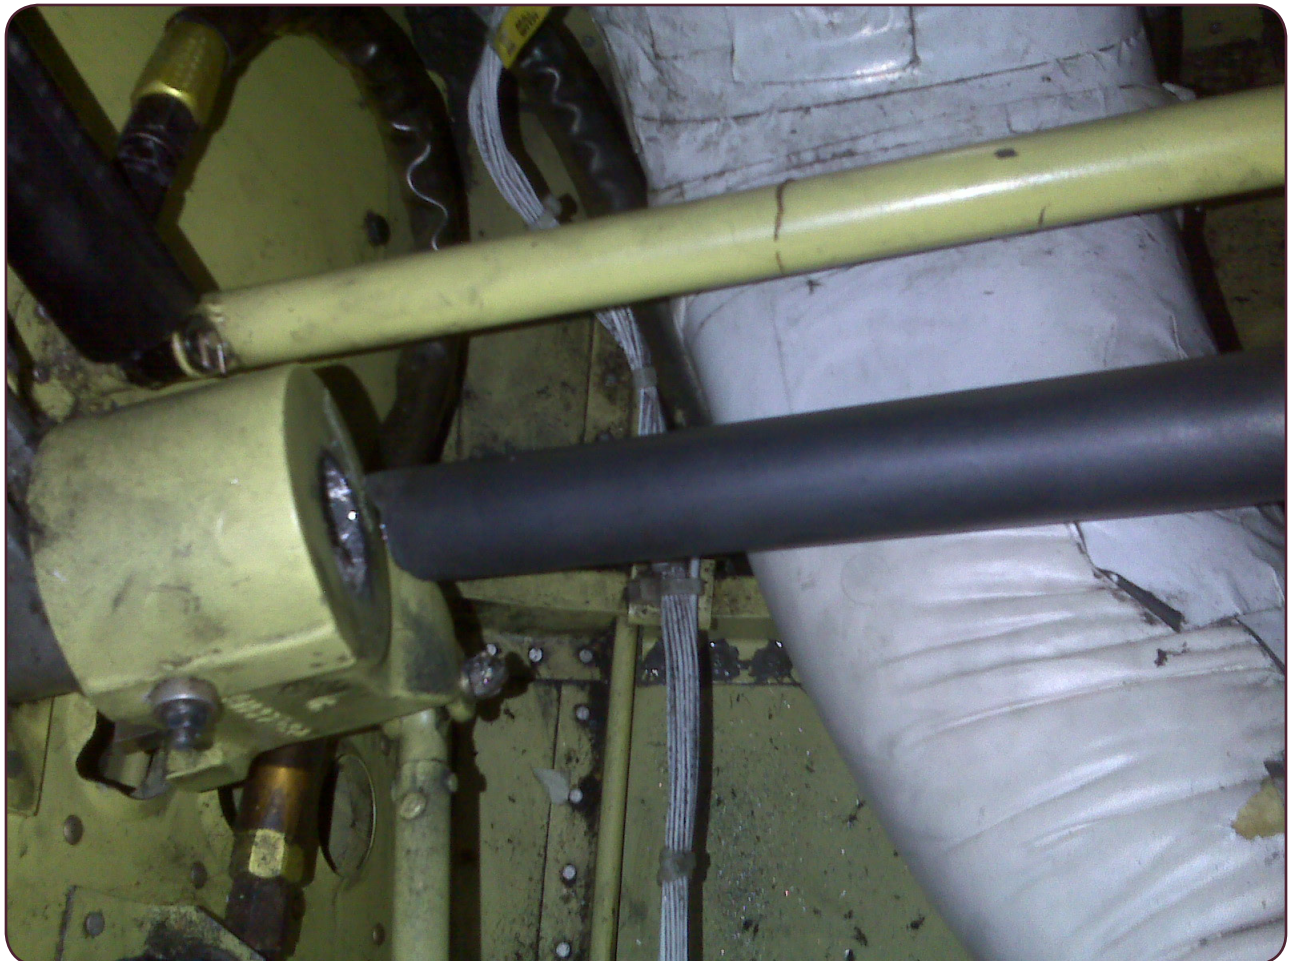
Rudder Torque Tube – Failure

During a functional check, the Aircraft Maintenance Engineer found that the L/H torque tube was broken just inboard of the left rudder pedal block. Disassembly revealed that the rudder torque tube failure started at the taper pin hole that is used to secure the rudder pedal assembly block to the shaft. Further inspection revealed a secondary crack at about 90 degrees. A third crack was found parallel to the initial crack. The failure appears to be from an overload condition.

It is difficult to detect a failure of this type as the initial failure takes place in an area not visible unless the pedal assembly block is dismantled. Once the crack gets large enough to compromise the torsional ability of the shaft, complete failure would likely occur. The entire

rudder and steering system was inspected to determine if other related systems were a factor in this event. No fault found.

Because the pedal block is not disassembled unless necessary, it is recommended that this area be closely examined for defects around the pedal block/torque tube interface. A physical check for any “rotational play” of the torque tube may give an indication of impending failure. ✕

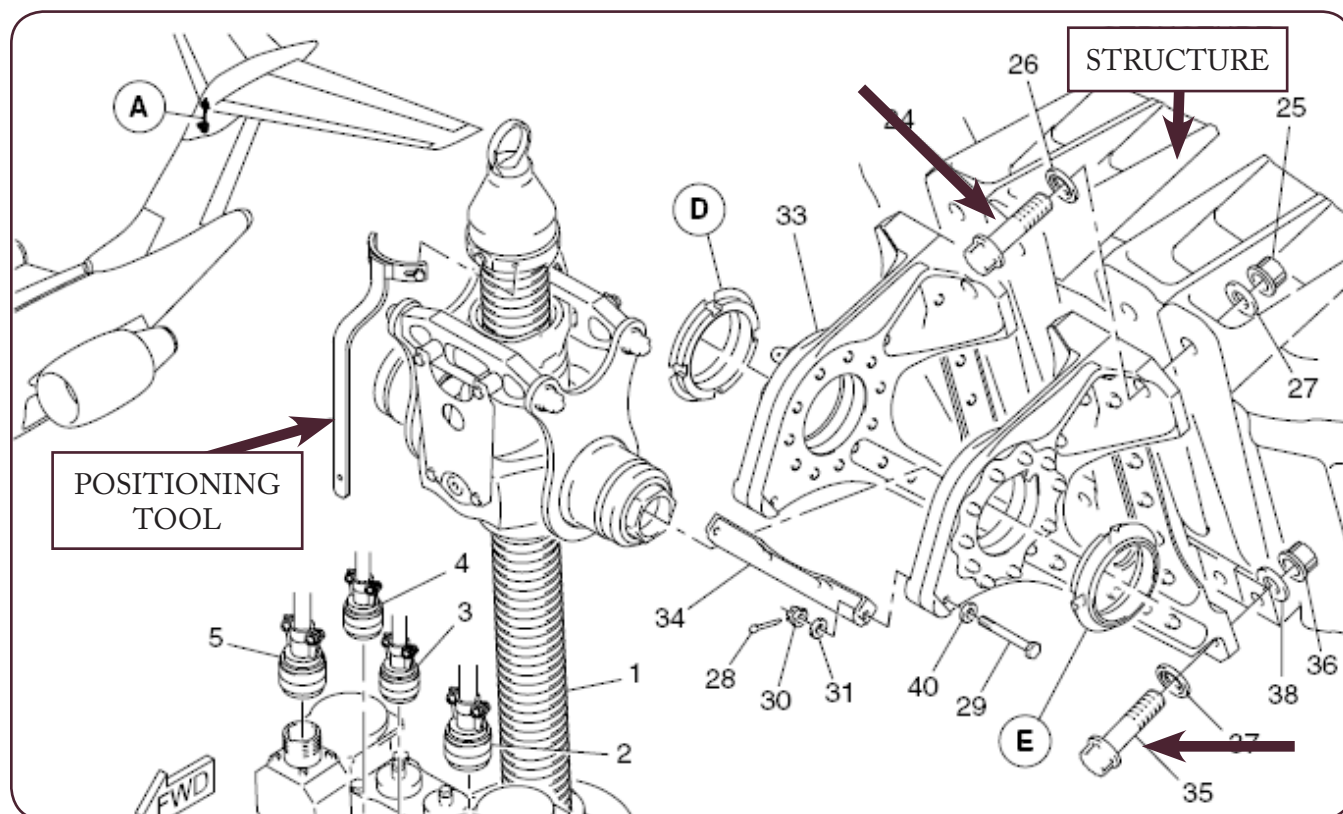
Pitch Trim Actuator - Upper Attachment Loose Bolts

During a routine maintenance check in the translating nut area of the horizontal stab trim actuator (HSTA), two bolts were found loose. These bolts, which are positioned at the upper L/H & lower R/H bolt location, connect the upper half of the pitch trim actuator assembly (Item 33) to the aeroplanes structure. See pictorial below. (Reference CRJ700/900 AMM Figure 27-42-01, Items 24 & 35)

a revision was made to the AMM TR 27-0345 and TR 27-0346 to address the installation of the trim actuator. Manual Change Requirement (MCR) Chapter 20 will now require paint strip marks on the bolt and the nut. The TCH now advises replacement of the nuts after each use.

The 2000 Flight Hour oil level check on the HSTA may be an opportune time to do a precautionary one-time nut torque check. ✖

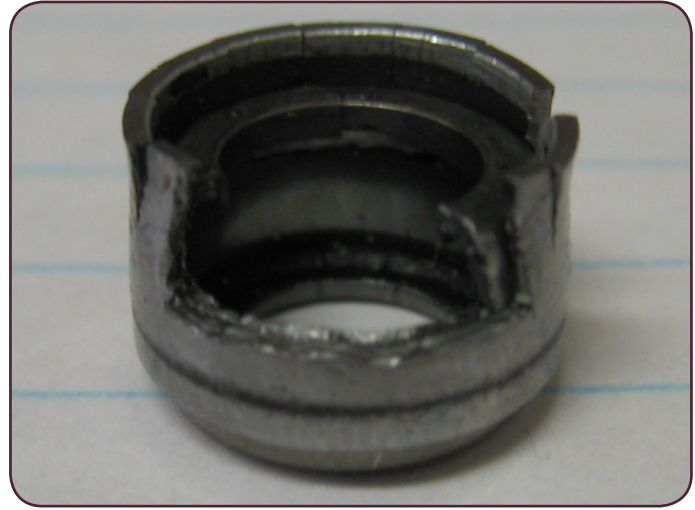
Assymetrical (Split) Flap Condition – Flap Rollers

Shortly after take-off, the R/H flap retract flap cable failed. This was visually confirmed by the pilot. The consequences of the cable failure caused the L/H flap (slave flap) to fall into the fully extended position with the R/H flap (master flap) proceeding to go to the selected flap retracted position. Fortunately, the pilot was able to gain control of the aeroplane.

Initial investigation revealed that the R/H cable was completely severed in the area where the cable rolls over the central flap pulley cluster located in the middle of the cabin behind the headliner (FS 65.33). The subject flap cable was also found frayed in several other areas along the complete flap cable run.

Further inspection found that the L/H aft outboard flap roller (Part Number 0523921) failed due to a “flat spot” on the roller and would not roll thus locking the flap during the retraction cycle. With the slave flap locked in the flap track, the flap motor continued to tension the flap retract cable until the cable failed. The flap motor and transmission can create extremely high torque/tension, which exceeds the tensile strength of the flap cable, if the flap is in a “jammed” condition. The root cause of this event appears to be due to the failure of the flap roller with the flap cable failure as a subsequent event.

Transport Canada Civil Aviation wishes to advise owners/operators to closely inspect the flap rollers for cracks or flat spots. Premature fraying of flap cables may also be an indication of an impending flap roller failure. ✖

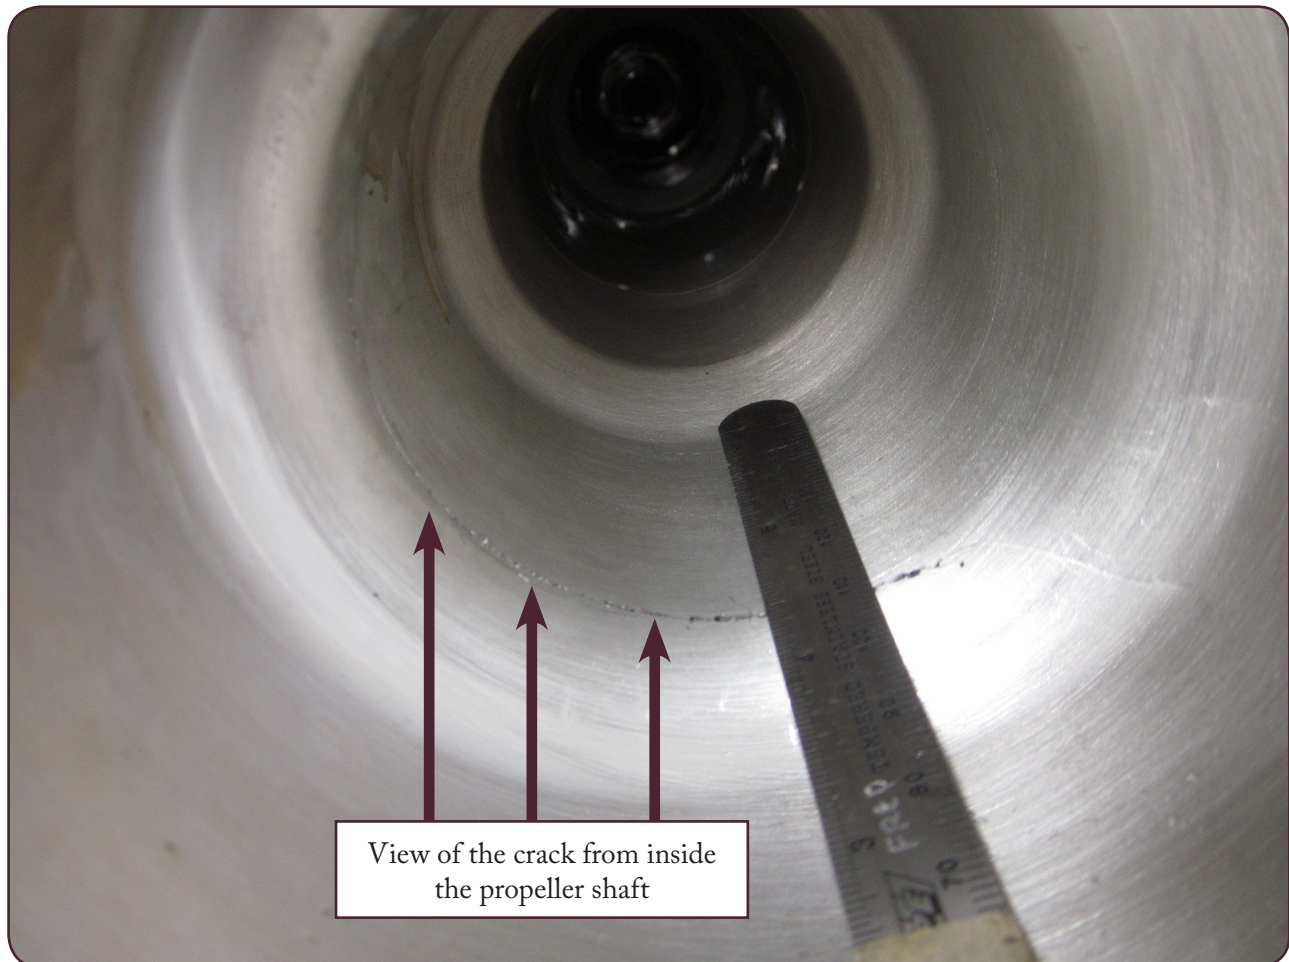
Engine Propeller Shaft Crack

During a pre-flight walk around, the pilot noticed an external oil leak from the propeller shaft area. A more detailed inspection revealed a crack almost half way around the circumference of the shaft at approximately 10 to 11.5 cm (4 to 4.5 inches) from the front flange.

visual inspection and metal testing have confirmed that the crack was caused by hydrogen embrittlement.

The engine was removed and replaced and the aeroplane was made serviceable.

PWC are progressing with a more in-depth investigation and have issued Service Information Letter PW100-139 as well as Service Bulletin 21798 advising all PW100 Series engine operators of this possible scenario.

Transport Canada Civil Aviation would like to emphasize to all affected operators the importance for thorough flight crew and maintenance awareness when addressing propeller shaft oil leaks. ✖
