AVIATION INVESTIGATION REPORT
A05P0227

ENGINE POWER LOSS LEADING TO LOSS OF CONTROL

ENSTROM 280C (HELICOPTER) C-FKEO
DUNCAN, BRITISH COLUMBIA
17 SEPTEMBER 2005

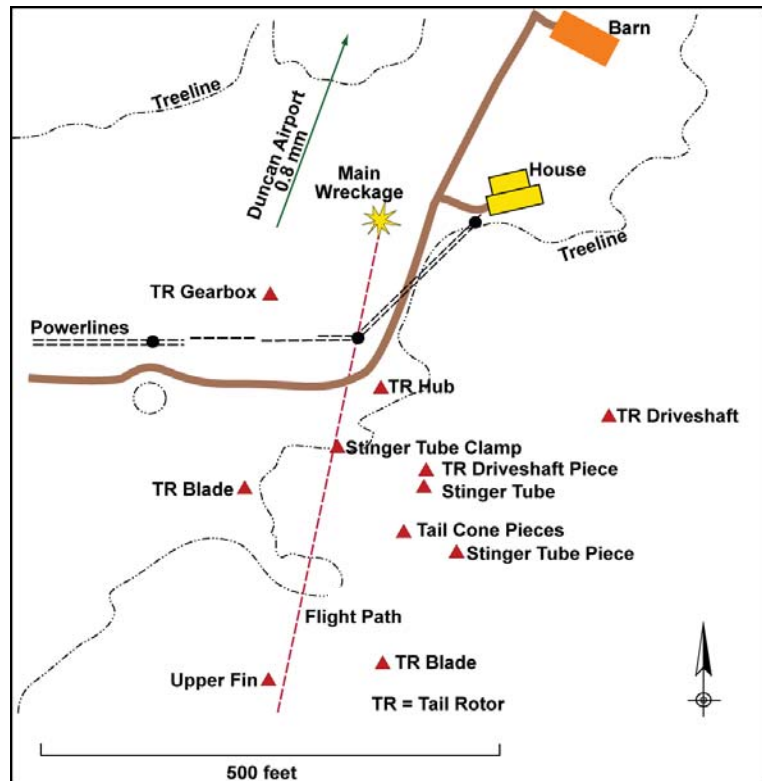
Figure 1. Diagram of wreckage site

During the last 300 feet of the flight path, the tail rotor assembly broke away from the helicopter. The helicopter climbed steeply then descended rapidly to the ground. An explosion and fireball occurred at ground impact, and the helicopter came to rest on its left side. Both occupants were fatally injured at impact, and the cabin and pylon areas were destroyed by impact forces and fire. The wreckage distribution patterns and the dimensions of the debris trail are characteristic of an in-flight break-up event (see Figure 1).

The aft end of the tail cone exhibited main rotor strike damage. Tail section parts found along the flight path as far back as 500 feet from the main wreckage site also exhibited main rotor strike damage. The orientation of the strike marks on the tail components indicates that the main rotor blades contacted the tail cone. Subsequent strikes to components located aft of the tail cone (such as the tail rotor blades) occurred when those components moved into the main rotor path.

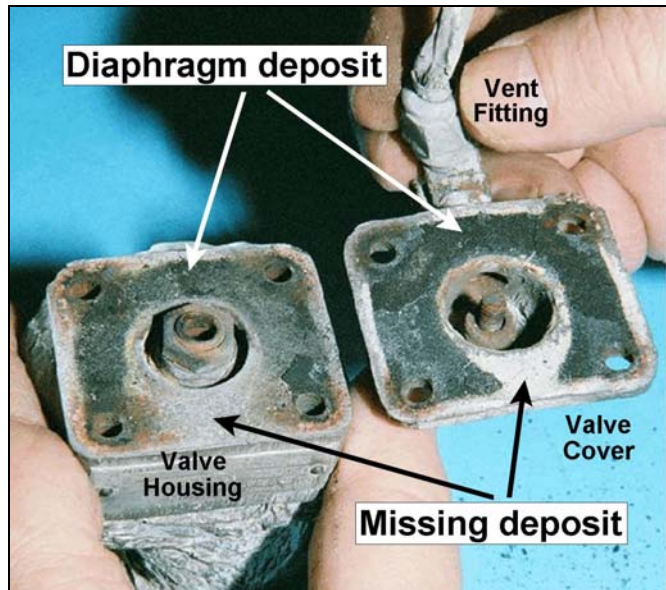
The engine was equipped with a Crane (Lear Romec Division) engine-driven rotary fuel pump, part number RG17980K, serial number B 8714. The fuel pump examination found that the diaphragm (part number RA-7434), located between the relief valve housing and relief valve assembly cover, had been reduced by fire to an ash deposit. An area between the two relief valve attaching screws opposite the vent fitting (see Photo 1) was free of ash deposit. This ash-free area would be adjacent to the magnetos when the pump was installed on the engine. The gasket between the relief valve housing and the fuel pump housing had also been reduced

to an ash deposit. However, the ash pattern resembled the complete gasket shape. The installation torque on the four relief valve-to-pump-housing attachment screws could not be determined due to fire damage. No additional anomalies were observed regarding the fuel pump.

Photo 1. Valve housing and cover with gap in diaphragm

Technical information confirms that the engine-driven fuel pump diaphragm is a known vulnerability. As the helicopter maintenance records indicated that the torque check on the relief valve retaining screws had not been repeated as required by the AD and because a portion of the diaphragm residue was found missing, a fuel leak most likely developed at the split line between the relief valve housing and the relief valve cover. This concurrently allowed the fuel to leak externally from the pump into the engine cowl where sources of ignition were abundant and, due to the lack of the required restricted fuel pump vent fitting, to leak internally into the intake manifold causing an over-rich fuel mixture. Either the over-rich mixture or the loss of fuel pressure or a combination of both would result in a rough running engine and loss of engine power. As the magnetos were among the most heavily damaged of the engine accessories, and as the leak was adjacent to the magnetos, the fire may also have affected the ignition system in flight and further contributed to the power loss.

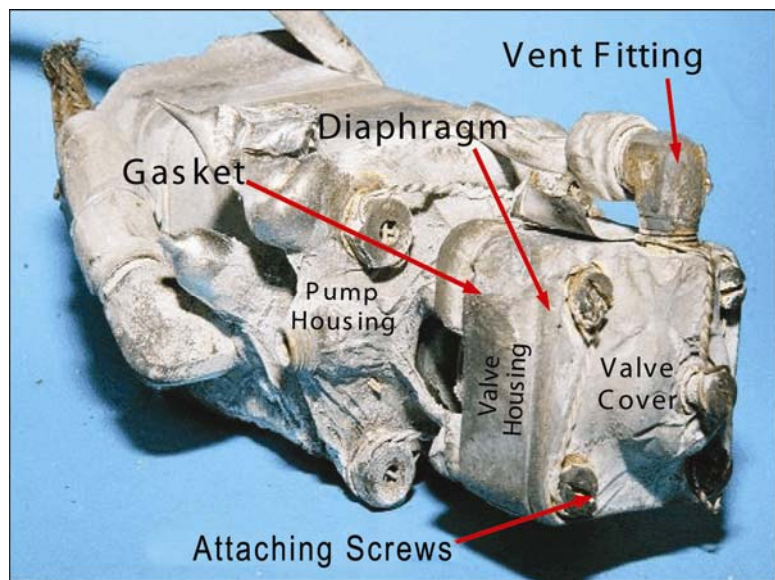
Photo 2. Engine-driven fuel pump

AD 2003-14-03, which supersedes AD 98-18-12, requires a torque check inspection of the four fuel pump relief valve attaching screws (part number AN500A10-22) for the prescribed torque of 23 to 25 inch-pounds. This inspection is to be completed every 50 hours time in service or every six calendar months, whichever comes first. These screws secure the assembly of the valve cover, diaphragm, valve housing, and gasket to the fuel pump. It has been determined that loss of torque on these screws allows the extrusion of the gasket (part number RA-15981) between the

valve housing and the pump housing and the extrusion of the diaphragm between the valve housing and the valve cover (see Photo 2). According to the information in the ADs, extrusion of the gasket and/or the diaphragm is known to have caused serious fuel leakage, which in turn can lead to engine failure, engine fire, and damage to, or loss of, various aircraft. The most likely source of ignition from an external fuel pump leak is the extremely hot turbocharger and exhaust system.

The supporting logbook entries detailing the maintenance performed between 03 March and 13 May 2004 record that the AN500A10-22 screws were tightened to "60" lbs" (60 inch-pounds), asserting that AD 2003-14-03 was completed with this action. This recorded torque is nearly three times the torque of the 23 to 25 inch-pounds prescribed by the AD. Engineering

calculations show that AN500A10-22 screws stretch and fracture when the applied torque exceeds approximately 40 inch-pounds. The screws from the accident pump were specifically examined during the disassembly of the fuel pump; none showed signs of stretch or fracture. The screws, therefore, had not been tightened to the value recorded in the logbooks.

AD 2003-14-03 further allows a terminating action (replacement of the pump with one having a new design valve housing) to be performed once in lieu of the repetitive maintenance action. The pump in C-FKEO did not incorporate the redesigned valve housing, nor was there any
