**AVIATION INVESTIGATION REPORT  
A06P0095**

**LOSS OF CONTROL**

**NORTHERN ROCKIES AIR CHARTER  
CESSNA 185B C-FPKJ  
PRINCE GEORGE AIRPORT, BRITISH COLUMBIA  
31 MAY 2006**

Report Number A06P0095

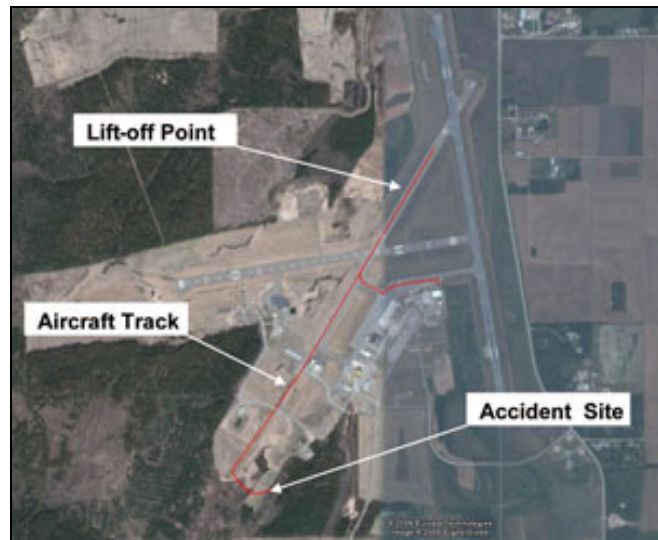
The pilot departed Prince George, British Columbia, from Runway 19 on a flight to Scoop Lake, British Columbia. The aircraft flew on the runway heading until it was about 2400 feet beyond the departure end of the runway, where it abruptly pitched up, climbed steeply, turned left, and rapidly descended into trees about 600 feet left of the runway's extended centreline. The aircraft was airborne for less than 47 seconds and reached a maximum height of about 270 feet above ground level. The aircraft was destroyed, and the pilot, who was the sole occupant, was seriously injured. There was no fire.

**Photo 1.** Departure path from Prince George Airport
