## **AVIATION INVESTIGATION REPORT A06O0186**

### **COLLISION WITH TERRAIN**

**CESSNA 180H N720CS  
CORDINGLEY LAKE, ONTARIO  
19 JULY 2006**

Report Number A06O0186

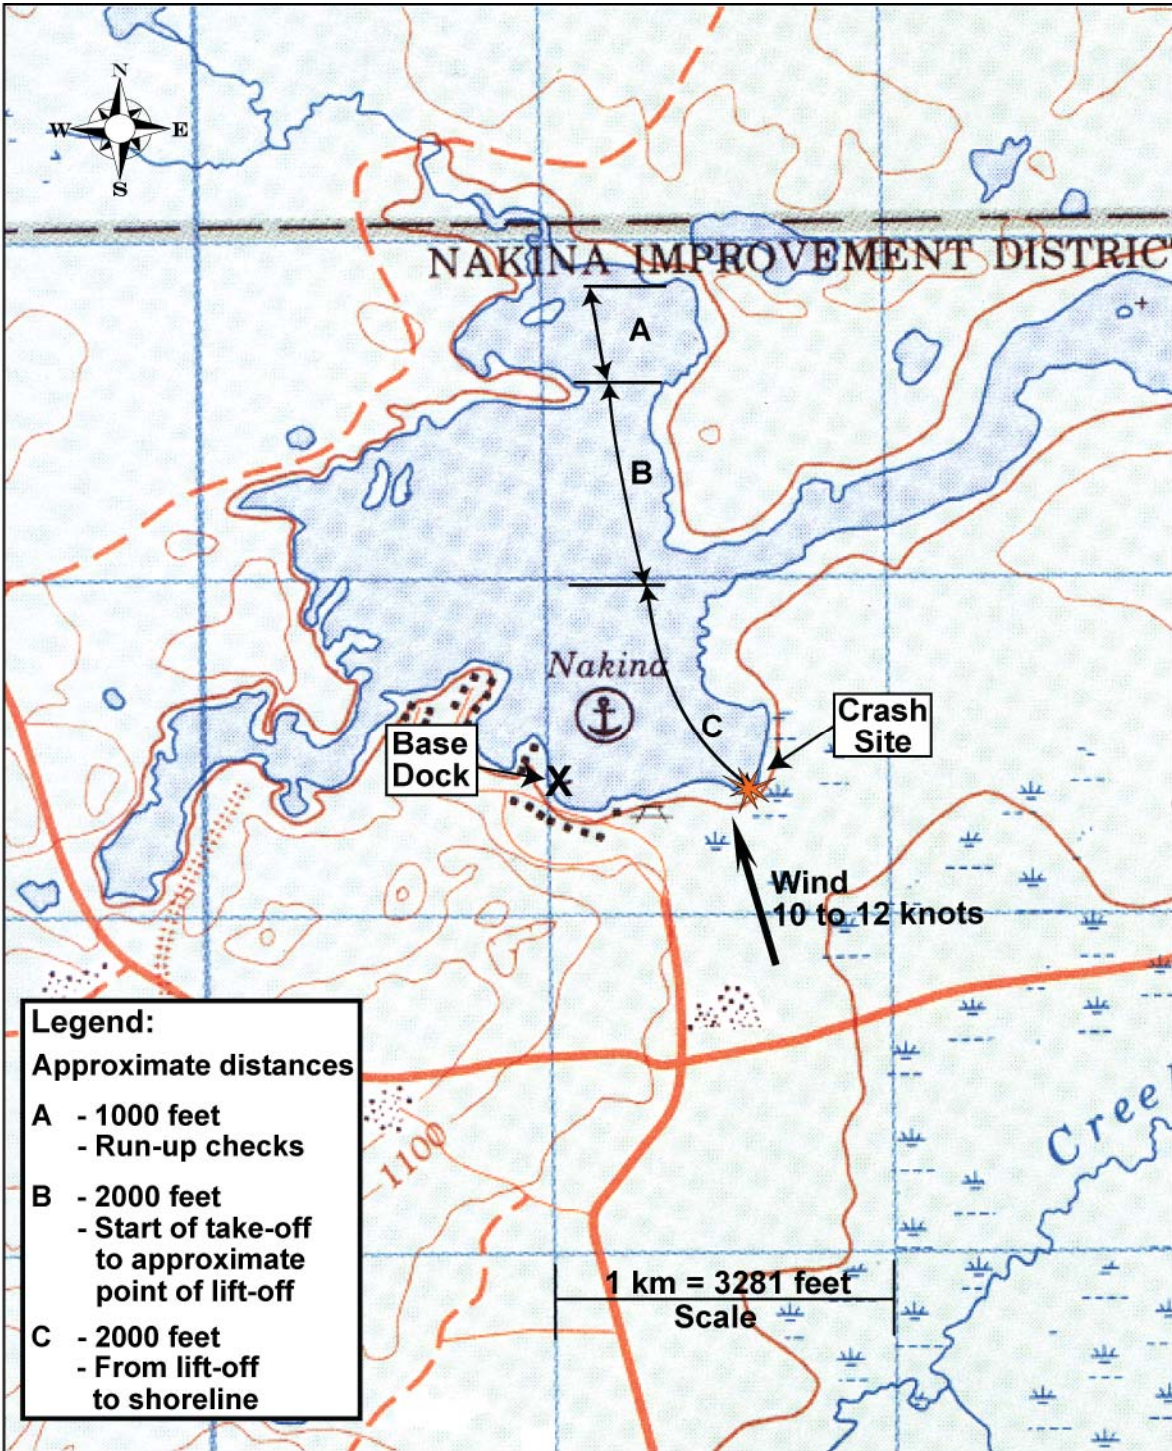
# Appendix A – Aircraft Take-off Path

The aircraft's floats were pumped out as part of the pre-flight checks. The aircraft was taxied to the north end of the lake and turned into wind for run-up checks of magneto and propeller operations. The aircraft travelled approximately 1000 feet during these checks. At 0905 eastern daylight time <sup>1</sup>, it began its take-off run with approximately 4000 feet remaining to the shoreline (see Appendix A - Aircraft Take-off Path). Flap setting was 20°. The aircraft came up on the step normally. The right float was rolled off the water; then it settled back. The right float was rolled off again and the aircraft became airborne at a speed of approximately 60 mph. The actual water run was approximately 2000 feet.

After the aircraft was airborne, it accelerated to about 65 mph and climbed to about tree-top height. It then stopped accelerating or climbing and the airspeed decreased to about 60 mph. The aircraft was turned 20° to 30° to the left to take advantage of lower terrain in that direction. The distance remaining to the shoreline was considered to be too short to permit a safe landing straight ahead. As the aircraft crossed the shoreline and made initial contact with the tops of trees, full flap (40°) was lowered and the controls were pulled aft in an attempt to slow the aircraft and cushion the impact by striking with the bottom of the floats first. The engine remained at full power.
