AVIATION INVESTIGATION REPORT

A06Q0157

ENGINE FAILURE

CESSNA 172M C-FFRV

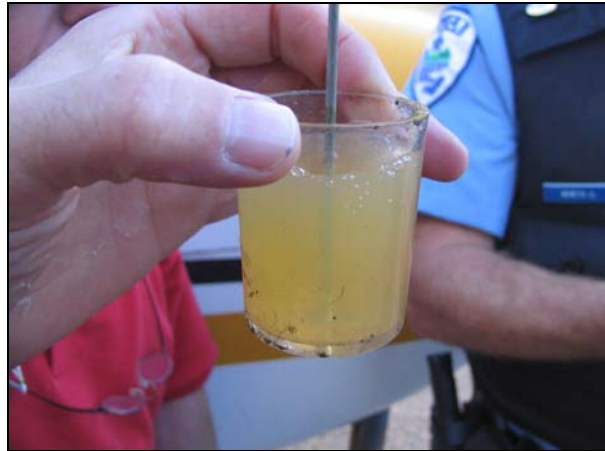
The aircraft was examined at the accident site, and a few water droplets were initially collected from the right wing tank drain valve. The left tank could not be drained because the dented wing skin obstructed the access to the drain valve. The gascolator bowl in the engine compartment was drained, and 5 to 6 ounces of yellowish water was collected (see Photo 1).

Photo 1. Water from gascolator

Analysis of the gascolator bowl showed that it had been in contact with water for a considerable period of time, probably several years. Since the aircraft was parked in the same place with a right bank angle most of the time, the quantity of water in the right fuel tank was undetectable. It is possible that a small quantity of residual water that was not drained from the fuel tanks made its way from the right fuel tank to the gascolator bowl in flight and stayed there until the next draining. The accumulated quantity of water that migrated during the occurrence flight saturated the gascolator bowl, causing the engine to stop.

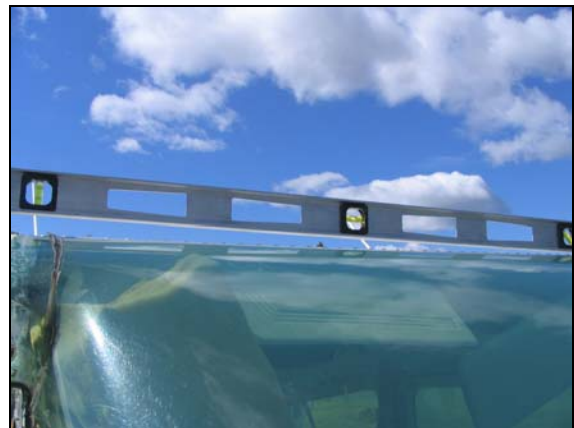
- the seals on the two fuel filler caps showed no defects;
- the left wing tank showed no evidence of water and the fuel filler cap installation was in accordance with manufacturer specifications;
- the chain used to tether the cap to the right fuel tank filler pipe was found at the bottom of the fuel tank;
- the two S-hooks on the chain showed signs of corrosion;
- debris was observed on the surface of the gascolator filter screen;
- the bottom of the gascolator bowl had stains from yellowish water;
- debris was observed on the surface of the carburetor filter screen;
- the area where the aircraft was usually parked was not level. The aircraft was always parked with a right bank angle. The right wing was about 1.5 inches lower over a distance of about 48 inches (see Photo 2).

Photo 2. Aircraft out of level

1. The aircraft was not on level ground when the draining was done before the flight. Consequently, the water in the fuel tank was lower than the drain valve and could not be removed with the pipette.
2. The water accumulated in the right fuel tank migrated to the gascolator bowl, saturating it, and causing the engine to stop.
