AVIATION INVESTIGATION REPORT

A06P0190

LOSS OF CONTROL - TRANSMISSION PYLON SUPPORT SPINDLE FRACTURE

**QUANTUM HELICOPTERS LTD.
BELL 206B (HELICOPTER) C-GSLV
ALICE ARM, BRITISH COLUMBIA
19 SEPTEMBER 2006**

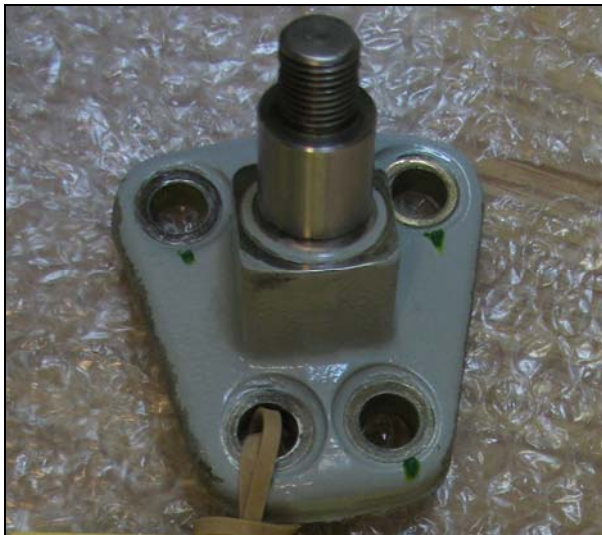
Photo 1. Exemplar pylon support spindle

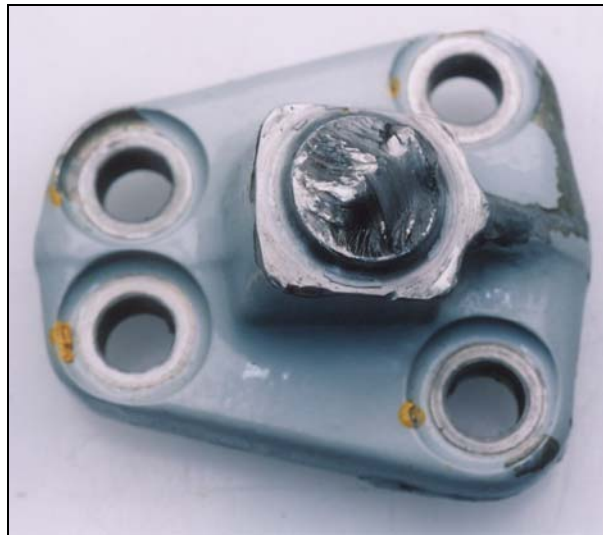
Photo 2. Fractured right-hand pylon support spindle

Both spindles were identified as part number 206-031-554-003. Serial number B12-14395 was the fractured right-hand spindle and B22515 was the intact left-hand spindle. The history of the spindles was not known in the early phase of examination; therefore, only a representative with metallurgical expertise from BHTI was invited to attend the examination at the TSB Engineering Laboratory facilities. Scanning electron microscope examination of the right-hand spindle confirmed fatigue as the primary mode of failure and vibratory loading as secondary. A second distinctive feature of the fracture surface was the presence of a thin annular ring, of a more crystalline appearance, around the full circumference of the journal. Such a feature would be consistent with a layer of plated material, indicating that a repair had been made. Coincident with the crack location was the presence of a subsurface radius produced by a grinding operation.

Examination of the left-hand spindle from the subject transmission also identified the commencement of cracks, limited to the plating layer, in the same region of the subsurface radius. This suggests that a stress concentration feature introduced by the repair was responsible for cracking at this particular location.

The right-hand pylon support spindle was found fractured at the root end of the journal section, yet the spherical bearing supporting the spindle did not display impact-related damage. This indicates that the right-hand pylon support spindle was not in the spherical bearing at the time of impact. A fatigue fracture is not consistent with an impact force. The dimensional restoration repair of the spindle journal introduced a stress concentration feature at the location of the subsurface radius, which was responsible for the formation of the fatigue crack and subsequent failure of the right-hand pylon support spindle.

1. The dimensional restoration repair of the spindle journal introduced a stress concentration feature at the location of the subsurface radius, which was responsible for the formation of the fatigue crack and subsequent failure of the right-hand pylon support spindle.
2. Failure of the right-hand pylon support spindle in flight caused the helicopter to become uncontrollable and collide with the level ground.

On 27 February 2007, TC issued Airworthiness Directive (AD) CF-2007-02, which mandated removal of all Bell 206B pylon support spindles that had been repaired by Cadorath Aerospace Inc. and mandated that maintenance records be annotated accordingly.
