AVIATION INVESTIGATION REPORT
A06W0002

IN-FLIGHT ENGINE FIRE

BUFFALO AIRWAYS LIMITED
DOUGLAS C-54G-DC (DC-4) C-GXKN
NORMAN WELLS, NORTHWEST TERRITORIES (CYVQ)
05 JANUARY 2006

Report Number A06W0002

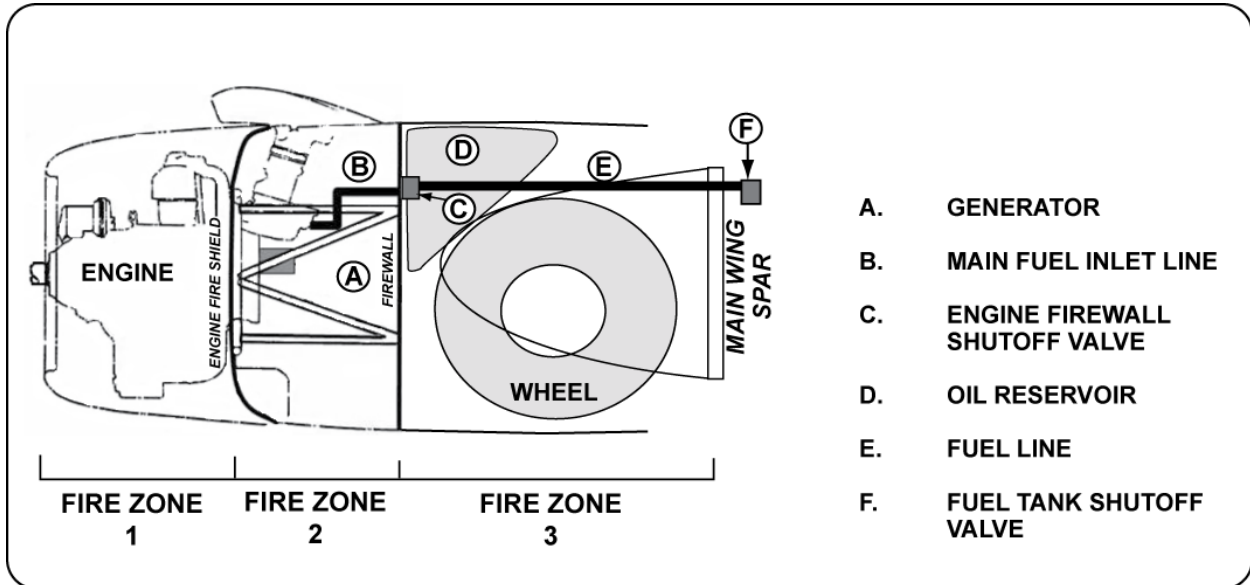
Figure 1. Number 2 engine nacelle diagram

The Engine Fire Checklist procedures (see Appendix A) contained steps to shut down the engine, close the firewall shutoff valves to stop the flow of fuel, oil and hydraulic fluids to the engine, and discharge the CO₂ fire extinguishers into zones 2 (engine accessory section) and 3 (nacelle section). Closing the firewall shutoff valve had no effect on the flow of fuel into Zone 3 because the fire had compromised the fuel line between the tank and shutoff valve (see Figure 1).

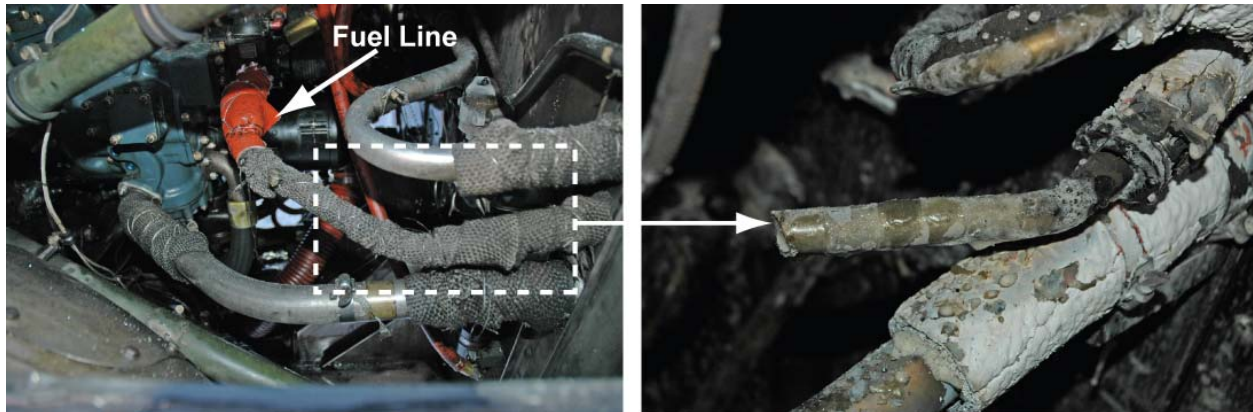
Figure 2. Typical installation of the Zone 2 fuel line compared to the compromised fuel line.

Examination of the number 2 engine area (Pratt & Whitney USA, R-2000) indicated that the fire originated in the lower left-hand accessory section (Zone 2). The intensity of the fire was consistent with a fuel-fed fire accelerated by engine oil and hydraulic fluid. The fuel source was the main fuel inlet line assembly, which is routed from the outboard firewall area to the engine-driven fuel pump. The line assembly consisted of a rigid tubular aluminum line connected with rubber hose couplings at the firewall and fuel pump fittings secured with hose clamps. There was no record of when the rubber couplings were last replaced, or their time in service. This assembly (see Figure 2) was wrapped and water-glassed from the firewall to the pump fitting. A fire shield sleeve was installed over the connector and fitting at the fuel pump. No special inspection criteria or schedule for this assembly is specified except for a leakage test at engine change. In June 1948, Douglas Aircraft issued Service Bulletin (SB) DC-4 No. 66 regarding engine fire prevention on aircraft specified by *Civil Air Regulations* amendments 41-3, 42-2, and 61-2. The SB specified a replacement flexible hose assembly to eliminate the aluminum line/rubber couplings/hose clamp assembly. An Airworthiness Directive (AD 48-12-01) was subsequently issued mandating the implementation of SB DC-4 No. 66 for aircraft used for air carrier operations. The modification had not been incorporated on C-GXKN.

The fuel line assembly of metal tubing, rubber hose couplings, and hose clamps increased the possibility of leaks due to the different expansion rates of materials. The sealing characteristics would be more critical when subjected to drastic in-service temperature changes, rubber hose aging, and heat deterioration. The wrapping and fire sleeve would conceal any evidence of minor seepage until the leakage had progressed substantially. The SB and AD that mandated the replacement of the fuel line had not been implemented on C-GXKN.

1. Airworthiness Directive AD 48-12-01 mandates the replacement of the potentially hazardous fuel line, but the line had not been replaced on this aircraft.
2. A fuel leak from the main fuel inlet line in the engine compartment of this cargo DC-4 caused an in-flight fire that spread into the nacelle and wing.
3. The fuel-fed fire burned for an extended period of time because turning the fuel selector off is not required as part of the primary Engine Fire Checklist.
