AVIATION INVESTIGATION REPORT

A06Q0180

LOSS OF ELECTRICAL POWER

BEEHCRAFT KING AIR 100 C-GJLP

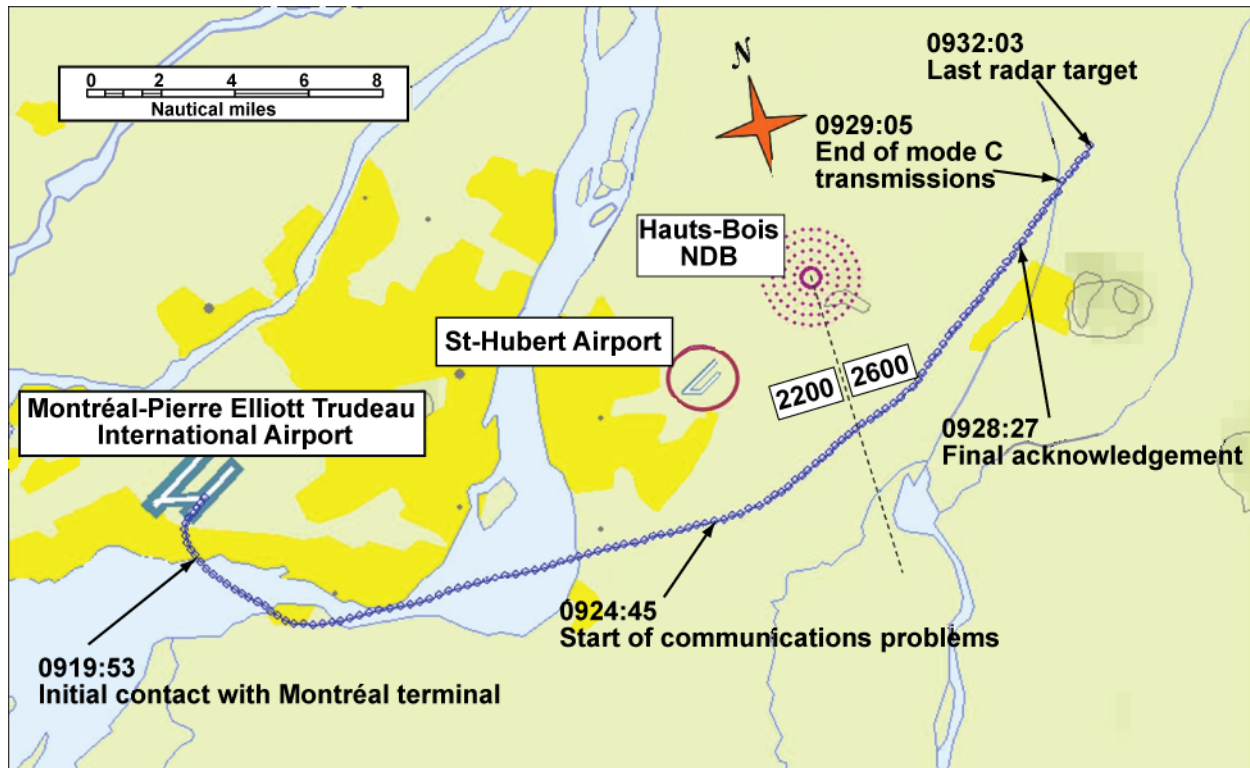
Figure 1. Radar track

During radar vectoring, the crew was able to estimate its position in relation to the St-Hubert Airport (see Figure 1). The pilot-in-command remembered that, during the initial climb in Montréal, he could see the ground through a thin scattered layer of cloud, to an altitude of about 2000 feet. The crew then decided to leave the last assigned altitude of 3000 feet for the minimum sector altitude (MSA),² which he believed to be 2200 feet. The MSA to the west of the Hauts-Bois non-directional beacon (NDB) (see Appendix A), the final approach fix (FAF) for Runway 24R, is 2200 feet while the MSA to the east of the Hauts-Bois NDB is 2600 feet.

At 2200 feet, the pilot-in-command saw the ground and made a steep turn to the left while maintaining visual reference. Once the aircraft was levelled, the crew estimated the ceiling to be approximately 200 feet above ground level (agl) and the visibility to be ½ mile. The radar track shows that, during the descent, the aircraft was 9 nautical miles (nm) east-northeast of the NDB; the MSA for this area would have been 2600 feet.

1. The crew descended to an altitude below the sector altitude applicable to its position, without knowing its exact position. This situation increased the risk of collision with the terrain or with obstacles.
