**AVIATION INVESTIGATION REPORT
A06C0181**

DEPARTURE FROM RUNWAY SURFACE

**PERIMETER AVIATION LTD.
SWEARINGEN AIRCRAFT CORPORATION
SA226-TC C-FTNV
NORWAY HOUSE, MANITOBA
08 NOVEMBER 2006**

Report Number A06C0181

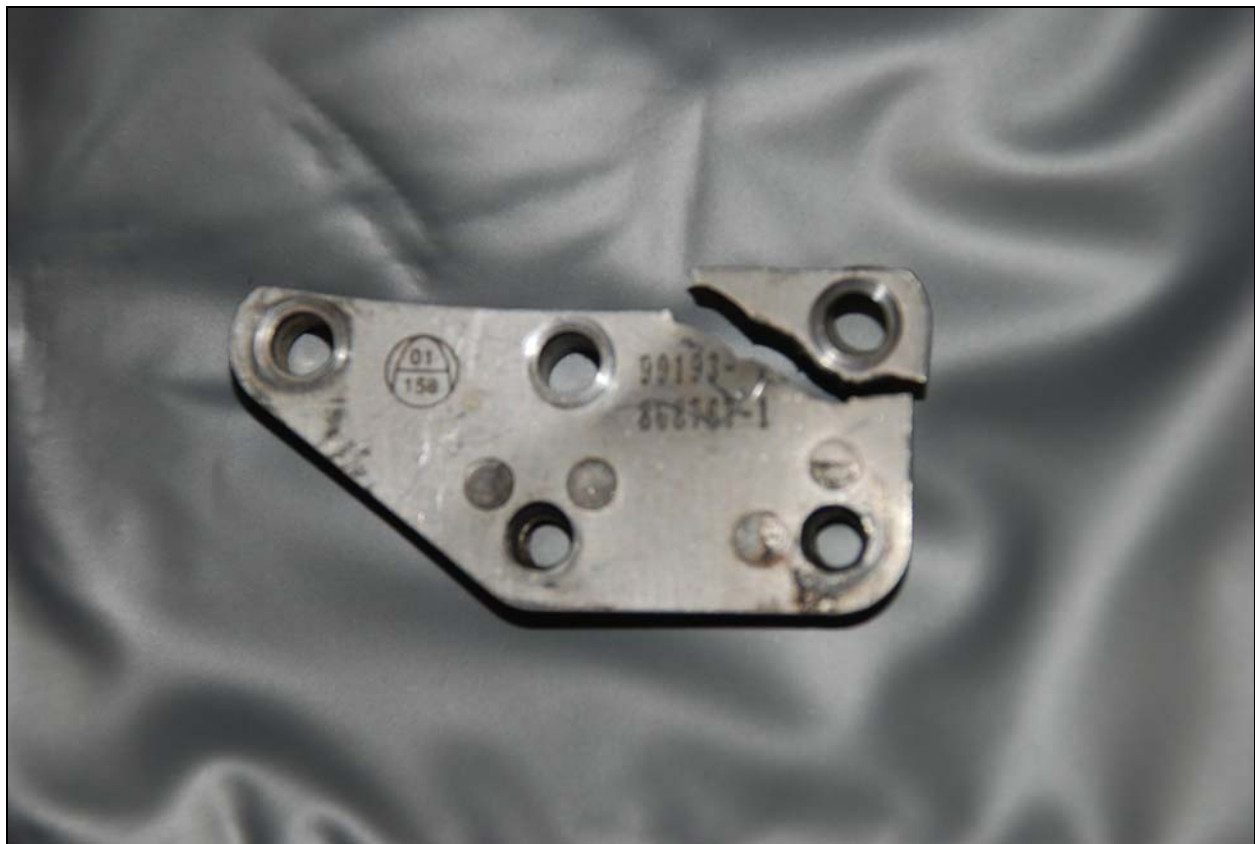
Photo 1. Left engine fuel control upper support assembly

When the left fuel control assembly was removed, the inboard corner and the corresponding attachment bolt of the part number 868767-1 support assembly were attached to the engine case, but separate from the remainder of the assembly. The centre bolt and the outboard bolt were in place on the remainder of the support assembly. A space was evident between the two separated pieces indicating that the outboard portion of the support had rotated slightly and

moved downwards. Engineering examination confirmed that the support assembly failed as a result of progressive fatigue cracking that had initiated in the vicinity of a spacer braze and progressed in two directions to both ends of the fracture face. Additionally, the braze material at the centre bolt spacer showed that similar cracking was commencing at several locations adjacent to that fastener.

After the support assembly failed, any loads applied to the fuel control were transferred to the remaining two bolts. The change in support resulted in a shifting of the support assembly and a subsequent change in the position of the fuel control. With the fuel control removed, the failed support components remained separated by 0.125 inches. It is suspected that, under the effects of loading, that separation could have been as much as 0.25 inches. A change in the position of the fuel control would result in a repositioning of the concentric control shaft and a corresponding change in dimensions at the propeller controls. The corresponding support bracket for the right engine remained intact.

1. The left engine fuel control support assembly failed in fatigue and released one of three attachment bolts, which resulted in a slight displacement of the fuel control and changed the propeller control dimension. As a result, Beta pressure was achieved and propeller reverse was available for the left engine before it was available for the right engine.
2. The pilot selected thrust reverse without confirmation that the Beta lights were on for both engines, and the aircraft veered from the runway, most likely as a result of temporary asymmetric thrust.
