AVIATION INVESTIGATION REPORT

A06Q0188

LOW FUEL EMERGENCY

BOMBARDIER CL-600-2B19 C-GJZF

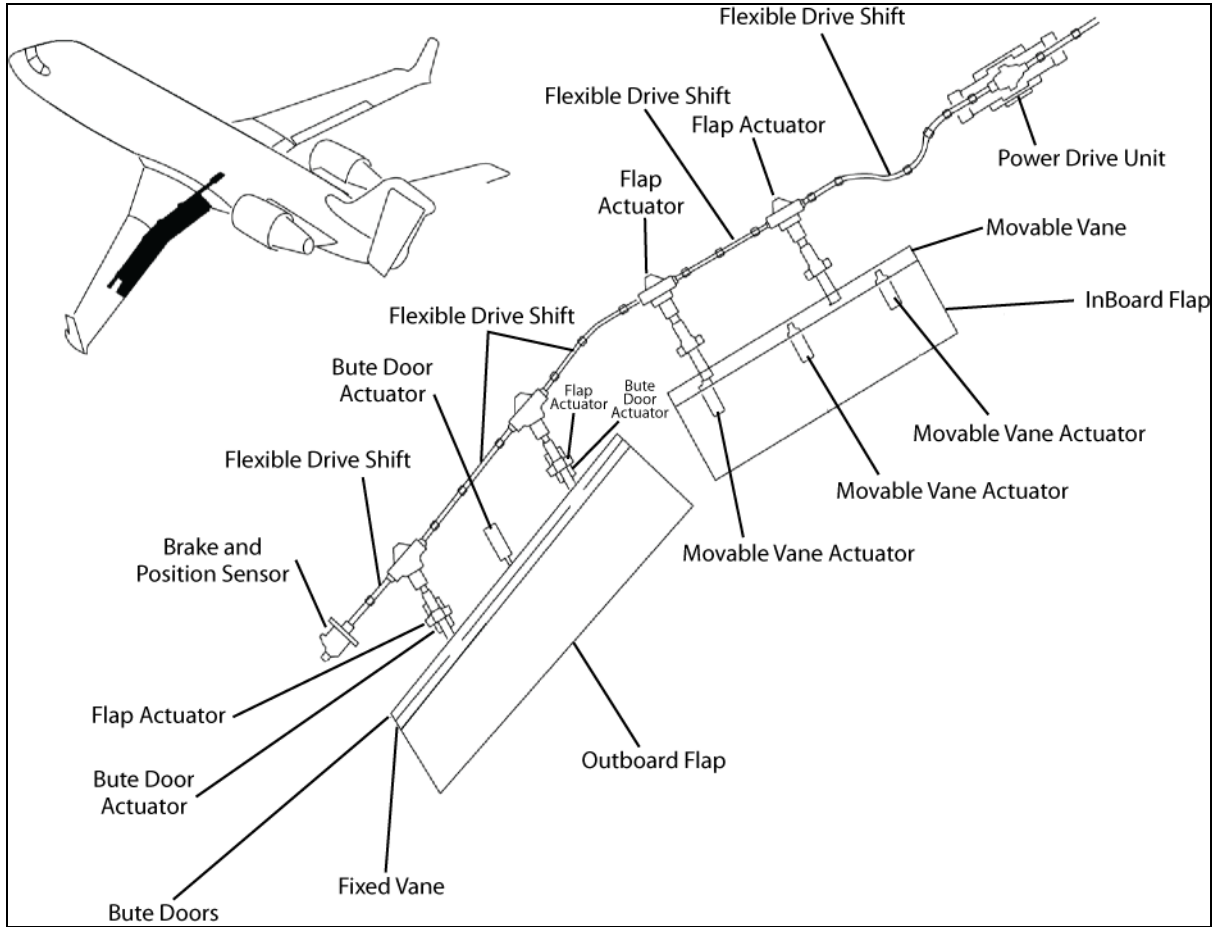
Appendix A – Flap Drive System

The flap control surface system consists of one inboard and one outboard double-slotted flap (see Appendix A) installed on the trailing edge of each wing. The two inboard flap panels move through a range of 0° to 45°, and the two outboard flap panels move through a range of 0° to 40°. Each inboard flap contains one movable leading edge vane and three movable vane actuators. Each outboard flap contains one bent-up trailing edge (BUTE) door and three BUTE door actuators.
