AVIATION INVESTIGATION REPORT

A06C0204

CARGO DOOR OPENING ON TAKE-OFF

BOEING 727-227 C-GJKF

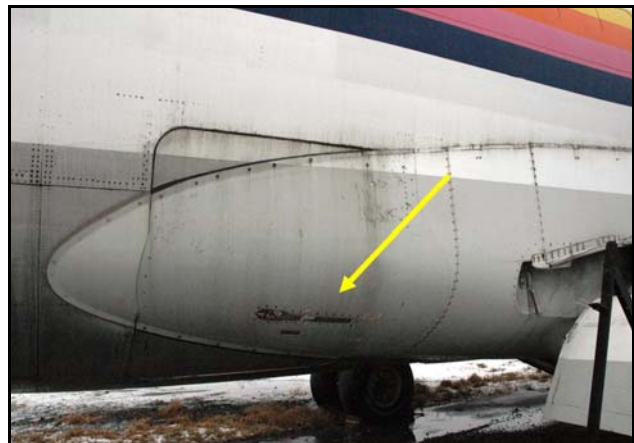
The first step in locking the cargo door is to close the door against the door frame while the external handle is fully extended. When the door is fully closed, the latch rollers are lined up with their respective cams. Movement/retraction of the handle inserts the overcentre latch rollers into their respective cams, resulting in the locking/inward and downward movement of the door. The door handle is then stowed into its recess (see Photo 2).

Photo 2. Aft cargo door handle stowed

The loading and unloading of KFA284 was carried out during the early hours of the morning, in the dark. It is likely that the cargo door was closed but not locked. Despite the position of the door handle, an unlocked aft cargo door in a closed position may appear to be locked, especially from a distance in the dark (see photos 2 and 3).

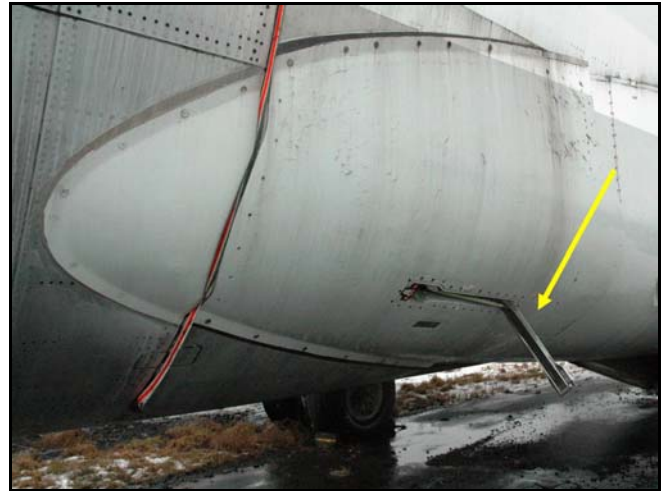
Further tests were carried out on an exemplary Boeing 727-227 aircraft. Numerous operational tests of the aft cargo door could not produce a condition that would extinguish the aft cargo door light on the second officer's annunciator panel and yet leave the door unlocked. Tests revealed that the door was able to close against the door frame and remain in position, with the handle fully extended (see Photo 3).

When the cargo door is open, the handle extends outward approximately 90° into the slip stream (see Photo 3). Previous analysis was conducted by Boeing and the United States National Transportation Safety Board on the external door handle of the cargo door, as a result of a similar occurrence. The analysis concluded that an airspeed of 190 knots produced a sufficient aerodynamic force to close the handle far enough to allow the spring forces inside the cargo door to pull the handle completely closed, even though the cargo door itself remained open. The maximum speed attained during the occurrence flight was in excess of 250 knots indicated airspeed.

Photo 3. Aft cargo door closed and unlocked

After the occurrence, Purolator Courier amended its ramp operations manual by introducing a checklist that requires ramp attendants to ensure the security of cargo doors. The checklist is required to be initialled by ramp personnel after the completion of each aircraft loading operation.
